Technical product information

| Topic | Rotating display/screen - Fault diagnosis - Mechanical malfunction DTC B140107 is evident within 005F |

New Continental GT

- Bentley Rotational Display (BRD) operational issues
- Mechanical malfunction DTC B140107 evident within 005F

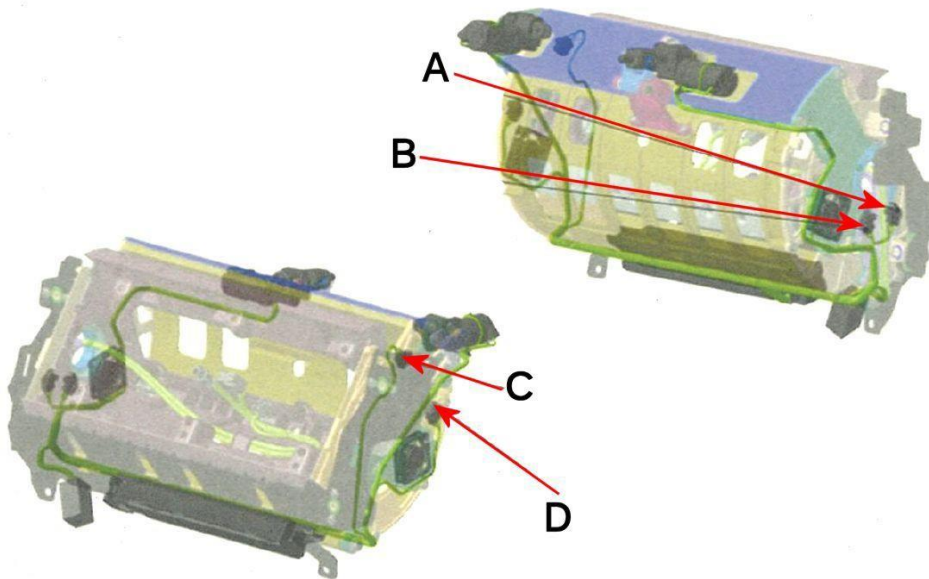
Figure 7 shows the location of each BRD switch (A to D) as follows:

- A - Rotational gauge fascia position
- B - Rotational veneer fascia position
- C - Longitudinal deployed position
- D - Longitudinal rotation position

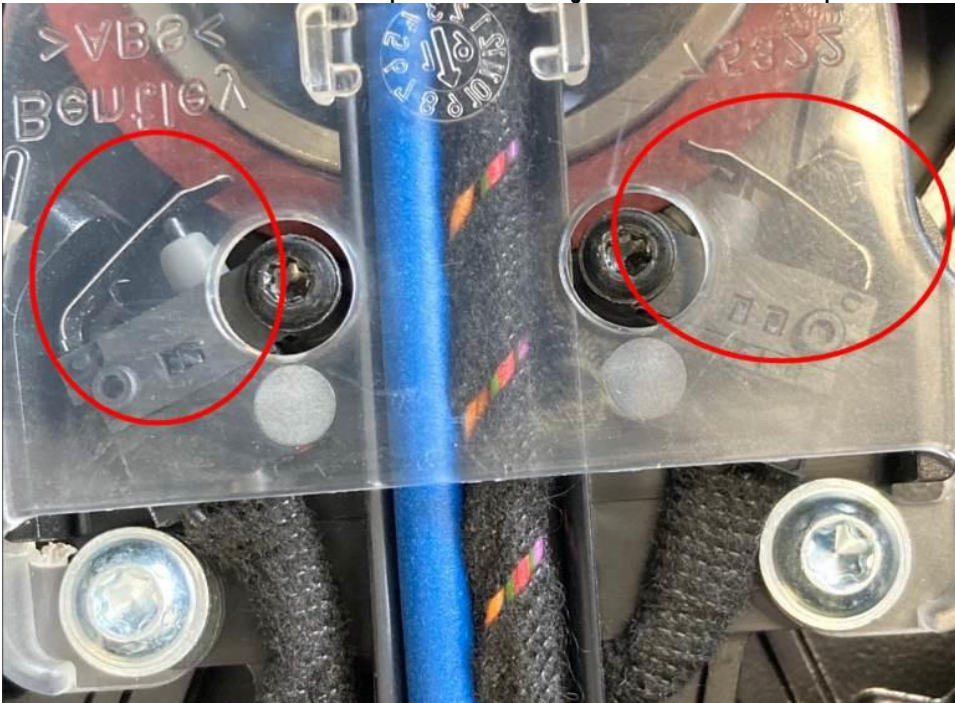
Figure 8

Referring to Figures 8 and 9 check/confirm the condition of the micro switches checking for any abnormalities for example damage and/or striker misalignment
