SERVICE BULLETIN

APPLICABILITY: 2010-2013 Legacy and Outback Models
SUBJECT: Sunroof Does Not Open or Close Properly
 Popping or Slamming Sound When Glass Lowers
 Prior To Opening

NUMBER: 07-72-13
DATE: 01-29-13

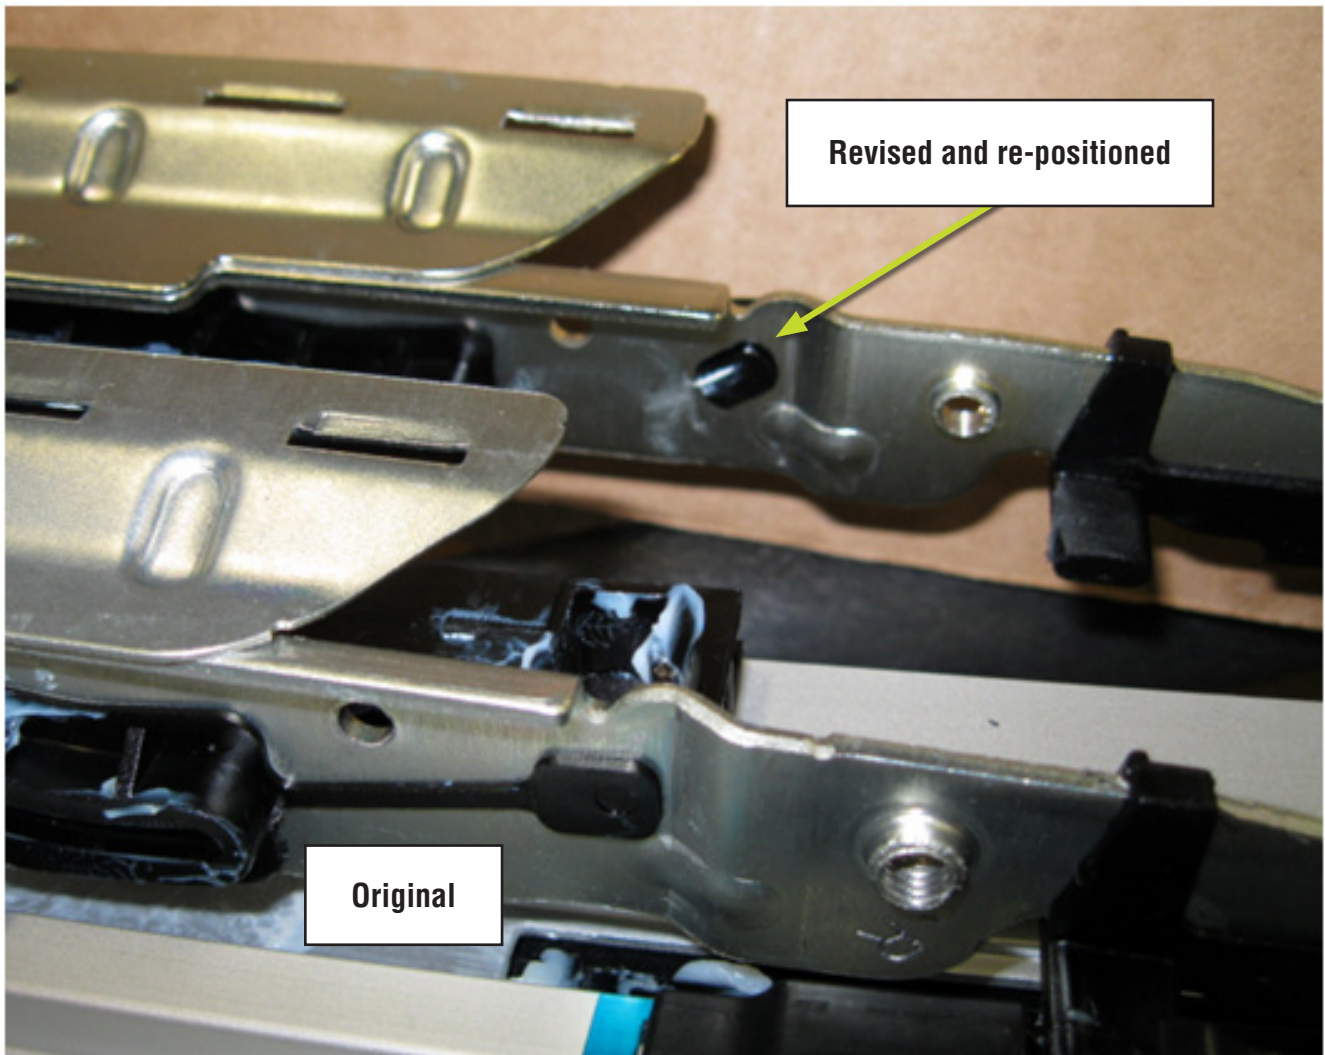
Revised Cable Bracket

The “Cable Repair Kit” consists of a revised lid bracket and sunroof operating cable assembly.

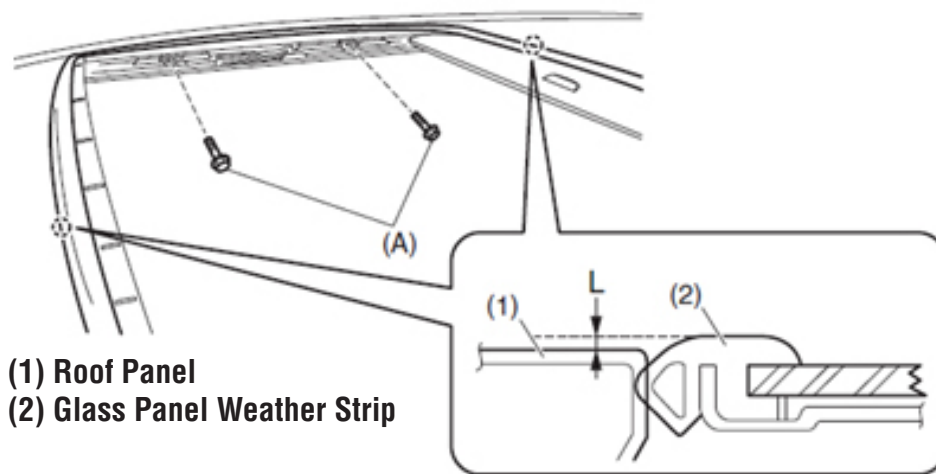
- Verify the customer's concern(s) as reported.
- Inspect the sunroof side rails and wedge cap areas closely for damage. If any damage is confirmed, remove the sunroof assembly from the vehicle following the procedure in the applicable Service Manual. No further inspection is required. Replacement of both cable assemblies and the rail assembly will be required to repair the vehicle.
- If the sunroof makes a sound when it is opening but no damage as outlined above is found:
 - o Close the sunroof completely.
 - o Confirm that the glass panel extends above the roofline by 1mm or less as shown by "L" in the illustration below.
 - o If the glass panel is not within the specified 1mm of flush, open the sunshade, remove the trim covers then loosen the four glass panel mounting bolts. Shim the glass panel assembly as necessary to achieve the desired measurement.

- Open the sunroof to the point where the rear edge of the glass is fully dropped down, just before it retracts under the roof panel.
 - o Determine the center point of the back edge of the glass panel by measuring from the outside edges in toward the middle from each side.
 - o Measure the distance between the top outside edge of the roof opening flange and the glass panel as shown in the photo below.
