## SERVICE BULLETIN

**APPLICABILITY:** 2013MY Legacy and Outback 2.5L Models  
 2012-13MY Impreza 2.0L Models  
 2013MY XV Crosstrek  
 2011-2014MY Forester  
 2013MY BRZ

**NUMBER:** 11-130-13R

**SUBJECT:** Difficulty Starting, Rough Idle, Cam Position or Misfire DTCs  
 P0340, P0341, P0345, P0346, P0365, P0366, P0390, P0391,  
 P0301, P0302, P0303 or P0304

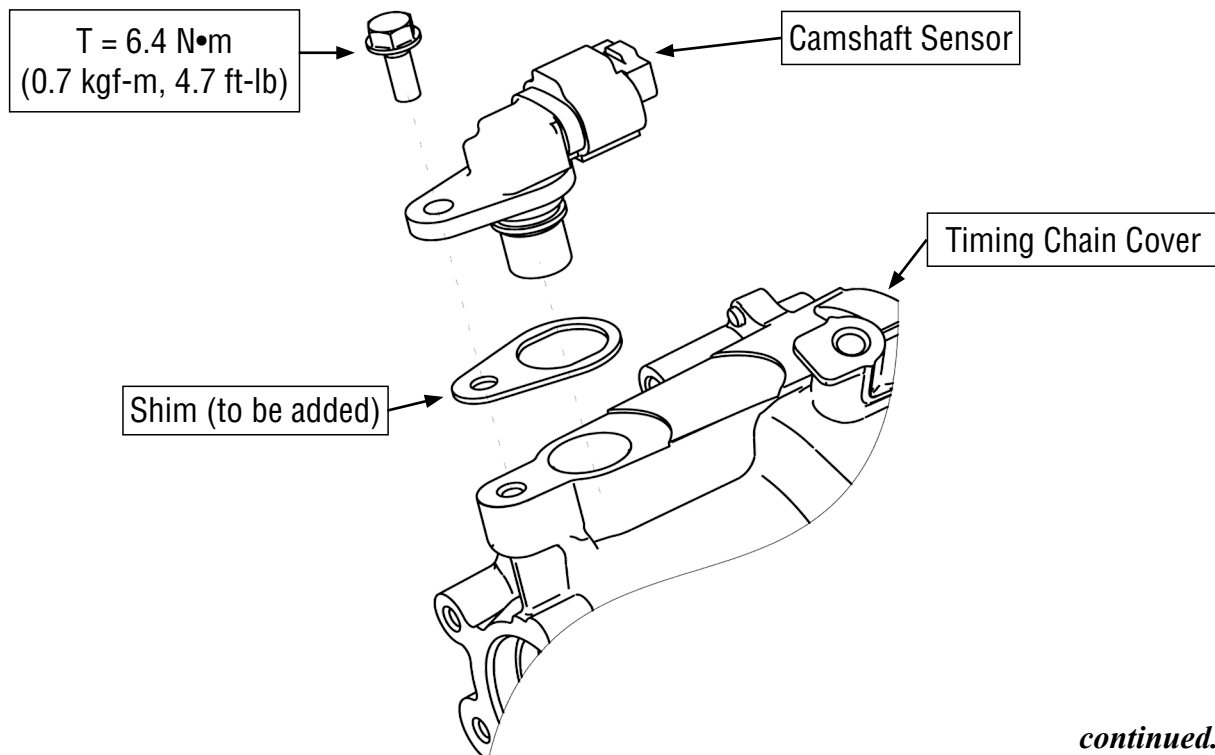
**The specified clearance is 1.3 +/- .05mm (1.25 to 1.35mm or .049" to .053").**

1. Record the customer's radio station presets (and navigation system favorites if applicable).
2. Disconnect the negative battery cable.
3. Remove the camshaft position sensor from the timing chain cover using the procedure in the applicable Service Manual.

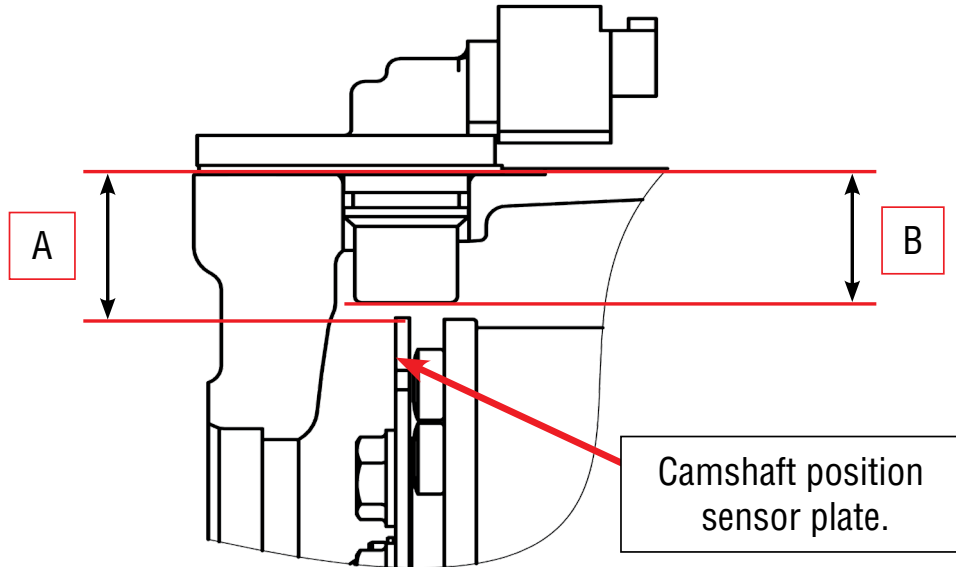
A = Top of timing chain cover to camshaft position sensor plate

B = Camshaft position sensor mating surface to the bottom of the sensor

**NOTE:** When measuring “A”, make sure you are measuring to the outside diameter or “top” of the sensor plate and not to the bottom of a notch as shown below. Be sure to record all measurements.

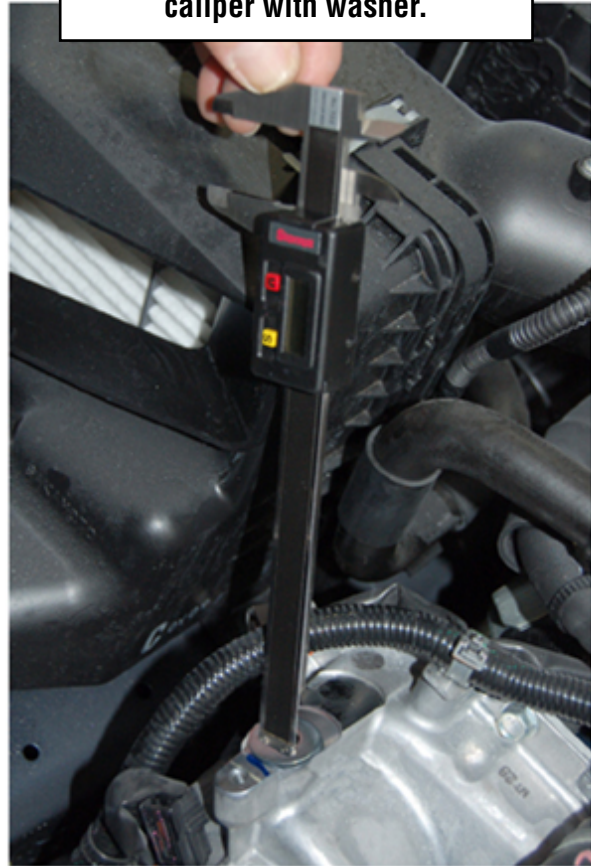
Measurement taken using digital caliper with washer.

**IMPORTANT:** When using the flat washer, make sure the washer is fully seated on the machined surfaces of the timing cover or your measurements will not be accurate.

1. Take a measurement and record the reading.
2. Using a breaker bar and 22mm socket, place the socket on the crankshaft pulley bolt and rotate the engine clockwise approximately 70°. **CAUTION:** Do not rotate the engine counter-clockwise, doing so will loosen the crankshaft pulley bolt. If the engine is accidentally turned counter-clockwise make sure the bolt is re-torqued following the proper procedure in the applicable Service Manual.
3. Take a measurement and record the reading.
4. Rotate the engine clockwise approximately 70°.
5. Take a measurement and record the reading.
6. Use the smallest of the three measurements and record the result.

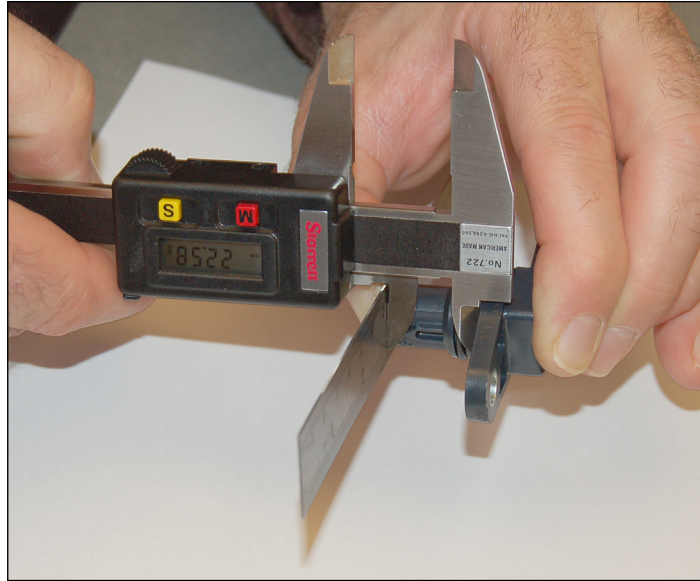
When taking measurement “B”, use a flat steel ruler or equivalent along with the digital caliper.

7. Measure the distance between the camshaft position sensor mounting surface and the bottom of the sensor as shown above.

**IMPORTANT:** Be sure to account for the thickness of the flat washer (if you are using one) when performing your calculations to determine the required shim thickness.
