May 26, 2023

SUBJECT: **Customer Satisfaction Program 22N12 – Supplement #1**
 Certain 2015-2018 Model Year Edge, 2019-2020 Fusion and MKZ Vehicles Equipped with a 2.0L EcoBoost Engine and 6F35 Transmission
 Rattle Noise at the Transmission Bellhousing Area – Flexplate Cracks

CERTAIN 2015-2018 MODEL YEAR EDGE, 2019-2020 FUSION AND MKZ VEHICLES EQUIPPED WITH A 2.0L ECOBOOST ENGINE AND 6F35 TRANSMISSION RATTLE NOISE AT THE TRANSMISSION BELLHOUSING AREA — FLEXPLATE CRACKS

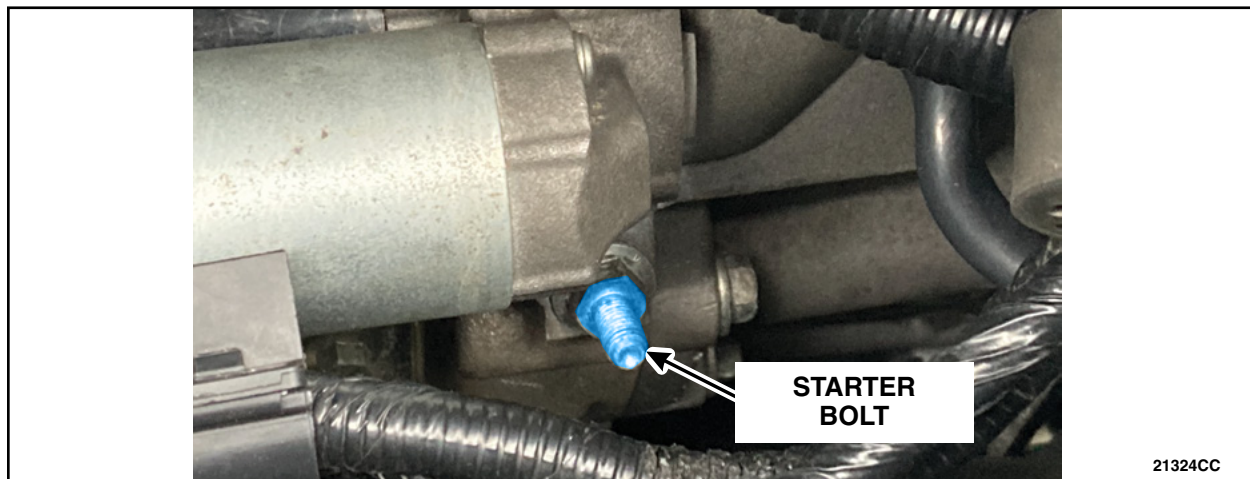
FIGURE 1

1. With an additional technician inside of the vehicle, position the vehicle on a hoist. Please follow Workshop Manual (WSM) Procedures in Section 100-00.
2. Start the vehicle.
3. Does the vehicle exhibit a rattle noise that has been isolated to the bellhousing?
 - Rattle noise will be most noticeable on initial engine start up. A few engine start up attempts may be needed.
 - The use of Chassis Ears (Rotunda part number JSP06600, or equivalent), may aid in narrowing down the noise to the bellhousing. Chassis ears should be placed on the transmission near the bellhousing, or the stud on the starter closest to the bellhousing. See Figure 1.
 - <https://rotunda.service-solutions.com/en-US/Pages/ItemDetail.aspx?SKU=JSP06600>
