Service Bulletin

Bulletin No.: 21-NA-049

Subject: Diagnostic Aid – PicoScope Information and Setup for Transmission Related Concerns

Brand:	Model:	Model Year:		VIN:		Engine:	Transmission:
		from	to	from	to		
Chevrolet	Corvette	2020	2023	—	—	All	All

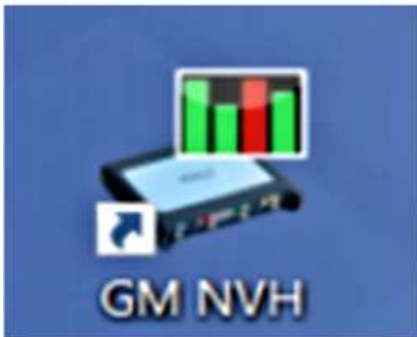
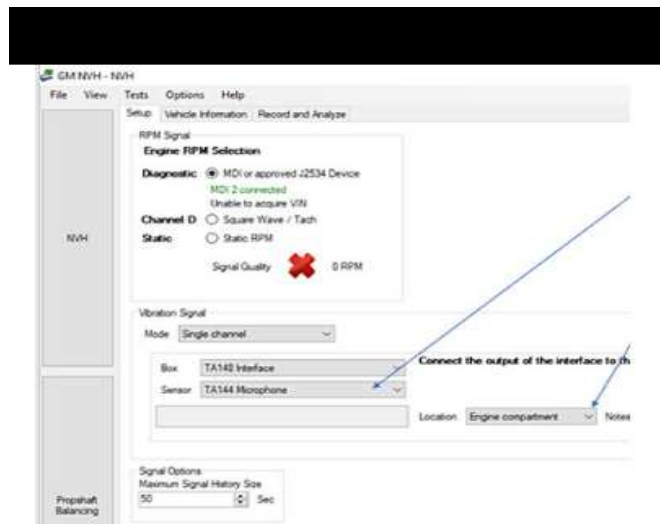
5751815

1. Place the PicoScope sensor on the bolt head shown in the image above. This is located on the right side of the transmission, near the transmission cooler. This bolt is used to secure a bracket for the wire harness. The sensor cable can be run into the passenger compartment with the engine compartment closed.

Note: Ensure to keep the cable routed away from the exhaust.
