Technical Bulletin

46 13 03 May 22, 2013 2015173 Supersedes T. B. V461302 dated April 19, 2013 to update rear disc brake turn labor operation in warranty table.

Brake Disc, Pulsation, All Vehicles except Routan (U.S. Only)

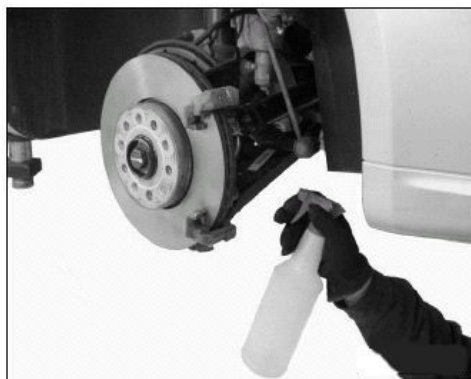
Recommended on-car brake lathes are either the PRO-CUT International™ PFM 9.0, or the Hunter Engineering Company model OCL 400. This design of brake lathe will produce a surface quality which will provide proper brake performance without a brake pad to brake disc break-in period.

To ensure that a high quality brake disc finish is produced, brake lathe cutting tools must be maintained as directed by the lathe manufacturer.

- Follow the brake lathe manufacturer's instructions for set-up and machining.
- Wash the brake disc with a soap and water solution upon completion of resurfacing to remove all machining particles.
