GLOBAL SAFETY FIELD INVESTIGATIONS DCS6609 URGENT - DISTRIBUTE IMMEDIATELY

- Subject: N232408020 Customer Satisfaction Program Missing Front License Plate Bracket
- Models: 2023 Chevrolet Blazer Equipped with License Plate Front-Frt Mounting Pkg (RPO VK3)
- To: All General Motors Dealers

N232408020 Missing Front License Plate Bracket

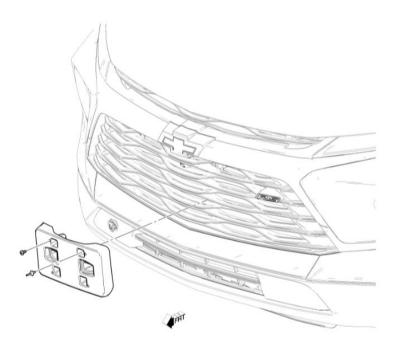
Condition	Certain 2023 model year Chevrolet Blazer vehicles may have been shipped from the assembly plant without the front license plate bracket.	
- [Correction	Dealers will install the front license plate breaket

Service Procedure
