HYUNDAI Technical Service Bulletin	GROUP CAMPAIGN	NUMBER 23-01-036H-1
	DATE JUNE 2023	MODEL(S) ELANTRA (CN7A) SONATA (DN8A) SANTA FE (TMA)
SUBJECT: HECU MODULE DARK CURRENT MEASUREMENT AND REPLACEMENT (SERVICE CAMPAIGN 990)

Description: Some Elantra (CN7A), Sonata (DN8A) and Santa Fe (TMA) vehicles may exhibit the Electronic Parking Brake (EPB) warning light on due to brake fluid entering the HECU electrical connector. DTC C1501 (EPB Switch Failure) may be present, but EPB performance remains unaffected. This bulletin describes the procedure to inspect, and if necessary, replace the Hydraulic Electronic Control Unit (HECU).

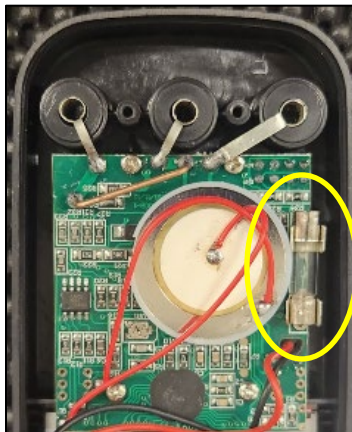
NOTE 1: Each dealer has been provided 1 multimeter for the start of the campaign.

NOTE 2: Before taking the dark current measurement, check the multimeter internal fuse. If the fuse is not intact, replace it before use.

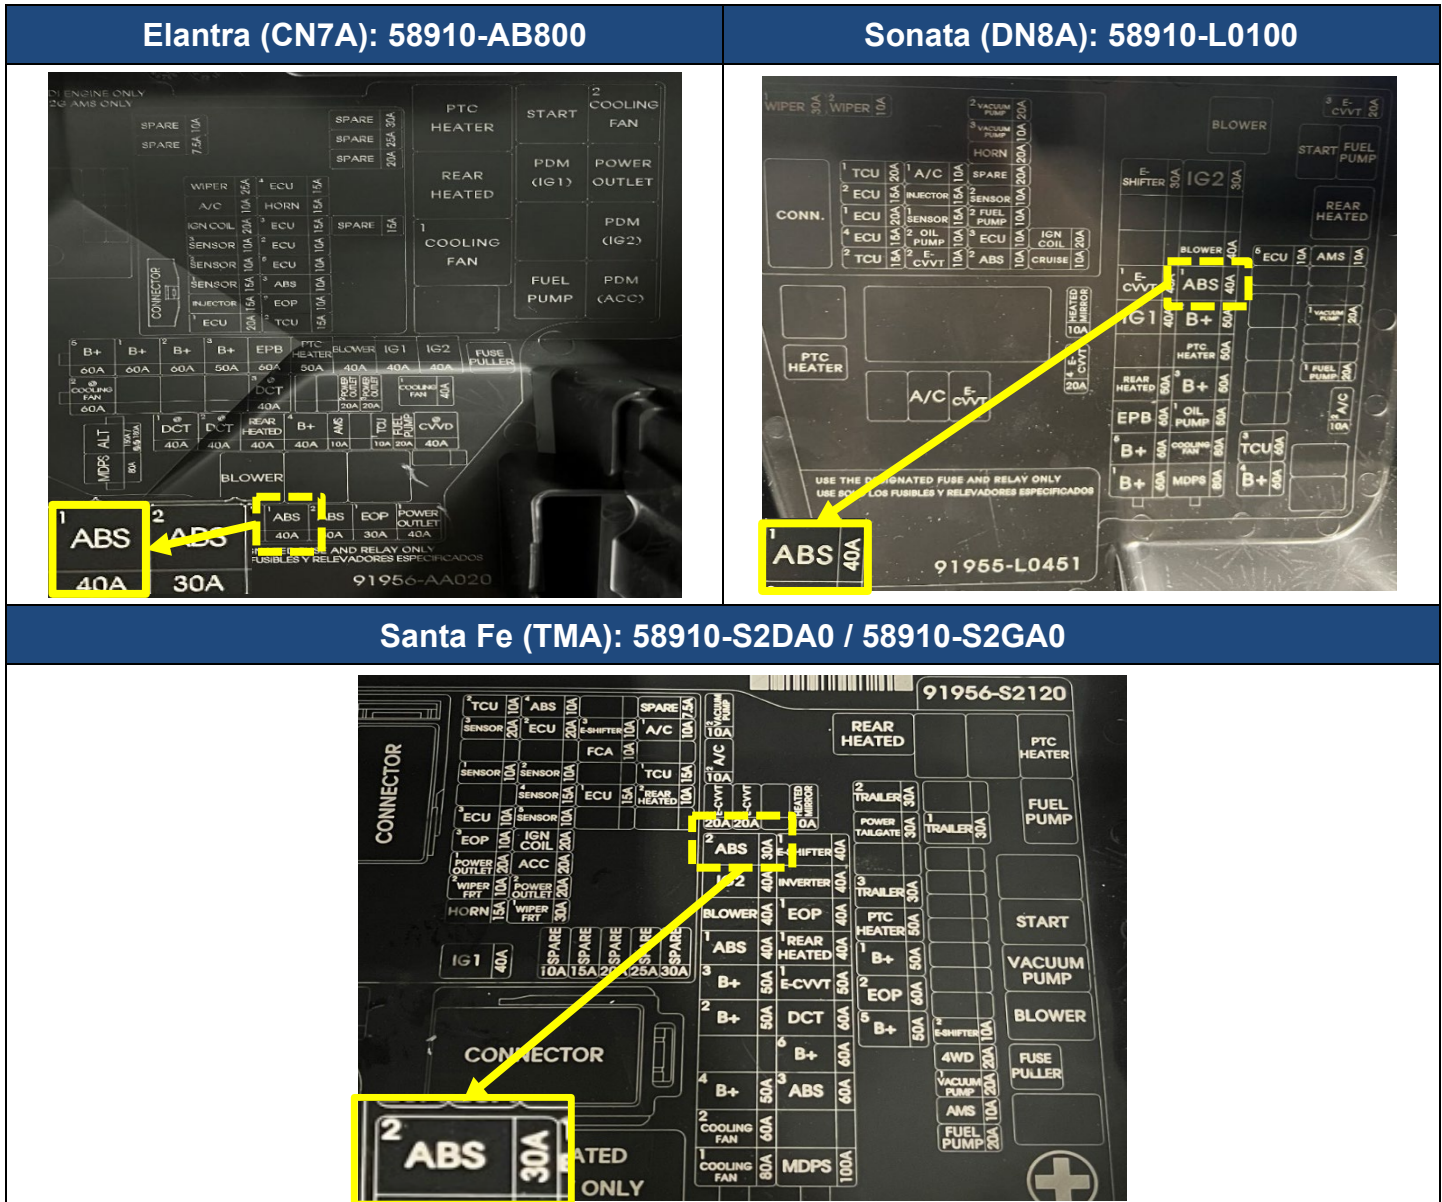
Fuse Box Cover Measurement Point Guide:

Model	Part Number	Part Name	Fuse Measurement Point	Maximum Dark Current Value
Elantra (CN7A)	58910-AB800	Hydraulic Unit Assy	40A (ABS)	95 μA
Sonata (DN8A)	58910-L0100	Hydraulic Unit Assy	40A (ABS)	95 μA
Santa Fe 2.5L (TMA)	58910-S2DA0	Hydraulic Unit Assy	30A (ABS)	95 μA
Santa Fe 2.5T (TMA)	58910-S2GA0	Hydraulic Unit Assy	30A (ABS)	105 μA

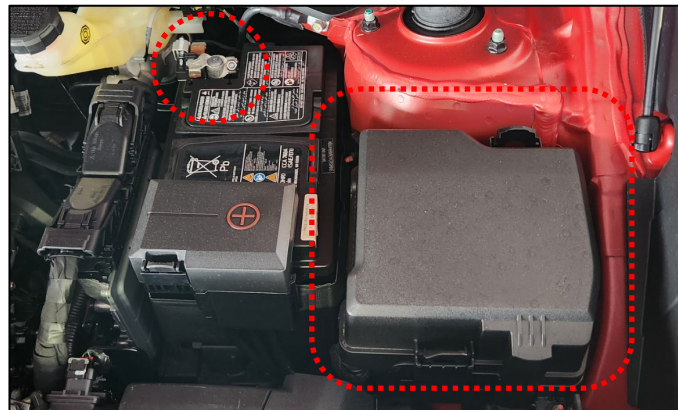
2. Disconnect the battery negative (-) terminal and remove the junction box fuse cover.

Negative (-) Battery Terminal Nut Tightening Torque:

lb-ft	• 3.0-4.4
kgf.m	• 0.4-0.6
N.m	• 4.0-6.0
