SERVICE BULLETIN

APPLICABILITY: 2023MY Outback & Legacy
2023MY Ascent

NUMBER: 15-311-23

SUBJECT: FOTA (Firmware Over-The-Air) Reprogramming for DENSO Gen 4.5 Audio Navigation Infotainment Systems via DCM

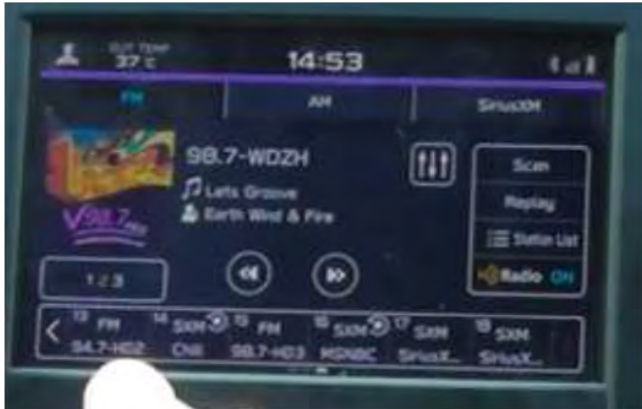
6	Android Auto Wireless (AAW) cannot be connected.
7	Android Auto Wireless (AAW) cannot be started from “Manage Devices” Screen.
8	Sound volume control does not work while using Android Auto. It is caused by data communication error between Android device and CCU.
9	Cyclic short noise like a drilling or vibration is heard from speakers.
10	<p>Sound is lost when changed to Subchannel 2 right after a preset HD radio channel has been selected.</p>
