APA4 - Check Connection Points on the Body and Rework if Necessary (Recall Campaign)

Vehicle Type: **911 Carrera (992) / 911 Carrera S (992)
911 Carrera 4 (992) / 911 Carrera 4S (992)
911 GT3 (992)**

Model Year: **As of 2020 up to 2023**

Concerns: **Connecting points on the body**

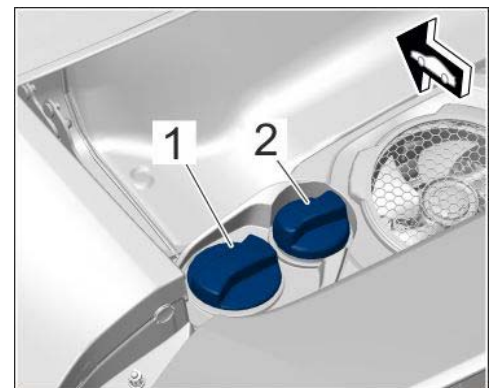
Oil filler neck cap

- Work Procedure:
- 1 Open the rear lid.
 - 2 Unscrew oil filler neck cover ⇒ *Oil filler neck cap -2-* and unclip left engine cover slightly upwards.
 - 3 **Visually inspect the connection points** in the marked area of the rear left side section.

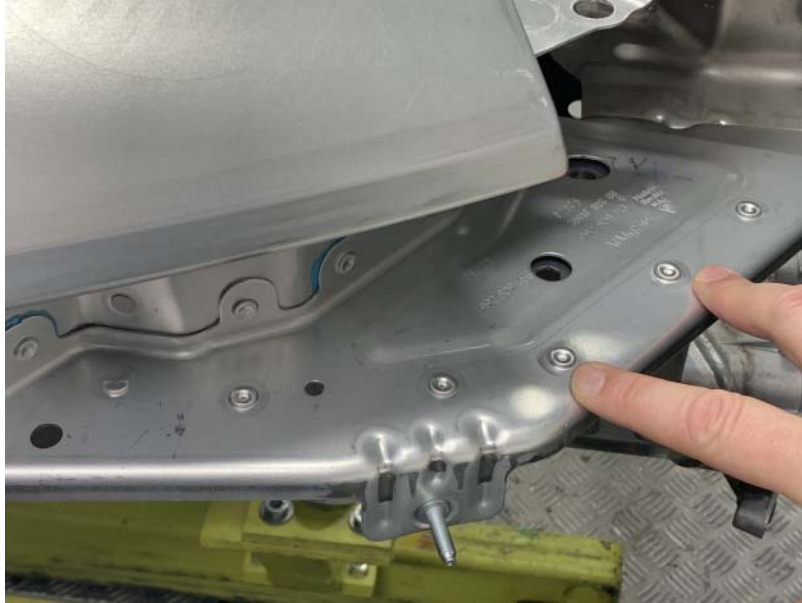
Example 1

Examples
of correctly
performed
welds
