Technical product information

Topic	New Continental GT and GTC - Window drop glass
Market area	Australia E04 Bentley rest Asia and Australia (6E04),China 796 VW Import Comp. Ltd (Vico), Beijing (6796),Germany E02 Bentley rest Europe (6E02),Japan E03 Bentley Japan (6E03),Korea, (South) E08 Bentley South Korea (6E08),United Arab Emirates E06 Bentley Middle East and Africa (6E06),United Kingdom E01 Bentley UK (6E01),United States E05 Bentley USA and rest America (6E05)
Brand	Bentley
Transaction No.	2070497/1
Level	EH
Status	Approval
Release date

New Continental GT and GTC

Retailer glass reset procedure for GT/GTC

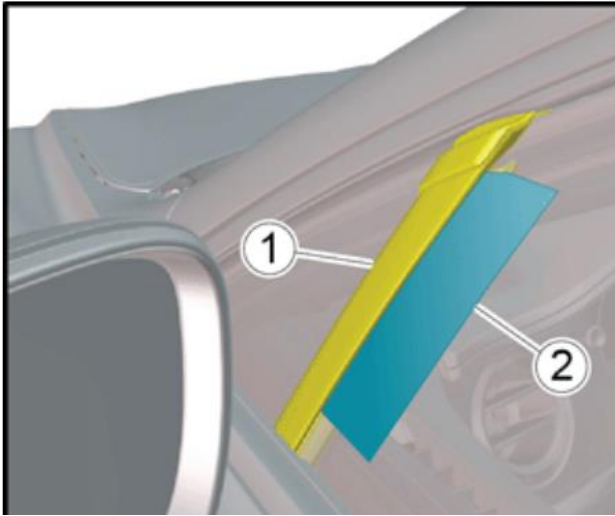
- **Measuring front glass intrusion into front division bar**

Example of incorrect fitment:
10mm intrusion into division bar seal not achieved. Only 6mm seen, front and rear side glasses will be too far rearwards, potentially clash condition between rear of rear glass and cant rail/roof seals

When reinstalling front drop glass ensure tape is applied at 10mm from front edge and align this with the previously set quarter glass division bar.
