VOLUNTARY SERVICE CAMPAIGN

Classification: AT23-003	Reference: NTB23-056	Date: June 21, 2023
-----------------------------	-------------------------	------------------------

VOLUNTARY SERVICE CAMPAIGN 2022-2023 FRONTIER AND 2023 TITAN/TITAN XD; AUTOMATIC PARK FUNCTION

CAMPAIGN ID #: PC982
APPLIED VEHICLES: 2022-2023 Frontier (D41)
2023 Titan/Titan XD (A61)

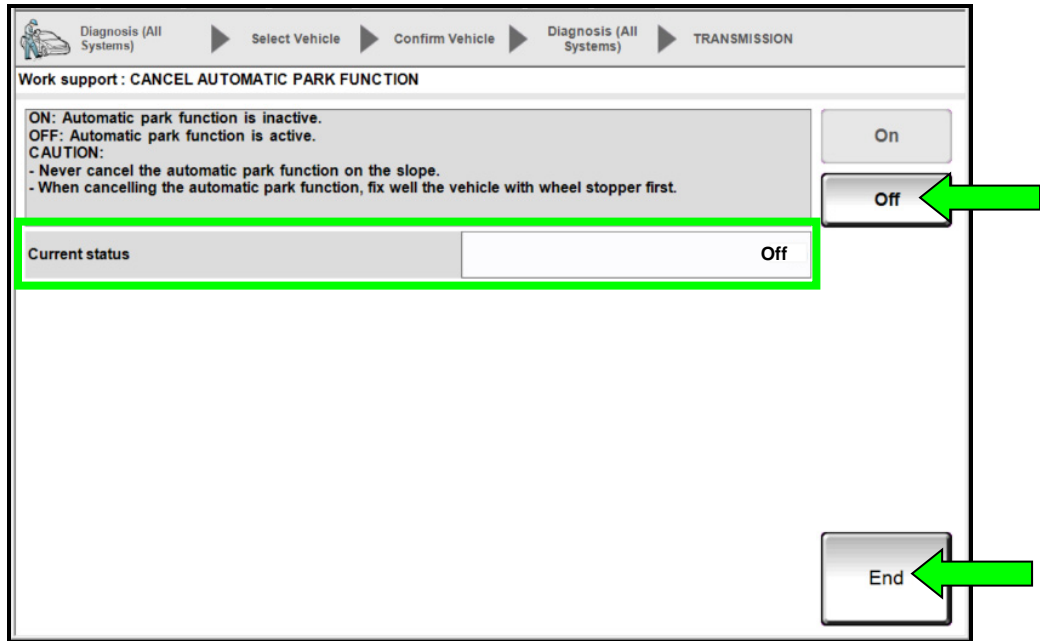
Figure 6

HINT: DTC P18A5-00 will automatically clear after changing the **CANCEL AUTOMATIC PARK FUNCTION** to **Off**.

15. Select **Off**, and then select **End**.

- Verify **Current status** shows “Off”.
