Service Bulletin

Bulletin No.: 23-NA-115

Subject: Ticking, Tapping or Snapping Noise from Engine - 5.5L RPO LT6 Realign Camshaft Caps as Required

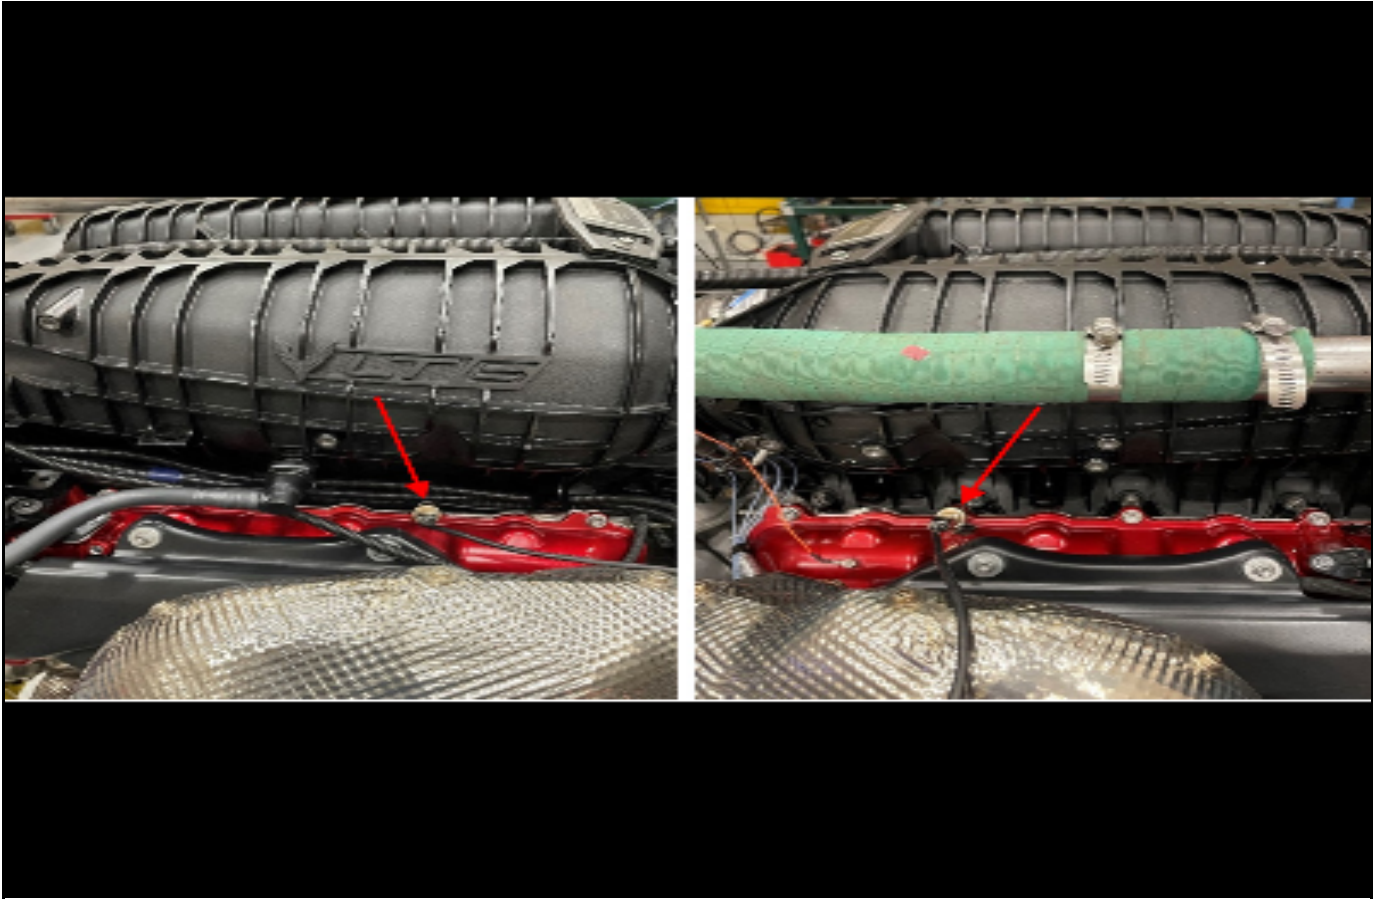
Place the accelerometer on the suspect bank.

- ⇒ With the suspect bank determined, prep/position the accelerometer so the X, Y, Z coordinate system (that's laser etched) is facing upwards before securing to the bolt head. After accelerometer is placed on bolt head, double check to ensure its centered and did not rotate on the bolt head. Doing so will ensure the best results.

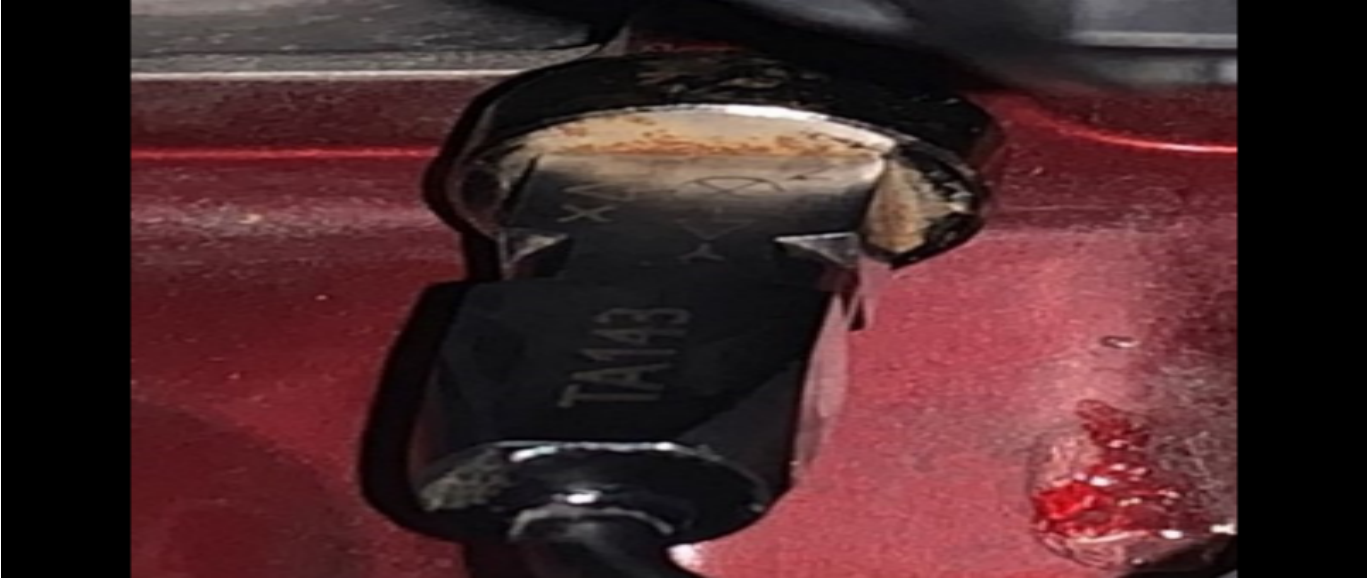
6374737

Important: Ensure accelerometer coordinates are facing up towards the intake.
