Technical Service Bulletin

15 Oil leak from the cylinder head - 2.9 and 3.0 TFSI only

15 23 44 2053278/9 July 14, 2023. Supersedes Technical Service Bulletin Group 15 number 21-39 dated June 25, 2021 for reasons listed below.

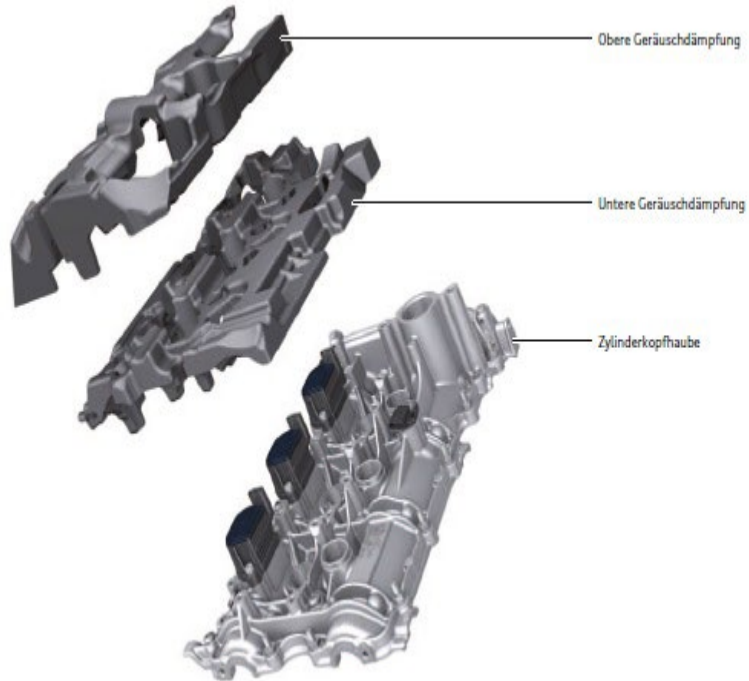
Figure 1. Removing the upper noise insulation.

1. Remove the engine compartment cover and the heat shield below it.
2. Remove the upper noise insulation of the affected cylinder bank (Figure 1).

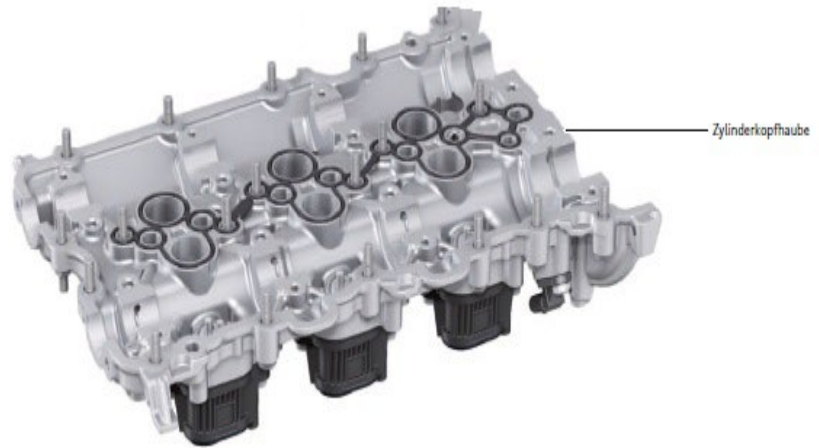
Figure 4. Remove the cylinder head cover and gasket.

6. Remove the cylinder head cover and the seal (Figure 4).

8. Install a new seal, re-assemble the camshaft cover, clean the engine compartment, and if necessary replace the noise insulation (if it is full of oil).
