Technical Service Bulletin

GROUP	NUMBER
CAMPAIGN	23-01-060H
DATE	MODEL(S)
JULY 2023	IONIQ 5 (NE1) IONIQ 6 (CE1)

SUBJECT: DTC P1A9096 CHECK FOR ICCU & FUSE REPLACEMENT AND ICCU SOFTWARE UPDATE (SERVICE CAMPAIGN 997)

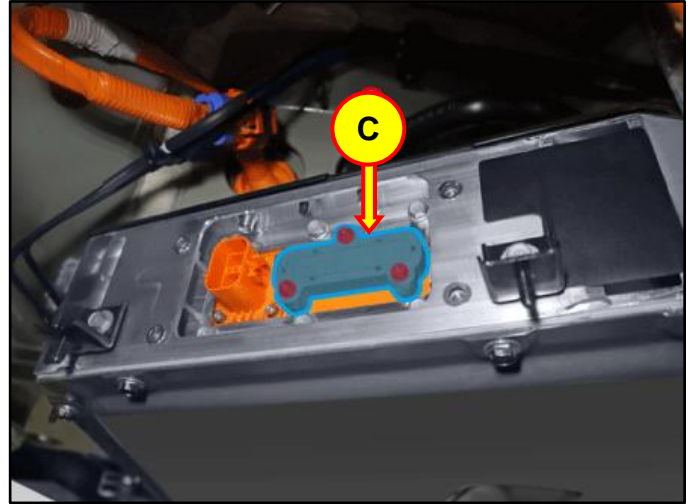
E5. Remove the ICCU fuse cover (C).

E6. Using a commonly available multimeter. Set at the ohmmeter measuring mode and inspect the fuse condition by checking the fuse's resistance value:

- **Fuse is Good:** Less than 1.0 ohm.

- **Fuse is Bad (Blown/Open):**
Resistance greater than 1.0 ohm or OL.

**ONLY REPLACE THE FUSE IF
FOUND TO BE BAD
(BLOWN/OPEN).**

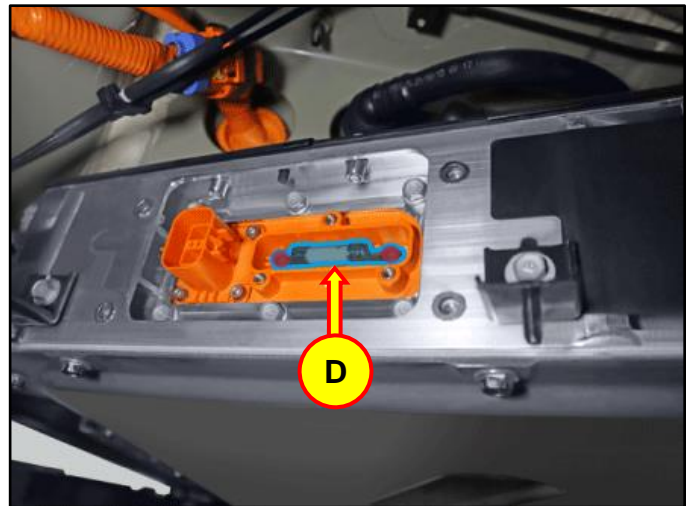
E7. Remove the ICCU fuse (D).

There can be difficulty removing the fuse, which may include the nuts of the at the back of the fuse holder falling back into the battery.

E8. Install the supplied new ICCU fuse.
