Complaint - Cylinder Head Cover Near the Injector Holes Leaking: Subsequent Work on Cylinder Head (180/18)

Vehicle Type: **Cayenne (9YA) / Cayenne Coupé (9YB) / Cayenne E-Hybrid (9YA) / Cayenne E-Hybrid Coupé (9YB) / Cayenne S (9YA) / Cayenne S Coupé (9YB)**

Concerns: **Cylinder head cover**

Cause: **Complaint about injector hole leaks**

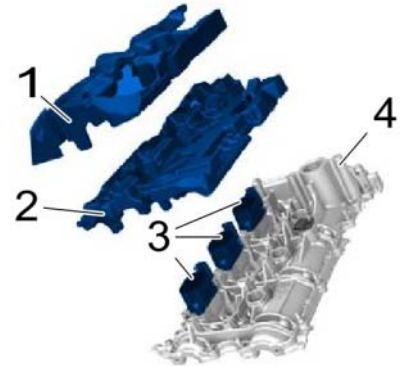
Cylinder head cover component overview

- 1 – Insulation on top of cylinder head cover
- 2 – Insulation on bottom of cylinder head cover
- 3 – Solenoid hydraulic valve for valve lift adjustment
- 4 – Cylinder head cover
