TECH TALK - VOLUME 275

July - August 2023

TECHNICAL INFORMATION

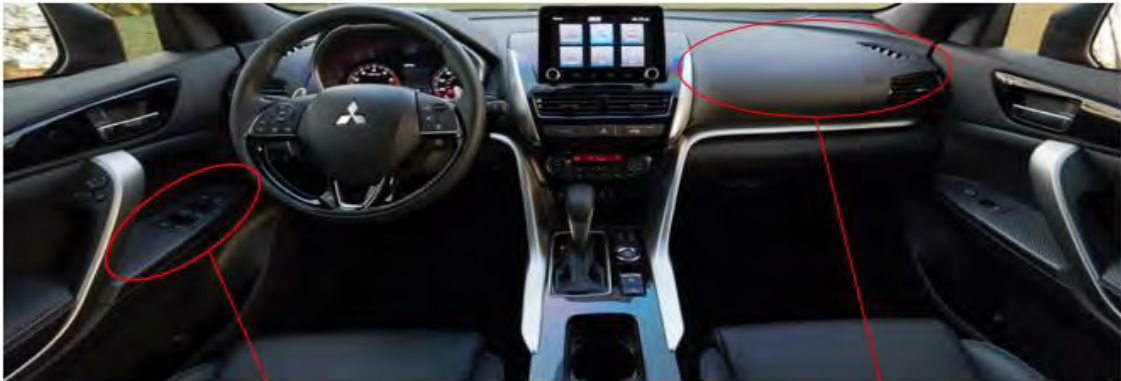
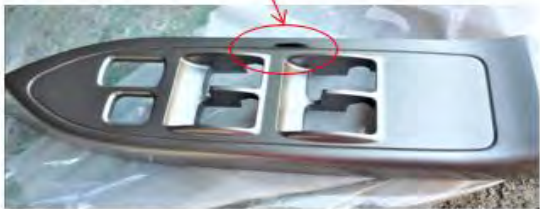
Avoid using household chlorine bleach(*) or alcohol of concentration of 60% or higher of cleaning of vehicles since it may cause the discoloration, erosion, and/or corrosion of vehicles parts. You should advise customers to use a neutral household detergent when cleaning their vehicle.

Sample Photos of Discoloration, Erosion, and/or Corrosion of Parts

Peeling paint on the door switch panel

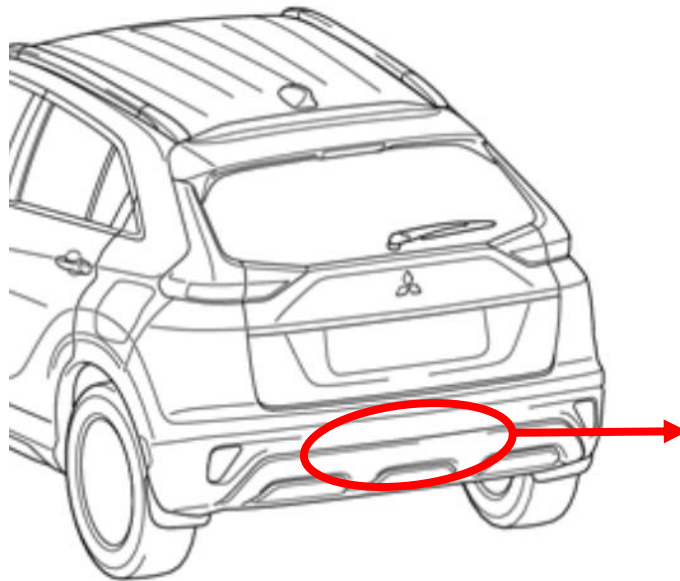
1. Check the presence and location of the ground terminal of the Rear End Harness.

If the pattern is 1 or 2, go to the next page.

If the pattern is 3, replace the Rear End Harness refer to the workshop manual.
