Technical Service Bulletin

35 Gearbox Malfunction Warning, DTC P0C2900, P176F00, P176E00 or P175E00 stored in the TCM

35 23 43 2050723/3 August 2, 2023. Supersedes Technical Service Bulletin Group 35 number 18-31 dated June 27, 2018, for reasons listed below.

Model(s)	Year	VIN Range	Vehicle-Specific Equipment
A3, and A3 Cabriolet	2017 – 2018	All	7 Speed S-Tronic
S3	2018

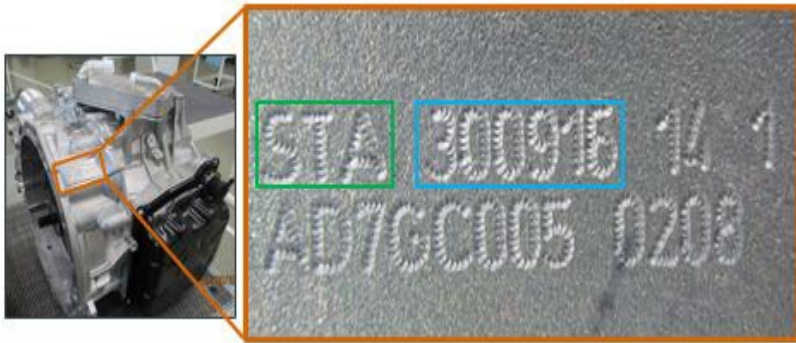
Figure 2: Transmission identification example.

Obtain the transmission identification information from the bellhousing (figure 2).

- If the gearbox production date is after 26.09.2017, this TSB does not apply. Proceed according to Guided Fault Finding. Please note that in this case, the costs for the repair cannot be billed under this TSB.
- If the gearbox production date is on or before 26.09.2017, continue as described below.
