Technical Service Bulletin

GROUP	NUMBER
BODY	23-BD-013G
DATE	MODEL(S)
AUGUST 2023	G80 (RG3)

SUBJECT: CENTER CONSOLE ARMREST STORAGE DIFFICULT TO OPEN

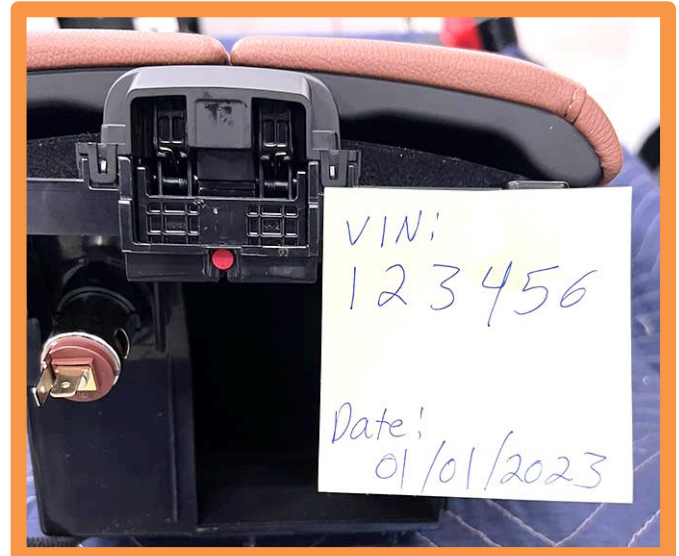
Using STUI, take a photo of the foam pad removed from the center console armrest with the last 6 digits of the VIN and date of repair on a piece of paper.

Upload the photo to STUI.
