Technical Service Bulletin

46 Brake pulsation diagnostic guidelines

46 23 50 2022584/12 September 18, 2023. Supersedes Technical Service Bulletin Group 46 number 22-26 dated January 31, 2022, for reasons listed below.

Model(s)	Year	VIN Range	Vehicle-Specific Equipment
All Audi Vehicles	2015 – 2025	All	Not Applicable

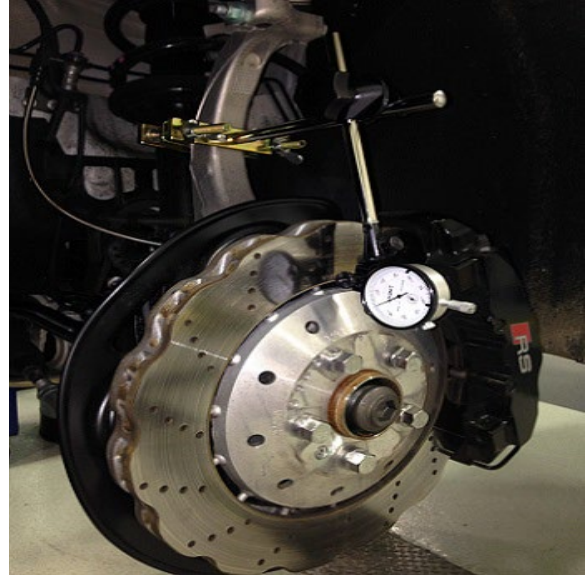
Figure 11. Example of the run-out measurement tool VAS6079/1 properly secured to a solid suspension component.

- All surfaces that will be measured must be free of rust/corrosion build-up or pad material transfer.
- VAS6079/1 (or similar measurement tool) is securely attached to the vehicle (Figure 11).
- The brake disc is secured to the hub with 5 bolts.
- Axle bolt/nut is installed and properly torqued.
- Run-out measurements should be taken with all parts installed on the vehicle.
