# WARRANTY BULLETIN

**NO:** D-22-17

**SUBJECT:** 2017 – 2023 (Current) Chrysler  
Pacifica (RU) and 2013 – 2016 Chrysler  
Town & Country/ 2013 – 2020 Dodge  
Caravan (RT) - Corrosion – **Complete  
Hood Panel Warranty Claim  
Simplification (Rev. B)**

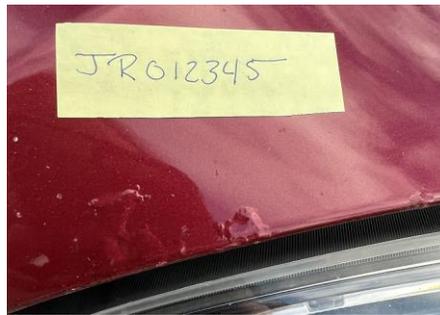
**VIN Example (Fig. 3)**

Photos to support corrosion repairs or replacement must show the VIN in the photo. The VIN can be written on masking tape, on the panel with a grease pen or a sticky note. The important part is that the VIN **MUST** be seen near the corrosion area to support the repair as seen in (Fig 3).
