<b>HYUNDAI</b> <b>Technical Service Bulletin</b>	<b>GROUP</b> <b>AUTOMATIC TRANSMISSION</b>	<b>NUMBER</b> <b>23-AT-008H-1</b>
	<b>DATE</b> <b>SEPTEMBER 2023</b>	<b>MODEL</b> PALISADE (LX2) SANTA FE (TMA) SANTA FE HYBRID (TM HEV) SANTA FE HYBRID (TMA HEV) SONATA (DN8/DN8A) SONATA HYBRID (DN8 HEV) TUCSON (NX4/NX4A) TUCSON HYBRID (NX4 HEV)
<b>SUBJECT:</b> <p style="text-align: center;"> AUTOMATIC TRANSAXLE (8-SPEED FWD)  POSITION SENSOR DTC P070500, P070512, P070514,  P07051C, P070600, P070661 &amp; P070696 DIAGNOSIS AND  REPLACEMENT </p>

***This TSB supersedes TSB 23-AT-008H to add harness information for Tucson (NX4/NX4A), Step 7.***

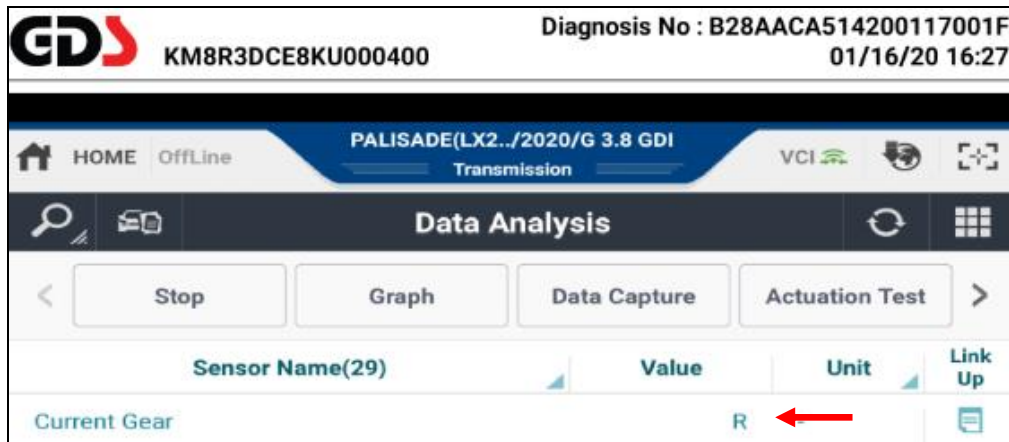
1. Start the engine.
2. Attach a GDS and check for DTC in the “Automatic Transaxle” menu. **Record the DTC and description.** Delete the DTC.
3. Select **Data Analysis, A/T** menu and **Current Gear**. Depress the brake pedal and move the shift lever through all gears (P, R, N and D) and monitor the **Current Gear**. Confirm the GDS and the indicator on the cluster shows all gears. Turn the ignition **OFF**.

4. If the GDS shows:
  - The correct **Current Gear**, the wiring **currently** has no open/short circuits - Go to Step 6.
  - Does not show the correct **Current Gear**, go to Step 5.
5. Visually check the wiring harness between the ECU and position sensor (inhibitor switch) for a damaged wire or open circuit/short circuit to ground. Check for a damaged pin or pin not fully inserted into the connector.
  - If damage is found, repair or replace the control wiring and drive the vehicle to confirm the repair.
  - If no damage or open/short circuit is found, go to Step 6.
