REFERENCE:	Nova Bus Manuals
SECTION:	16: Electrical System
RS N°:	MQR 7621-2357
EFFECTIVE IN PROD.:	N/A

SUBJECT:	Wiring Harness - Engine Compartment
JUSTIFICATION:	A bad connection at the ZF transmission connector may cause the transmission to jerk when shifting or show the fault code 188.

Service Instruction
QJ2357 : ZF Transmission Code 188

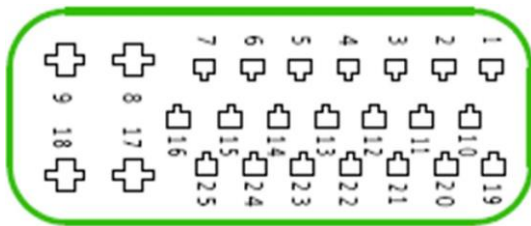
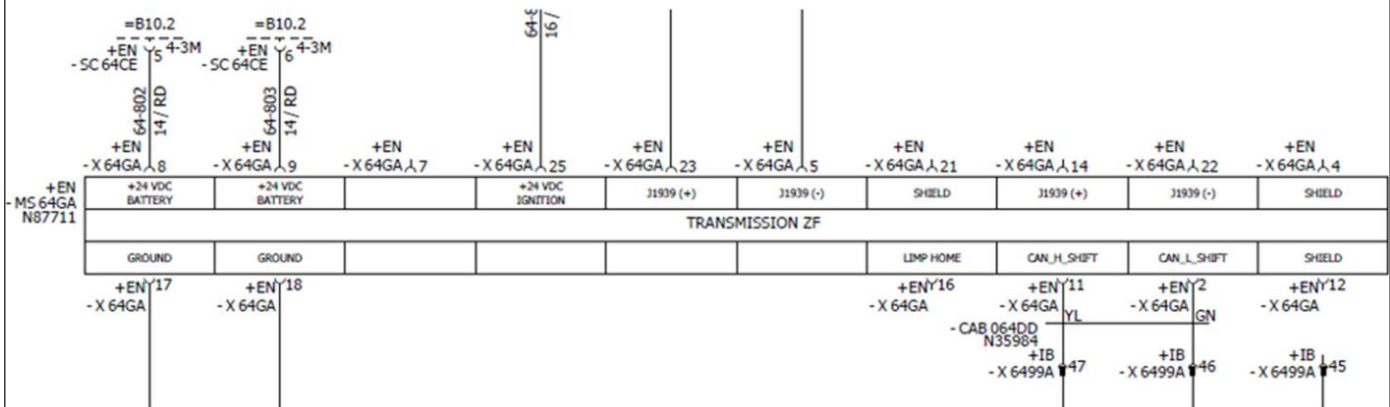
Connector's pinout:

Description: Using a male terminal of the same size as the male connector of the ECU, check if the contact is well made and if there is no verdigris or oxidation on the pin. If it is the case, replace terminals.

Used pins: SLK 2.8 terminals 8, 9, 17 & 18

Used pins: MLK 1.2 terminals 2, 5, 11, 23 & 25

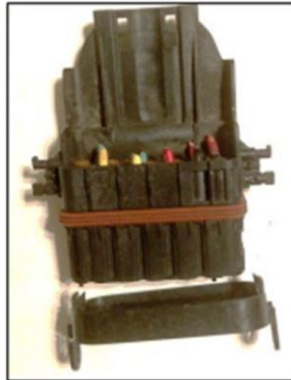
Remove shroud by pulling, it will slide off

Note: Shroud locking tabs easily break
