Service Bulletin

Bulletin No.: 22-NA-081

Subject: Paint Peeling or Chipping on Front Fascia at Headlamp or Fender Seam

Brand:	Model:	Model Year:		VIN:		Engine:	Transmission:
		from	to	from	to		
Chevrolet	Corvette	2020	2024	—	—	All	All

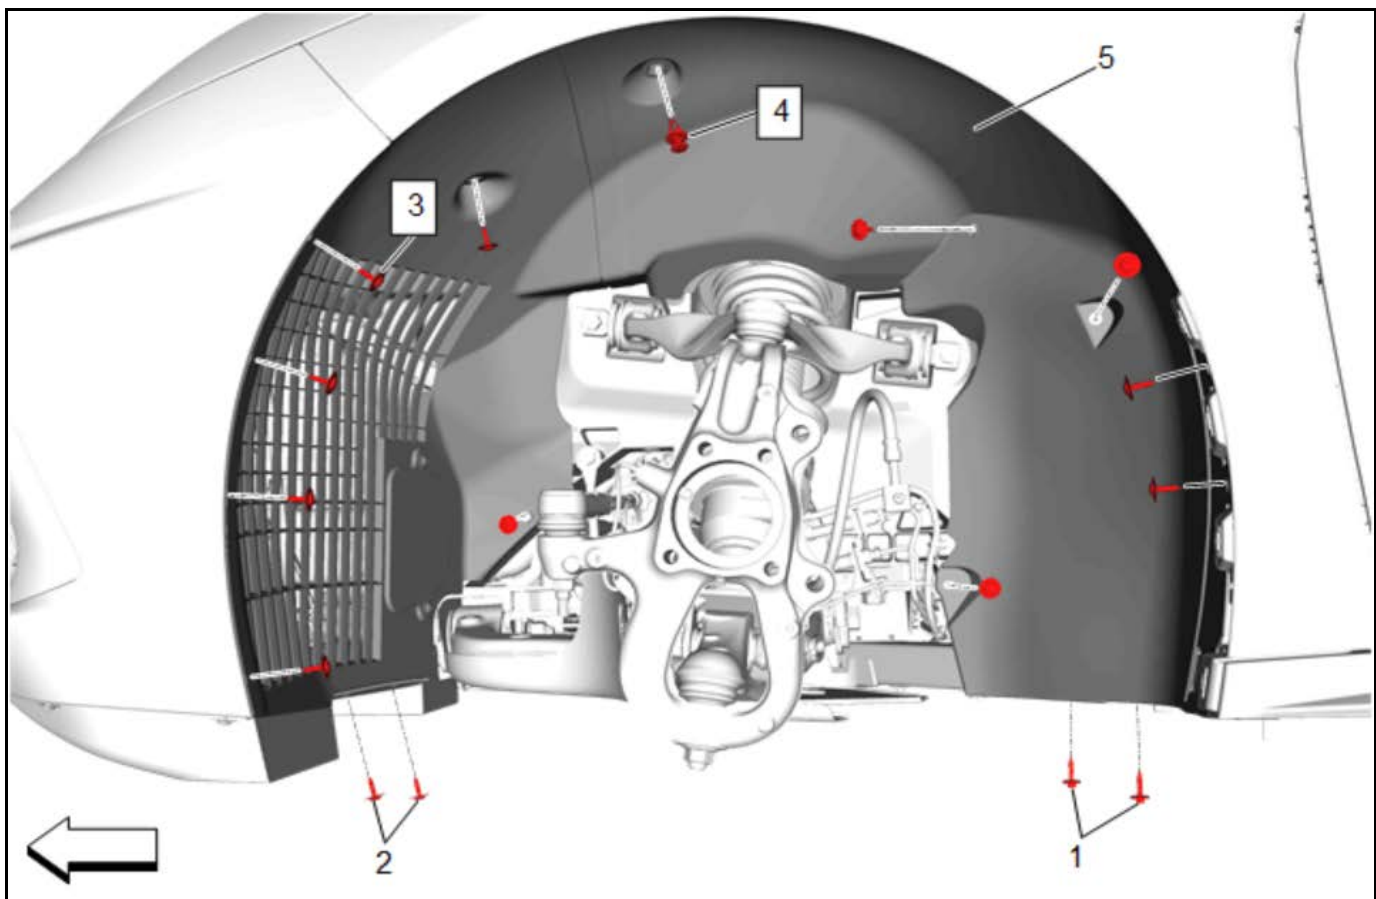
2. Check for a tight gap at area # 2.

- Remove both front tire/wheel assemblies and wheelhouse liners. Refer to the appropriate *Front Wheelhouse Liner Replacement* procedure in SI.

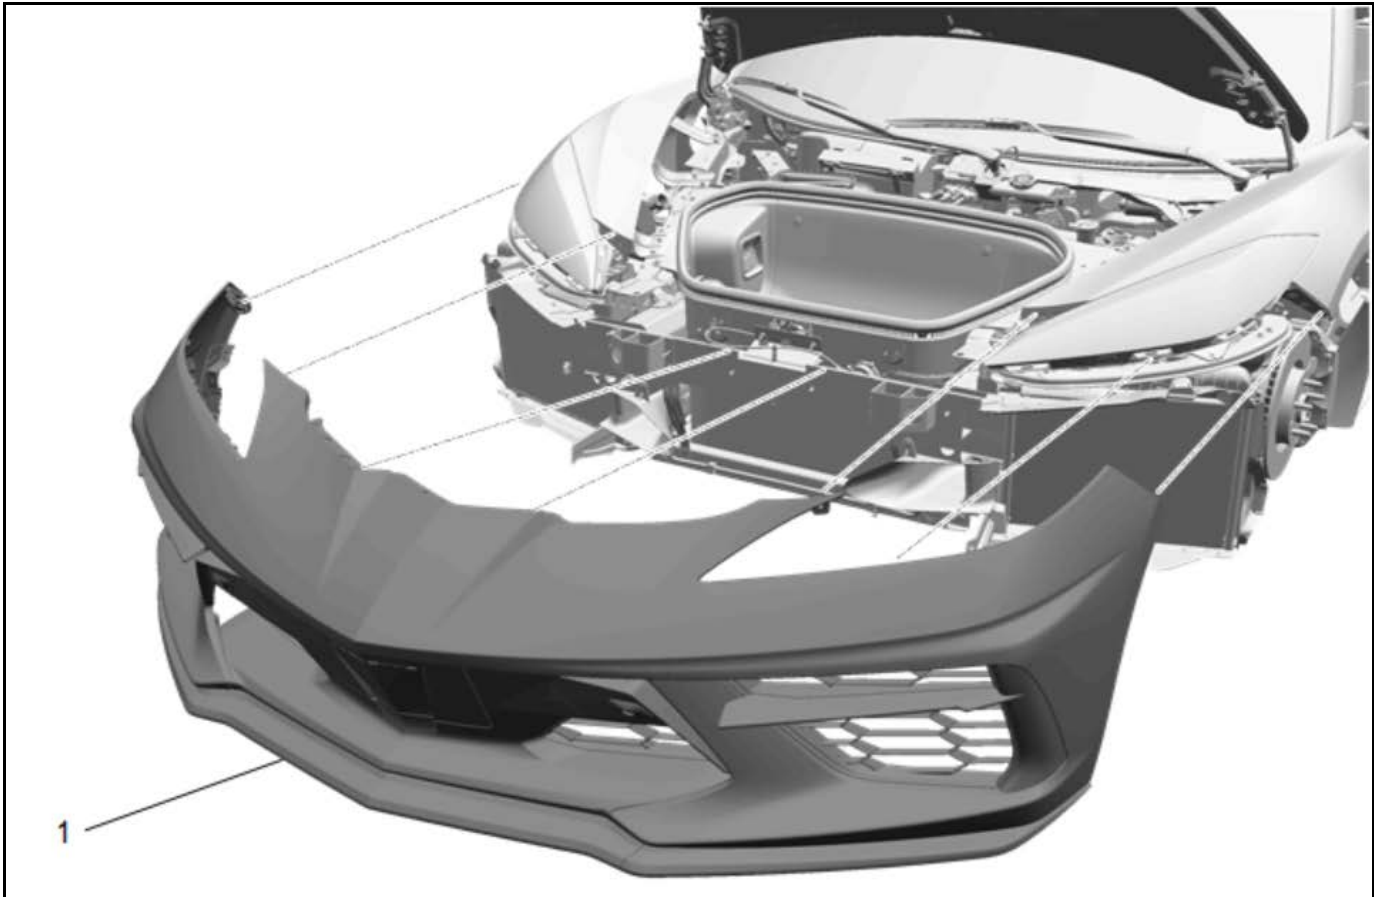
5354777

Note: The gap may not be completely uniform all around the headlamp, however ensure the gap is at least 0.5 mm wide in all areas.

7. Reinstall the front fascia (1). Refer to *Front Bumper Fascia Removal and Installation* in the Service Manual.
