Technical product information

Topic	Knock/clunk noise from the rear of the vehicle (Rear axle)
Market area	Australia E04 Bentley rest Asia and Australia (6E04),China 723 Volkswagen (Anhui) Automotive CO (6723),China 796 VW Import Comp. Ltd (Vico), Beijing (6796),Germany E02 Bentley rest Europe (6E02),Japan E03 Bentley Japan (6E03),Korea, (South) E08 Bentley South Korea (6E08),United Arab Emirates E06 Bentley Middle East and Africa (6E06),United Kingdom E01 Bentley UK (6E01),United States E05 Bentley USA and rest America (6E05)
Brand	Bentley
Transaction No.	2064477/5
Level	EH
Status	Released for publishing
Release date	03-Oct-2023

Knock/clunking noise heard from the rear of the vehicle when changing direction at low speed

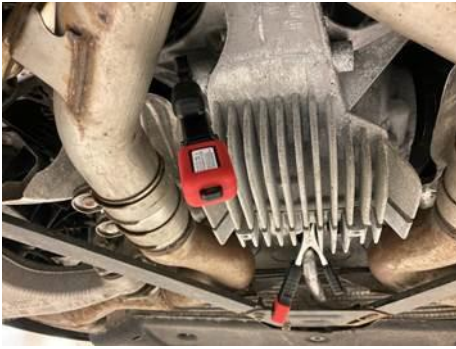
Figure 1

- Use **WT 10437 (Chassis Ear Tool)** to identify the source of problem by attaching the clamp and module assemblies to the areas of concern. For example, front and rear of the differential casing, as well as the upper control arms on the suspension (see Figures 1 to 3 for examples)
