Technical product information

Topic	New Continental GT and GTC - Window drop glass operation
Market area	Australia E04 Bentley rest Asia and Australia (6E04),China 723 Volkswagen (Anhui) Automotive CO (6723),China 796 VW Import Comp. Ltd (Vico), Beijing (6796),Germany E02 Bentley rest Europe (6E02),Japan E03 Bentley Japan (6E03),Korea, (South) E08 Bentley South Korea (6E08),United Arab Emirates E06 Bentley Middle East and Africa (6E06),United Kingdom E01 Bentley UK (6E01),United States E05 Bentley USA and rest America (6E05)
Brand	Bentley
Transaction No.	2070497/4
Level	EH
Status	Approval
Release date

Retailer glass reset procedure for GT/GTC

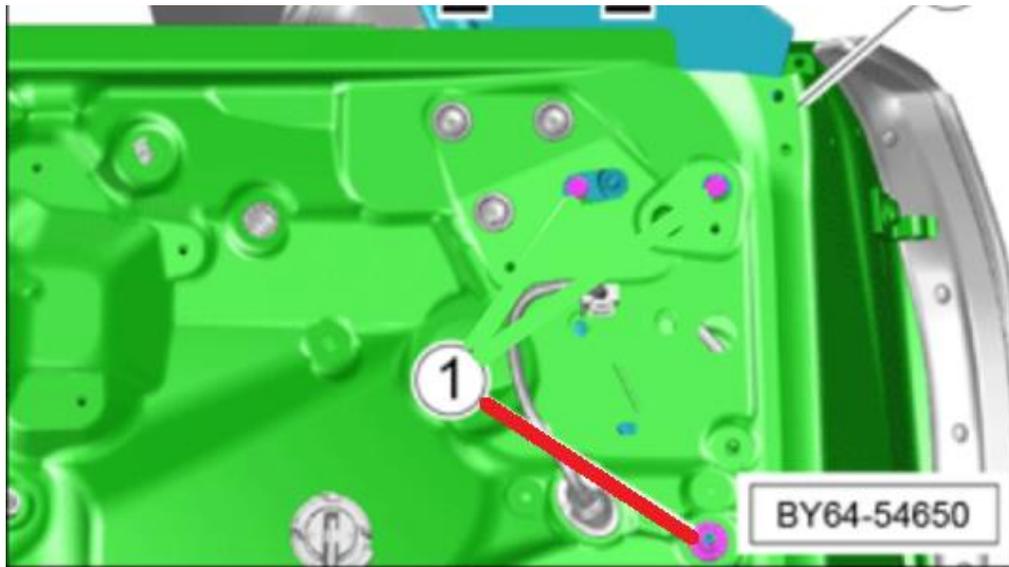
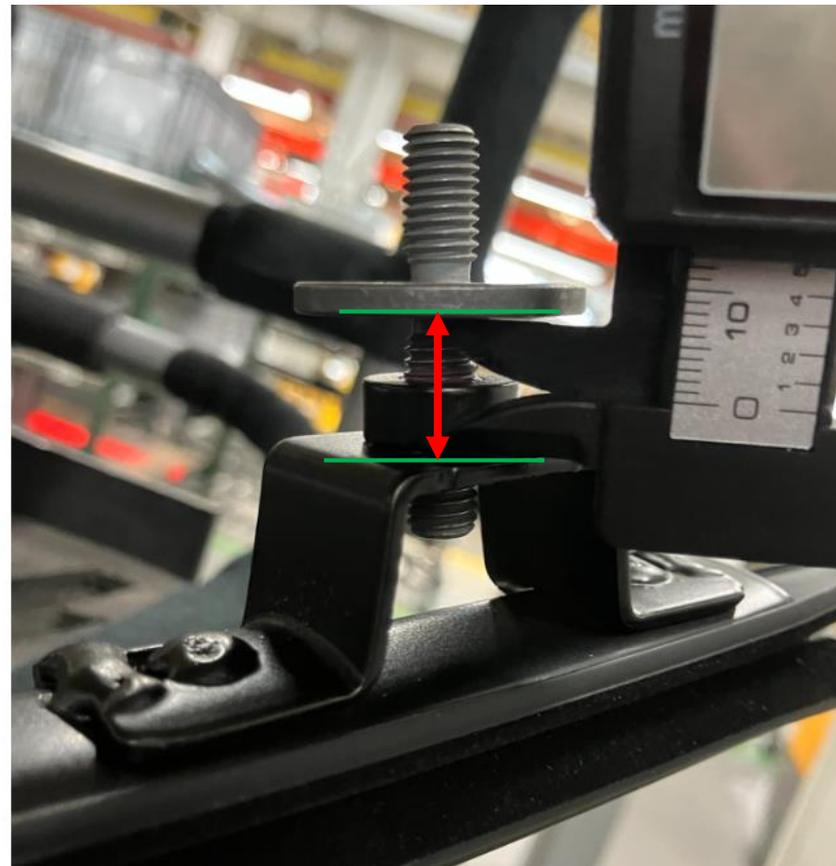
Image for reference, glass does not require removal from vehicle

To reset this adjuster without removing the quarter glass, loosen the lock nut, screw the adjuster all the way in clockwise until it bottoms out on the frame, then unscrew anti clockwise 4 complete turns then set height and profile to ELSA specification before moving on to the next step.

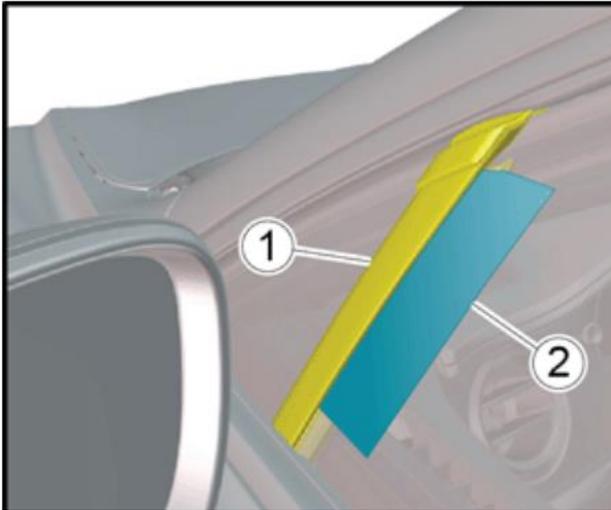
- **Measuring front glass intrusion into front division bar**

Example of incorrect fitment:
10mm intrusion into division bar seal not achieved. Only 6mm seen, front and rear side glasses will be too far rearwards, potentially clash condition between rear of rear glass and cant rail/roof seals

When reinstalling front drop glass ensure tape is applied at 10mm from front edge and align this with the previously set quarter glass division bar.

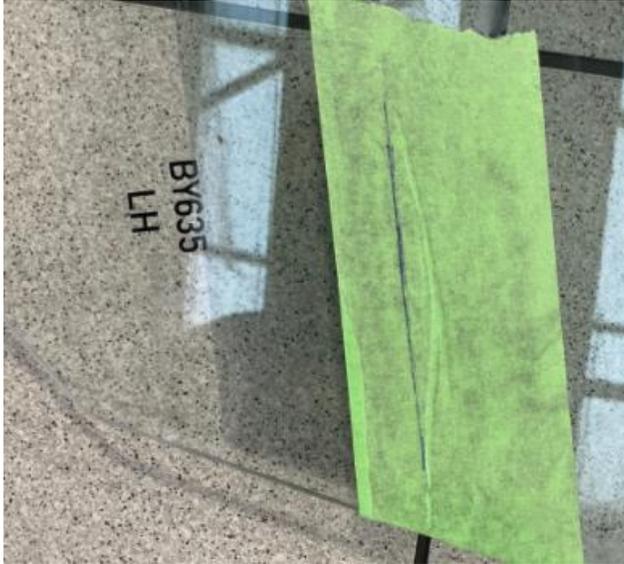
- Z Axis height adjustment on front drop glass

Example: Front drop glass Z axis not adjusted correctly. Bottom of tape was level with waist rail seal, after slackening pinch bolt (3 in bottom left image) front drop glass lowered 14mm to where pen marked line is.

Z-axis adjusters (bottom middle and right images) had not been used, pinch bolt had been slacked and glass lifted out of the regulator to achieve specification. This has a knock on effect of altering the 10mm division bar intrusion seen in previous slide as glass is loose and can be accidentally moved in X-axis.

Z-Axis height should only be adjusted by the 4mm Allen key adjusters as per ELSAPRO

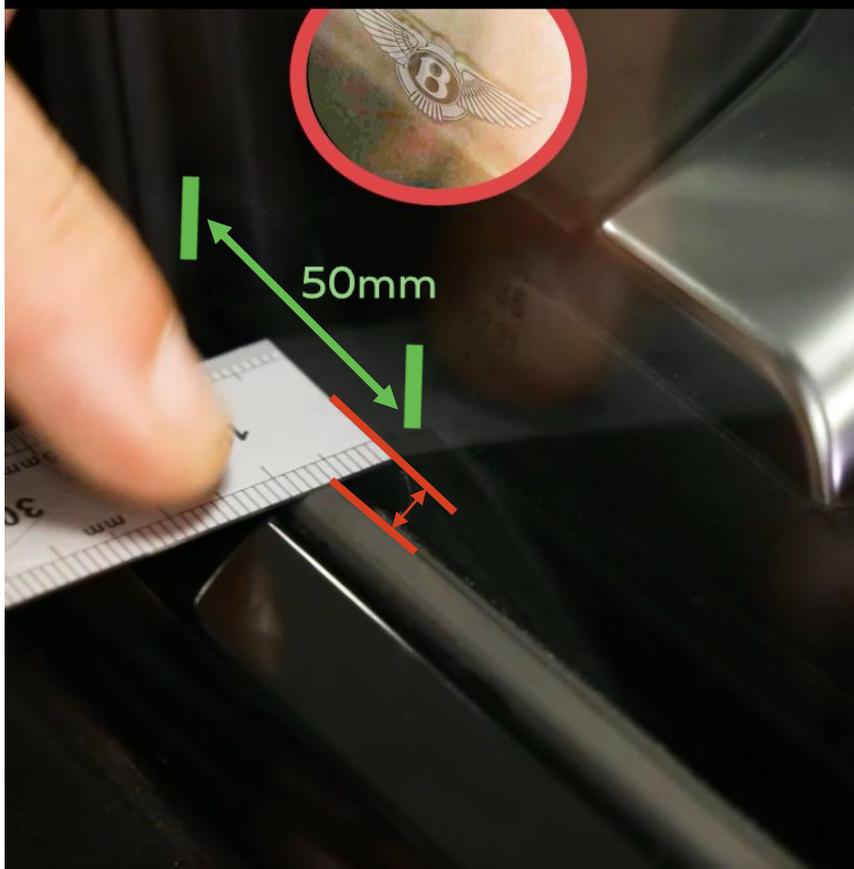
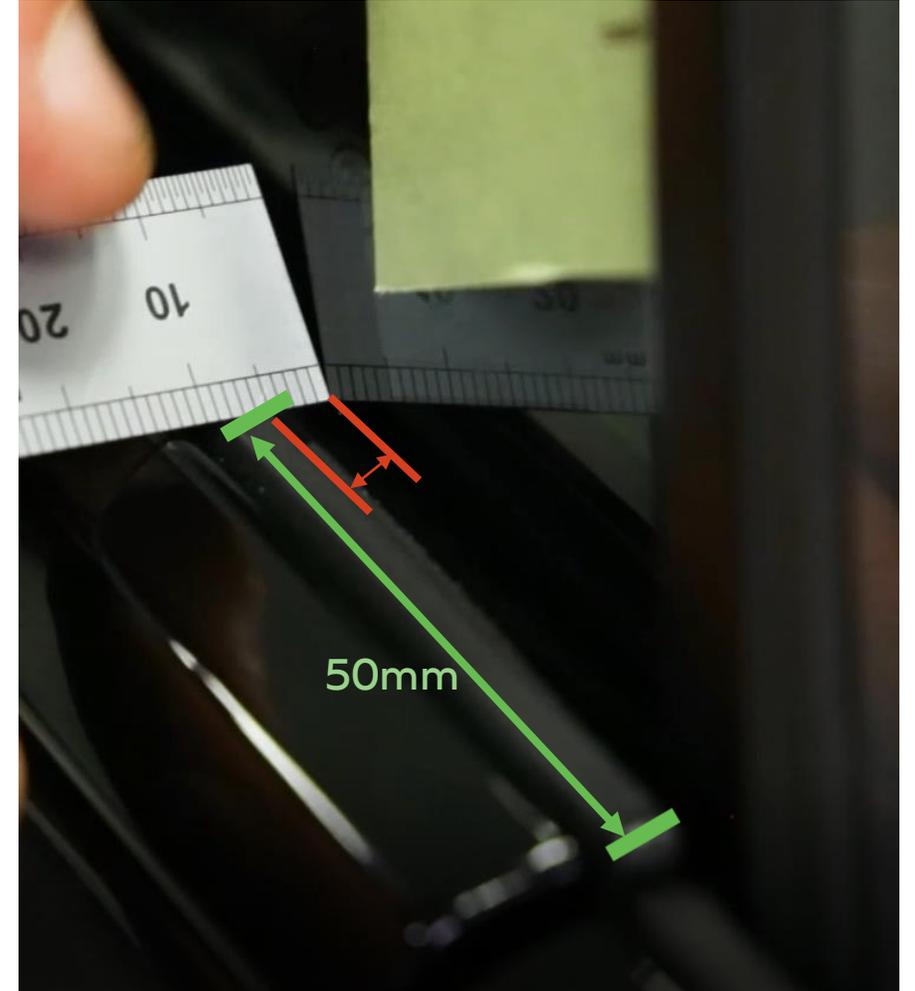
- **Waistrail measurement checking/resetting**

Set waist rail gapping to between 4-6mm as mentioned in Glass setting guide videos on E-Academy and also check for parallelism along front and rear windows to door/quarter. 50mm from edge of Waistrail seal, roughly underneath the Bentley wings.
