Service Bulletin

Bulletin No.: 21-NA-228

Subject: Full Size Trucks Idle Time-out Disable

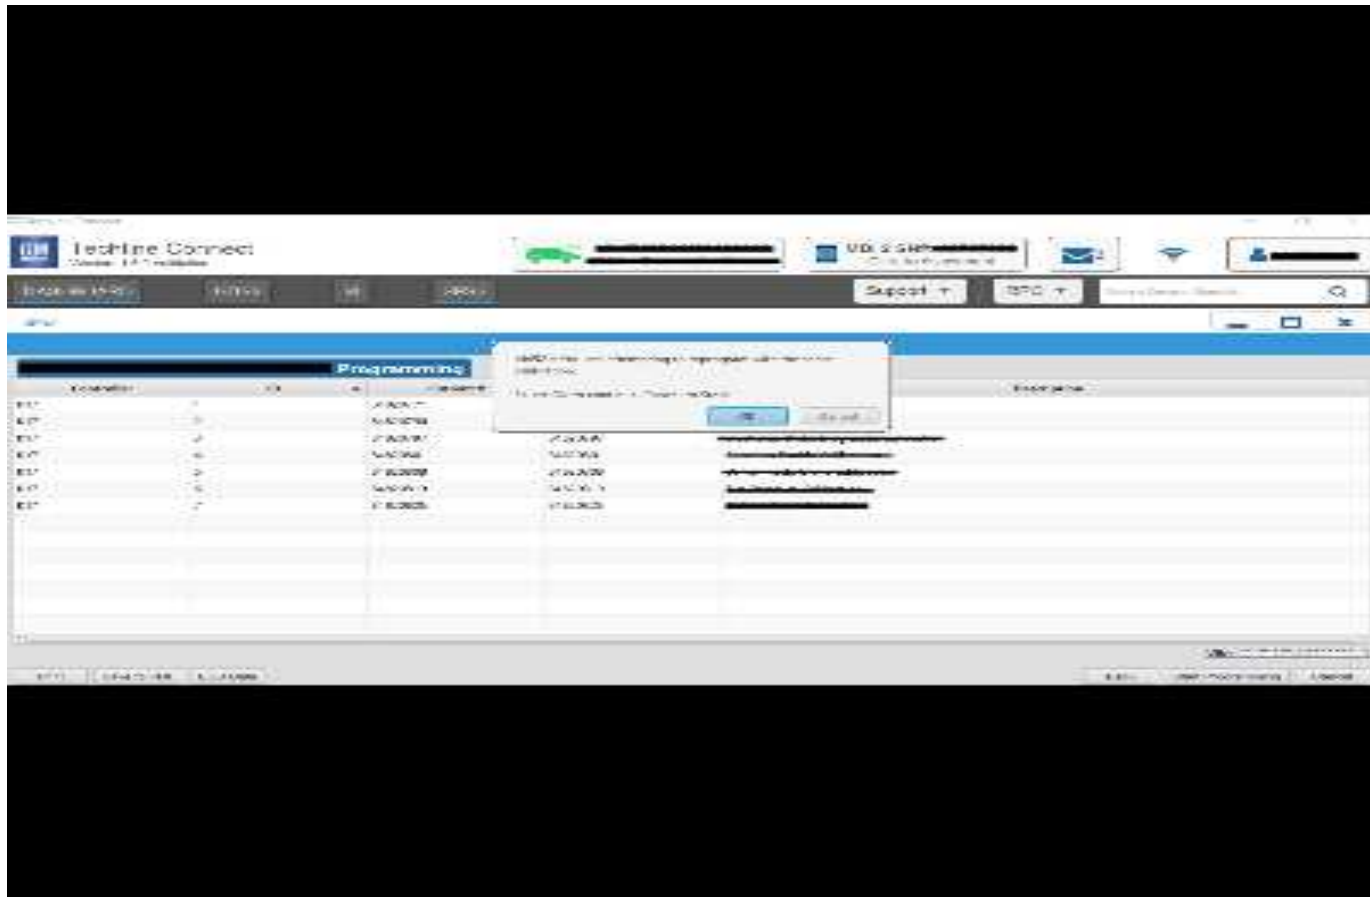
5644477

Important: Techline Connect screens shown above.

Important: If the same calibration/software warning is noted on the TLC Summary screen, select OK and follow screen instructions. After a successful programming event, the WCC is located in the Service Programming System dialogue box of the SPS Summary screen. No further action is required. Refer to the Warranty section of the bulletin.
