Service Bulletin

Bulletin No.: 23-NA-115

Subject: Ticking, Tapping or Snapping Noise from Engine - 5.5L RPO LT6 Realign Camshaft Caps as Required

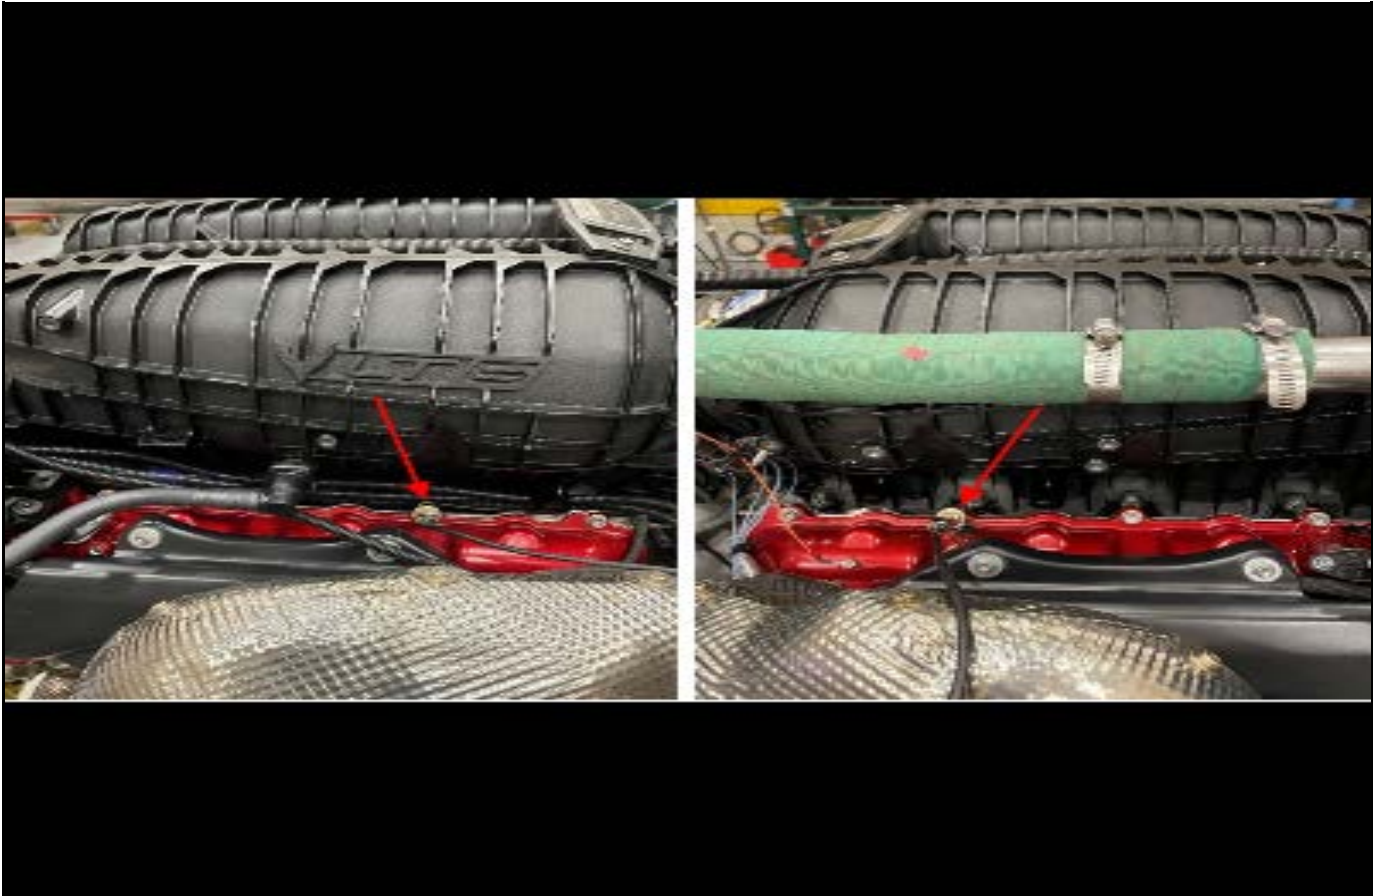
Place the accelerometer on the suspect bank.

⇒ With the suspect bank determined, prep/position the accelerometer so the X, Y, Z coordinate system (that's laser etched) is facing upwards before securing to the bolt head. After accelerometer is placed on bolt head, double check to ensure its centered and did not rotate on the bolt head. Doing so will ensure the best results.

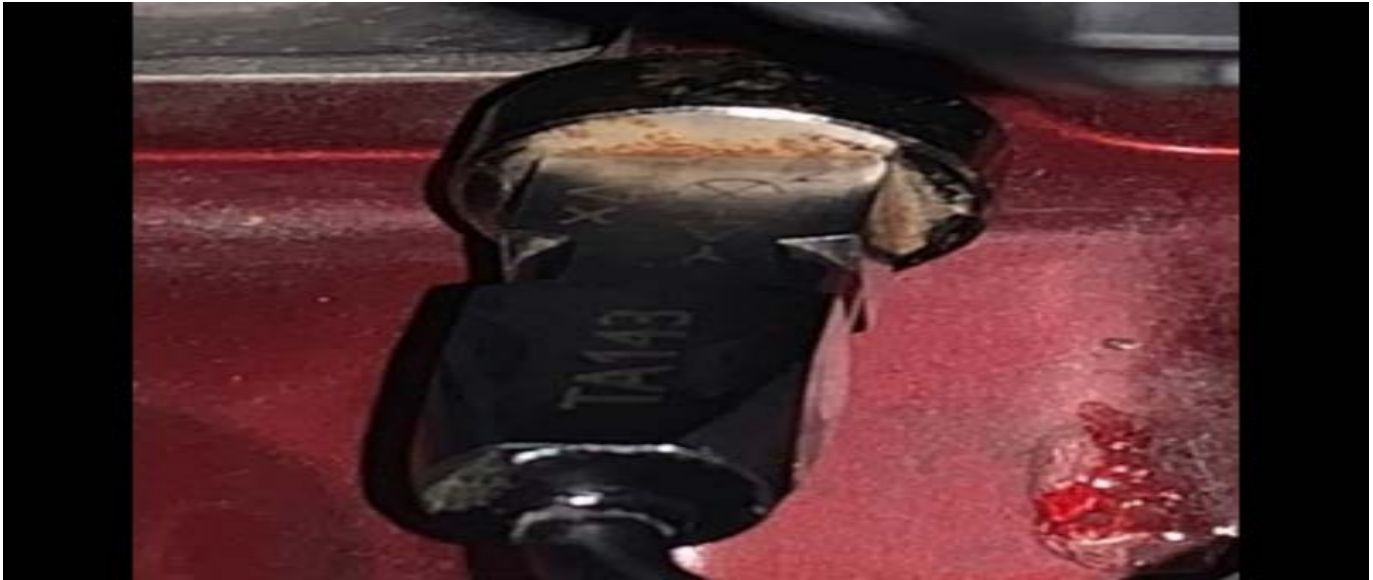
6374737

Important: Ensure accelerometer coordinates are facing up towards the intake.
