Little or No Cooling Power from the Air-Conditioning System: Checking Refrigerant Lines on Air-Conditioning Compressor (174/23)

Model Line: **Panamera (971)**
Cayenne (9YA / 9YB)

Model Year: **As of 2019 up to 2024**

Concerns: **Air-conditioning compressor**

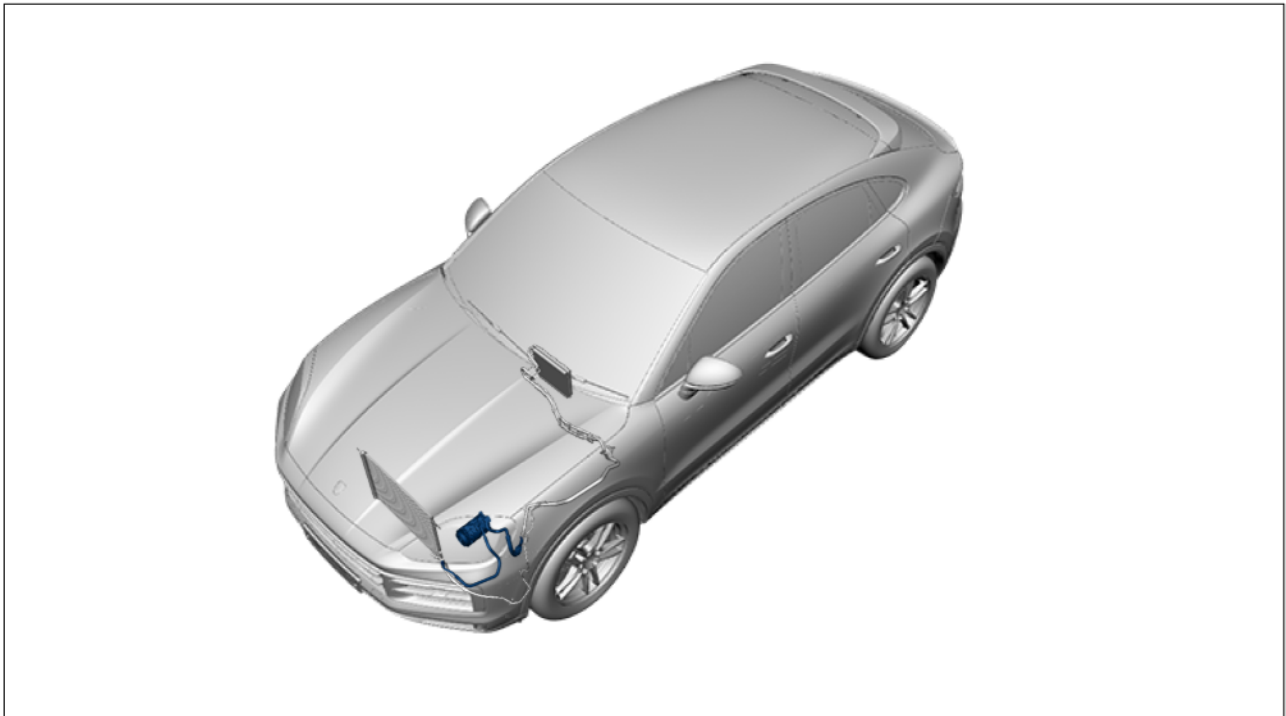
Installation location for air-conditioning compressor / refrigerant lines (shown on the Porsche Cayenne)

Action: If there is a complaint, check the respective O-ring of the affected refrigerant line and replace it if necessary.
