Service Bulletin

Bulletin No.: 19-NA-256

Subject: Diagnostic Tips for Knocking, Rattle, Squeak and/or Squeal Type Noise from Engine – Engine Replacement Recommendations for HFV6 Gen 1 and Gen 2

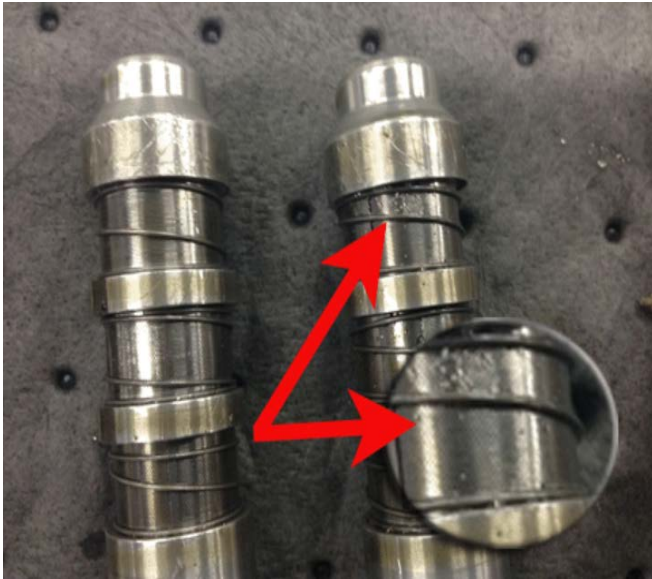
3961448

1. Inspect the oil control solenoids for metal debris. This shows the oil filter is in by-pass and unfiltered oil with bearing debris was pumped into the oil lubrication galleys, throughout the engine.

Any of the above 3 instances would be cause to replace the engine instead of repair.
