Recall Bulletin

PRODUCT SAFETY RECALL

SUBJECT: Front Passenger Air Bag Inflator

MODELS: 2003-2004 Pontiac Vibe

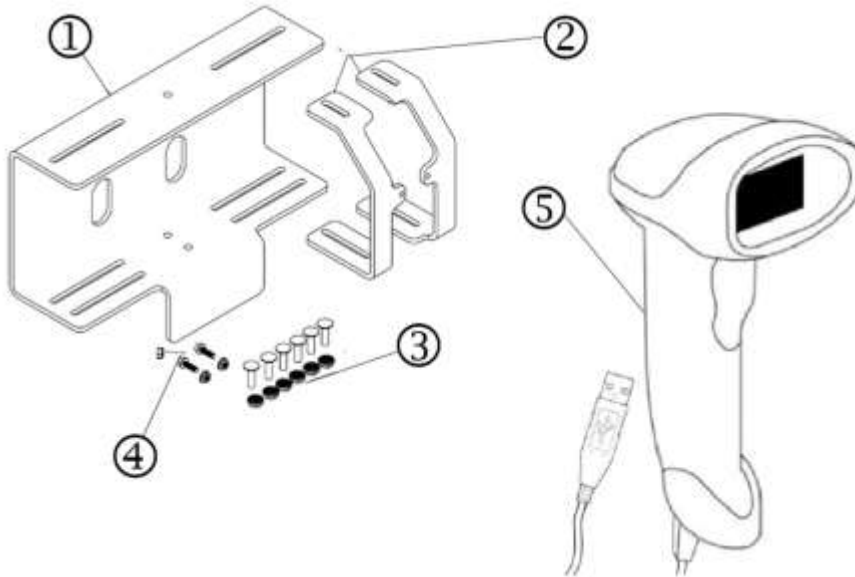
3607811

(1) Mounting Bracket (2) Support Bars (3) Support Bar Hardware (4) Air bag Mounting Hardware (5) Barcode Scanner

An air bag mounting bracket and bar code scanner, EL-51377 and EL51378, respectively, are being shipped to select dealers. Dealers were selected based on their prior designation as a Pontiac Service Center and/or if an involved vehicle was assigned to their location. Most of the tools were shipped on November 16, 2013 with the balance being shipped on November 25, 2013. The tools are being furnished at no charge.

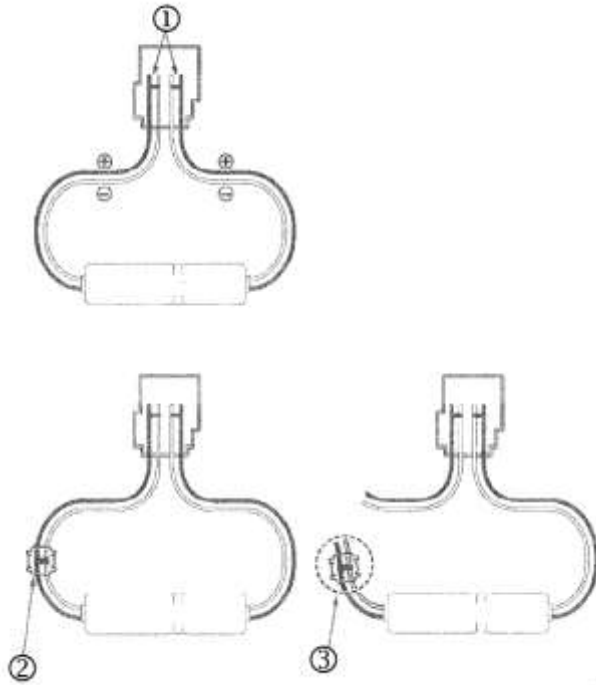
3470510

Note: The connector of an air bag inflator has a short-circuiting mechanism that eliminates voltage difference when disconnected (1). To allow for the replacement of the inflator module, a new short circuit using an electro tap (2) **MUST** be created **BEFORE** cutting the wires (3) and removing the inflator.

7. Create a short circuit before disconnecting the inflator wire harness.

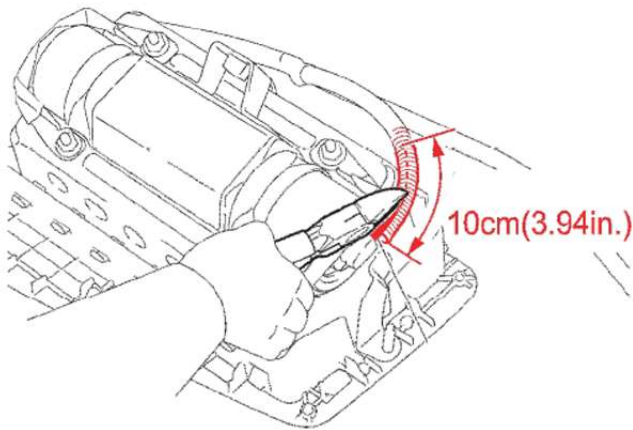
3470432

Caution: **DO NOT** damage the internal wires when cutting open the corrugate tube. **DO NOT** use a knife or razor blade to cut the tube to avoid damaging the wires. This step may be performed on either end if the inflator.

7.1 Cut open the corrugated tube on the yellow harness approximately 10 cm (4 in) using snippers.

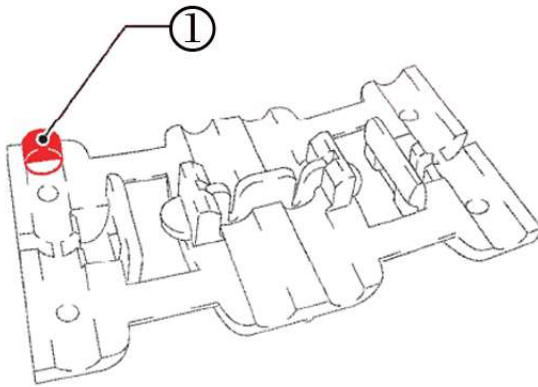
3470344

Danger: The tab on the electro tap must be removed to ensure a good short.

7.2 Cut off the tab of the electro tap (1) (included in the kit) shown in the illustration.

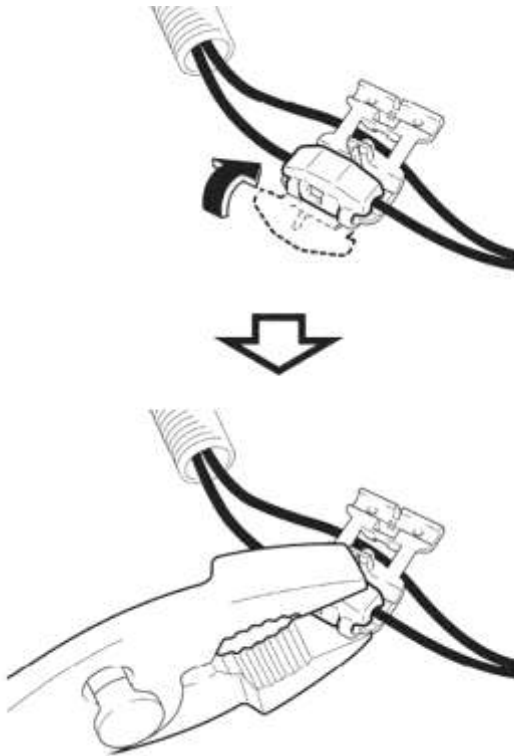
3470357

Note: Simultaneously working on the two wires tends to cause a mistake. Be sure to set the wire in the electro tap one wire at a time. Lock the electro tap firmly using pliers. If locked by hand, the electro tap may unfasten.

7.4 Fold and pinch the half of the electro tap where the first wire was just placed using pliers to lock firmly.

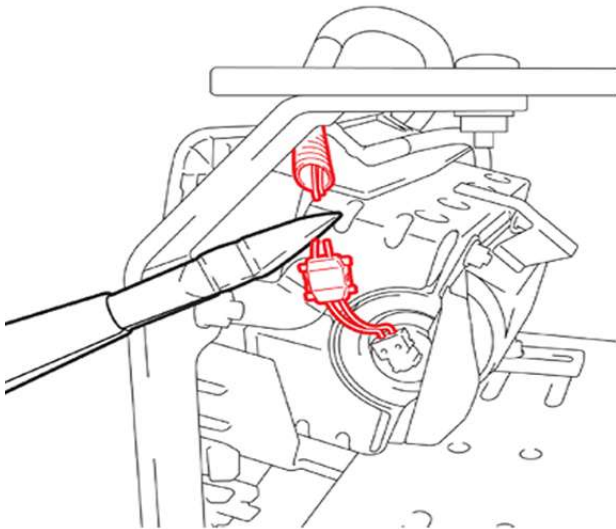
3607837

Danger: Do NOT measure resistance of the inflator wires. This may cause accidental activation of the inflator.

Caution: Ensure to cut the two wires at the correct location. Refer to the illustration.

8. Cut the two wires at the side of the electro tap opposite to the inflator (the side of the electro tap that is farthest away from the inflator).

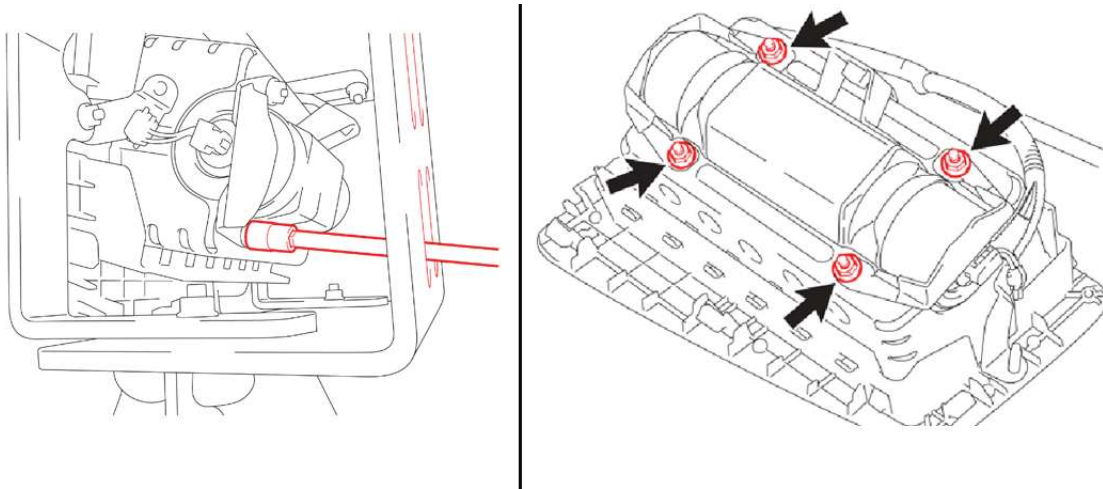
3607844

Caution: DO NOT use power tools. The bracket support bars may need to be repositioned to remove the nuts through the access holes.

9. Use the access holes in the bracket to loosen and remove the four self-locking nuts.

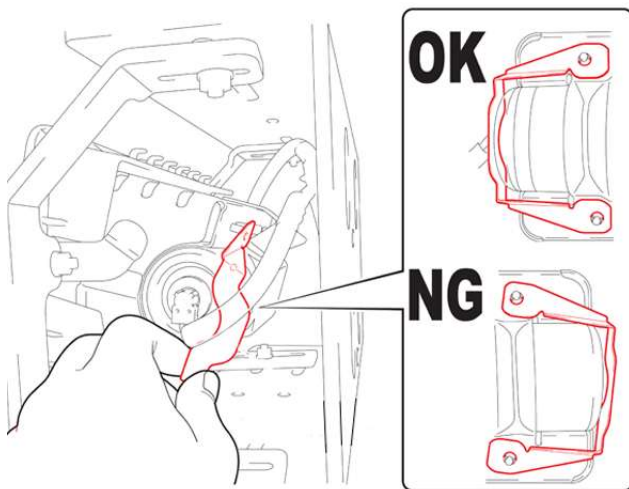
3607886

Warning: Confirm the stopper plate to inflator fitment is correct. **DO NOT** pinch the harness between the inflator and the stopper plate.

15. Loosely install a *new* stopper plate.

15.2 Confirm the end of the inflator sits flat against the stopper plate. If they do not align the inflator is installed backward.

15.3 Install **NEW** stopper plate nuts by hand. They will be torqued on a later step.

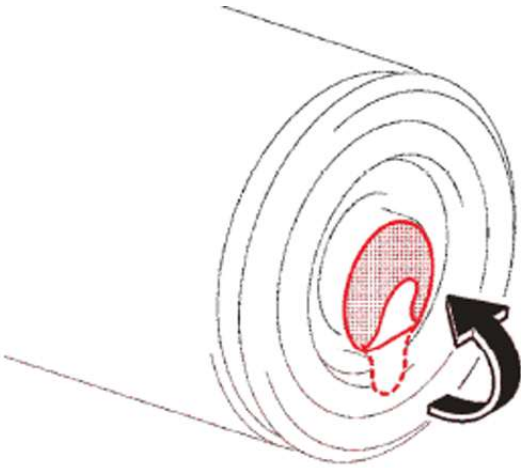
3470378

Note: *DO NOT* fully remove the seal until just before connecting the harness.

16. Fold the seal in order to prevent it from being caught under the position determining plate in the next step.

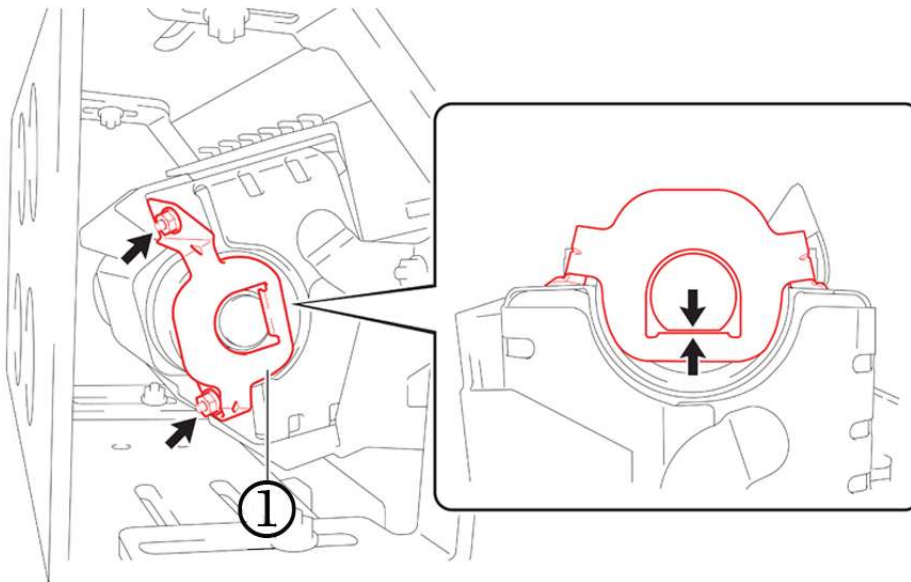
3610413

Warning: Confirm the flats on the position determining plate and inflator are aligned. *DO NOT* pinch the harness between the inflator and the plate.

17.1 Place the **NEW** position determining plate on the air bag assembly on the side with the connector seal.

17.2 Install **NEW** nuts by hand.

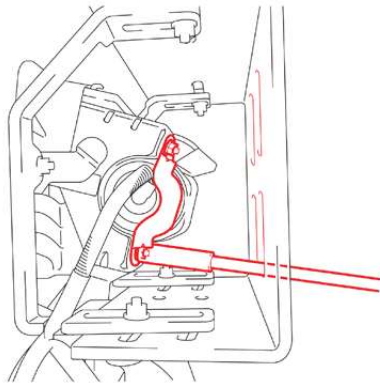
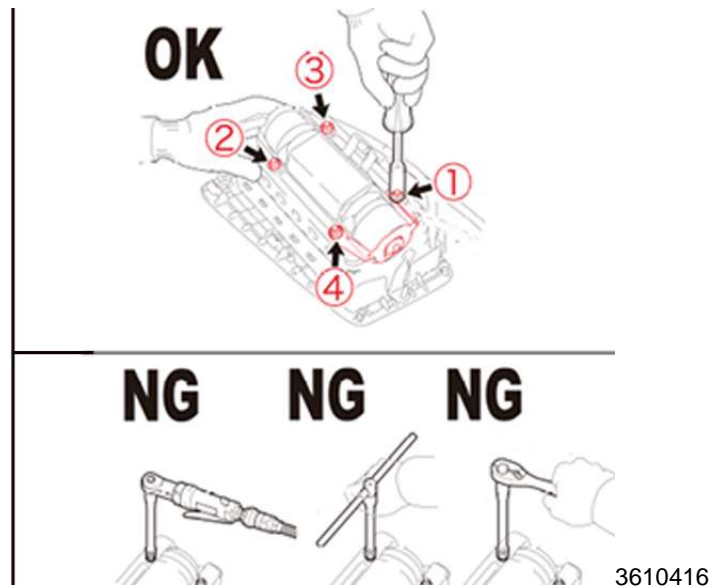
Caution: There will be some resistance when tightening the nuts because they are self-locking. Confirm the nuts are tightened correctly. **DO NOT** use a power tool, T-handle, or ratchet when tightening the nuts to avoid over-torquing.

18. Tighten four (4) **NEW** plate nuts evenly in several increments in the order shown in the illustration using a 10 mm socket driver while pushing the inflator. (You will encounter some resistance during tightening because these nuts are self-locking nuts.)

Torque Specification: 3.9 Nm (35 in-lb)

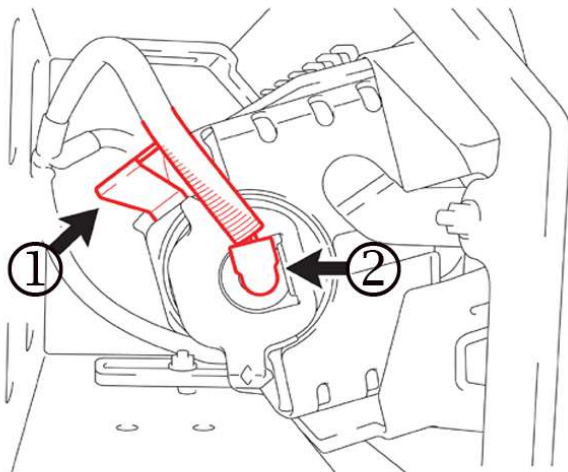
3610412

Warning: The connector should be connected **IMMEDIATELY** after removing the seal. Once the connector is installed it **CANNOT** be removed. If the connector is installed in the incorrect orientation the terminals may be bent or the connector may not fully engage.

19.2 Confirm the alignment of the harness connector as shown in the illustration, and then connect the harness. The connector wires should lead toward the center mounting bracket (1) on the air bag assembly.
