Service Bulletin

Bulletin No.: 21-NA-149

Subject: Engine Wire Harness Chafing / IPC Gauges Sweep / IPC Warning Message / SES/Check Engine/MIL / No Start / No Crank / Runs Rough / Stalls / Reduced Engine Power / Various DTCs

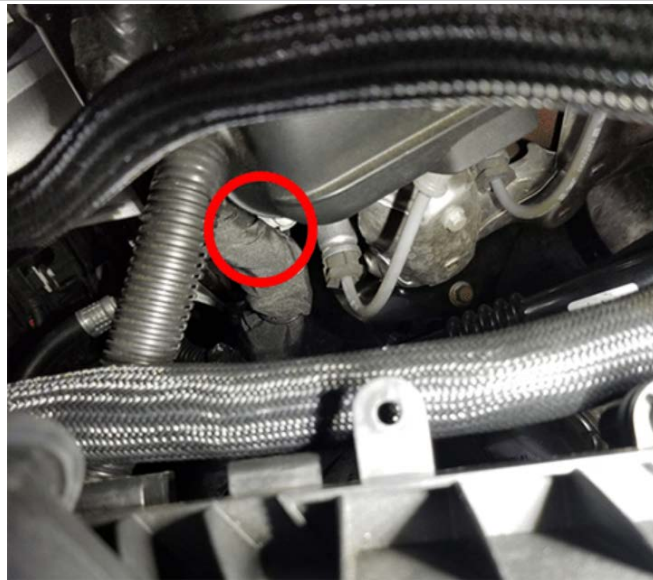
5911722

Note: The first graphic below is a before, and after (2), repair example of harness chaffing at the Oil Dipstick bracket.

To correct this concern, repair the damaged wiring following the SI wire-to-wire repair procedures. Once repaired, protect and reposition the engine wiring harness to prevent future harness damage.
