48-23-02 - Steering wheel / airbag: grinding/creaking/clacking noises when steering (cornering/parking/maneuvering)

Release date: 12/11/2023

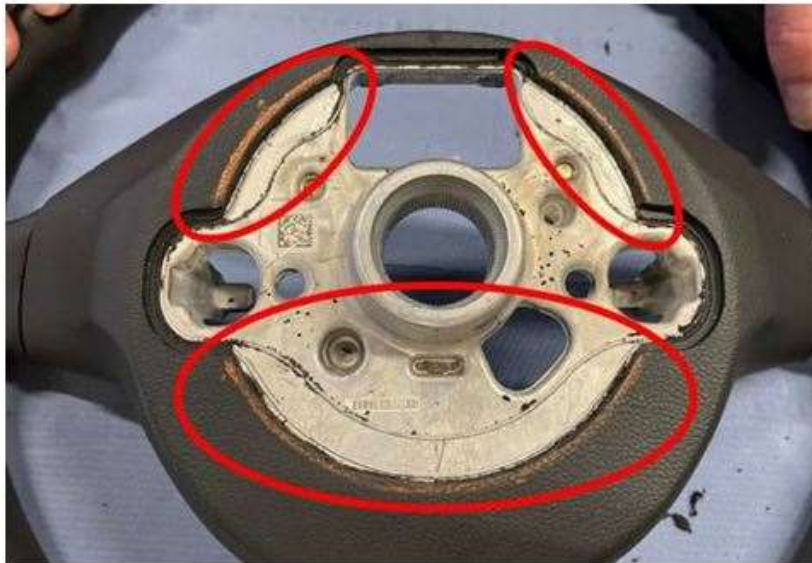
Figure 11.

Due to dirt ingress / entry of foreign bodies in the clock spring, such as long hair etc. a failure of the coil spring can occur.

In order to avoid further repeat repairs, an additional plastic ring must be installed to protect the airbag coil spring from dirt ingress/foreign bodies.

11. Install a new airbag coil spring (with additionally attached protective cap/plastic ring). See repair group 48 in Elsa.
