HYUNDAI Technical Service Bulletin	GROUP CAMPAIGN	NUMBER 23-01-089H
	DATE NOVEMBER 2023	MODEL(S) SONATA (YFA)
SUBJECT: REAR COMBINATION LAMP INSPECTION & REPLACEMENT (WARRANTY EXTENSION TXXT)

Description: Some 2011-14MY Sonata (YF) vehicles may exhibit inoperative brake lights that may be caused by melting/deformation of the rear combination housing lamps.

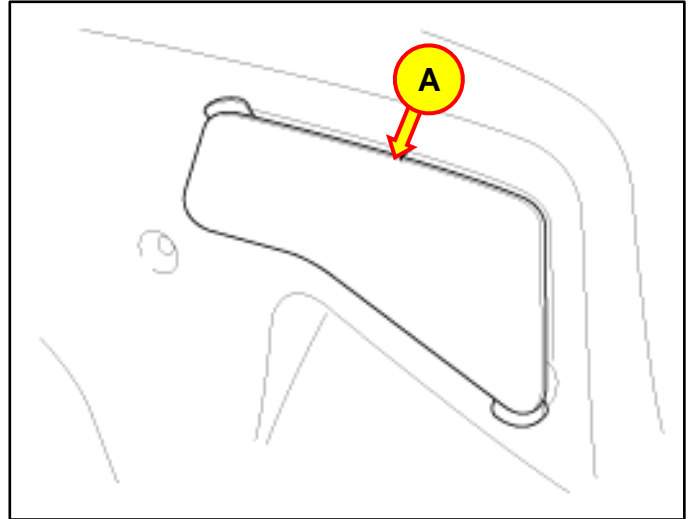
1. Record customer's audio presets, then disconnect the negative (-) battery cable.
2. From inside the trunk, remove the cover (A) of both the LH and RH rear combination lamps.

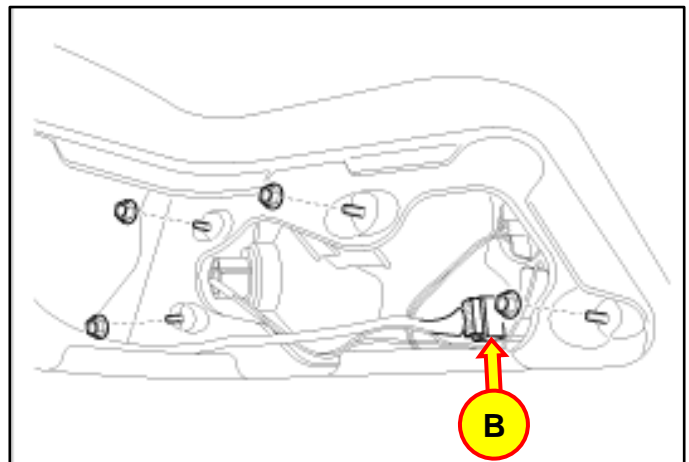
7. Remove the 4 mounting nuts and disconnect the floor harness from the combination lamp harness (B).

8. Install the replacement combination lamps.

Secure the four mounting nuts.
