SERVICE BULLETIN

APPLICABILITY: 2020-22MY Legacy and Outback Models **NUMBER:** 15-261-20R
SUBJECT: Reprogramming File Availability for Optimization of Gen 4 Denso CP1 Infotainment Systems **DATE:** 03/10/20
REVISED: 12/18/23

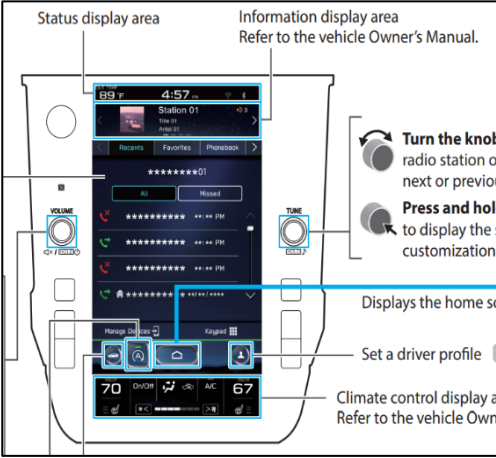
Number	Symptoms to be Improved:
1	While welcome animation on CID is displayed and the driver's door is left open, if turning ignition OFF/ON, the CID screen will be black screen.
2	After starting the engine, the loading animation remains and the screen does not transition remaining blank.
3	When the “All” tab is pressed on the TravelLink Sports screen, a blank screen appears.
4	During Bluetooth audio playing, the CID screen turns into a black picture.
5	<p>The Information Display Area at the top of the CID screen displays a different information screen from the last time.</p> <div style="text-align: center;">

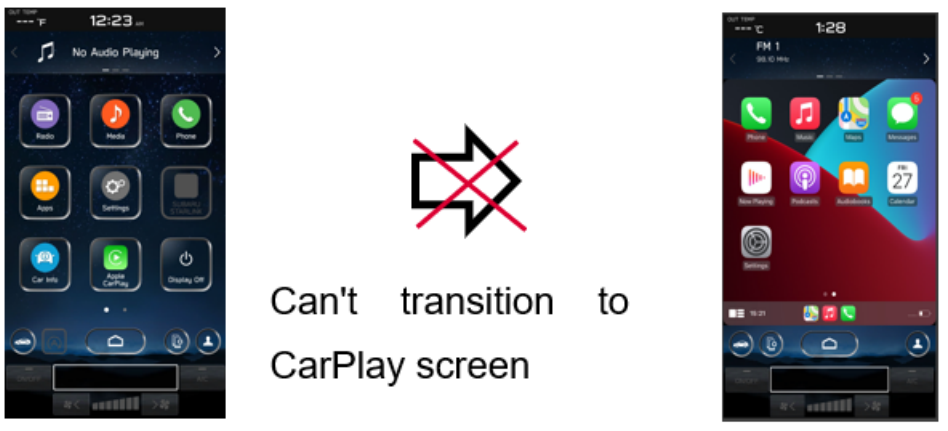
<p>14</p>	<p>When the engine is started with the iPhone connected via USB, CarPlay does not start even if the CarPlay icon on the home screen is pressed.</p> <p><Hint> This can be resolved by reinserting the USB cable.</p>

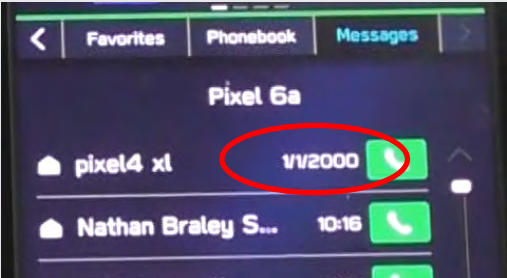
28	<p>The date of receipt of a received message is displayed as "2000/1/1." This occurs on some models of phones with Android OS 13 or later.</p>

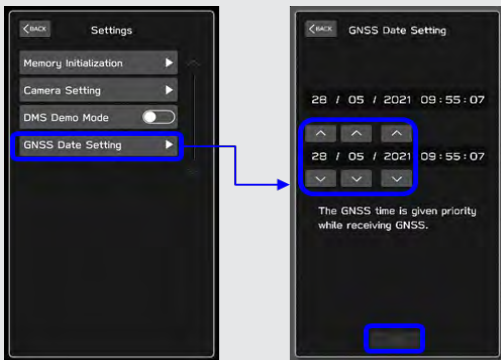
Number	Symptoms to be Improved:
35	After ACC-OFF while SXM is playing, SXM does not play automatically the next time ACC-ON.
36	When operating the navigation system by voice recognition, some regional place names (states, cities, etc.) are not recognized.
37	The destination setting cannot be deleted even if "Cancel Route" or "Delete Destination" is said with the voice recognition.
38	When a language other than English is set, the distance to the destination displayed in the navigation destination is abnormal. When the distance is greater than 1.0, the decimal point is rounded down. When the distance is less than 1.0, the value becomes 0.1.
39	When the clock was set to "AUTO," the date and time are shifted to a date approximately 20 years in the future due to anomalous values received from GPS or other reasons. If it occurs, the date and time cannot be corrected manually and have to be reset by disconnecting the battery terminal. As a countermeasure, a setting screen to manually adjust the clock display in the "AUTO" setting is to be added to the Dealership Mode (Dealership Mode->Settings->GNSS Data Setting).

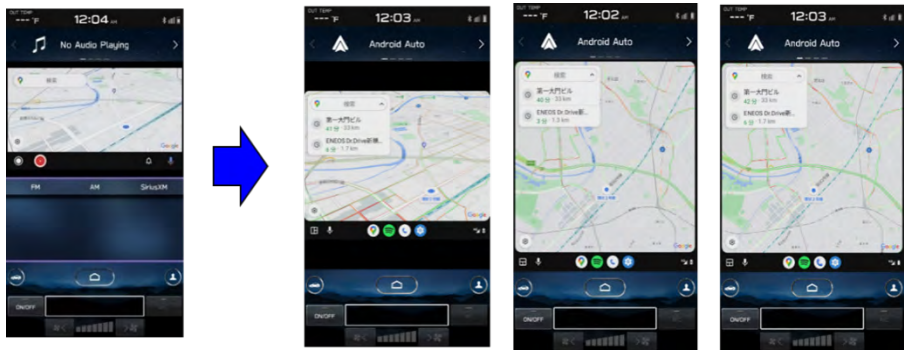
Number	New Functions and Enhancements
1	To improve the chance of reestablishing the connection in case of connection failure of Bluetooth and/or Android Auto due to error in the smartphone side, the CCU sends a request to the smartphone device again as additional attempt.
2	CCU Support vertical screen displays for Android Auto, but the actual display screen size differs depending on the Android device's OS version.

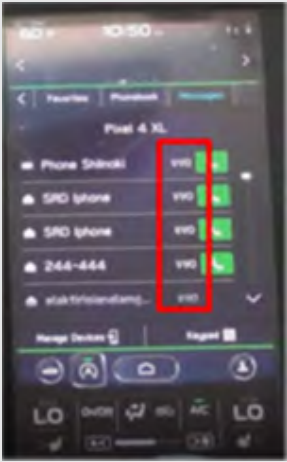
15	When “Call” button is pressed in “Confirm Destination” screen of Navigation system (to call the destination site,) the call can be made but the screen does not transit to phone call screen.
16	<p>When selecting “Phone->”Message,” message received time is displayed incorrectly as “1/1/0.”</p> <p>It can occur with an Android phone with a specific Android OS (Pixel 6, Pixel4a, Pixel4XL, Xperia etc.) in which time zone data is attached to the message receiving time.</p>

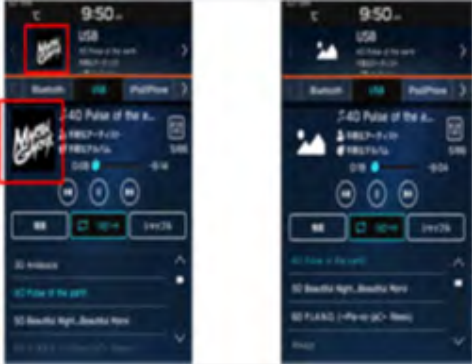
Number	Symptoms to be Improved:
17	Even when using the same mobile device that was paired previously, a message of “Are you sure you want to activate this profile?” is prompted and confirmation is needed to activate the device.
18	<p>Cover art of previous music is displayed when playing music without cover art in USB audio. It can occur when music with and without cover art is mixed and stored together a single USB.</p>

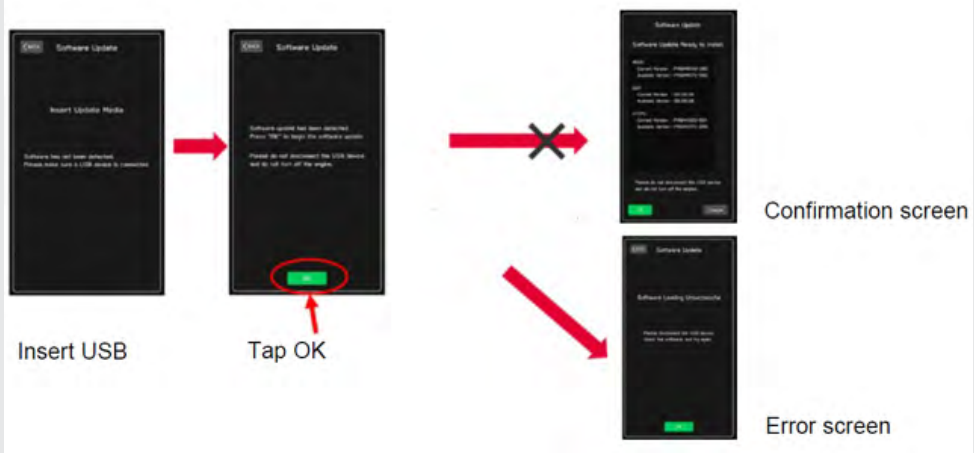
10	No functional response on touch screen in Radio mode even though the touch sound and visual reaction are confirmed.
11	<p>Reprogramming process takes extensive time (40 minutes or more.)</p> <p>After the ignition switch is turned off and on again, the combination meter display mode changes itself and shows the ECO gauge (Current fuel consumption/Driving range on remaining fuel.) Both attribute to processing errors in CCU.</p>
12	<p>When conducting USB reprogramming, the screen transition to error screen instead of confirmation screen.</p>

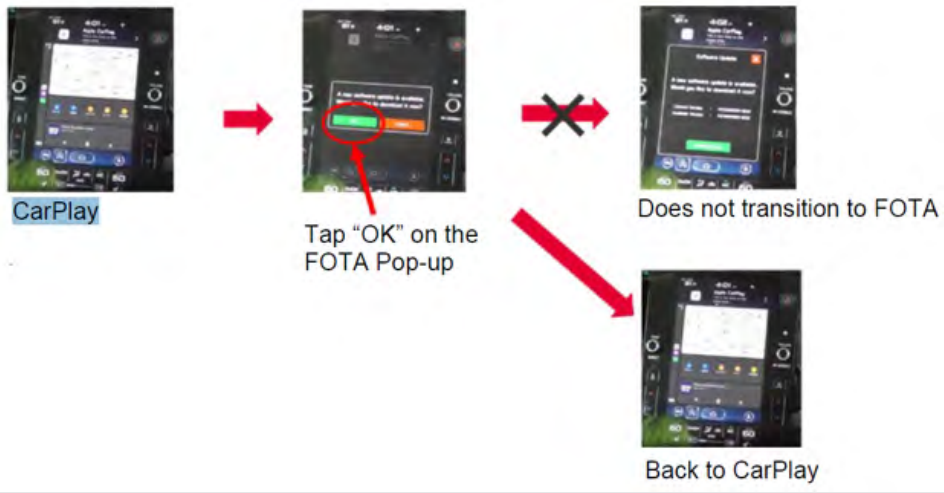
<p>Note* In case this USB update failure occurs, retry updating according to the instructions in “Appendix A”</p>
<p>14</p>	<p>When the FOTA pop-up (new software availability notification) is displayed while the CarPlay is being used, the display comes back to CarPlay screen even if the customer tries to get into the FOTA screen.</p>

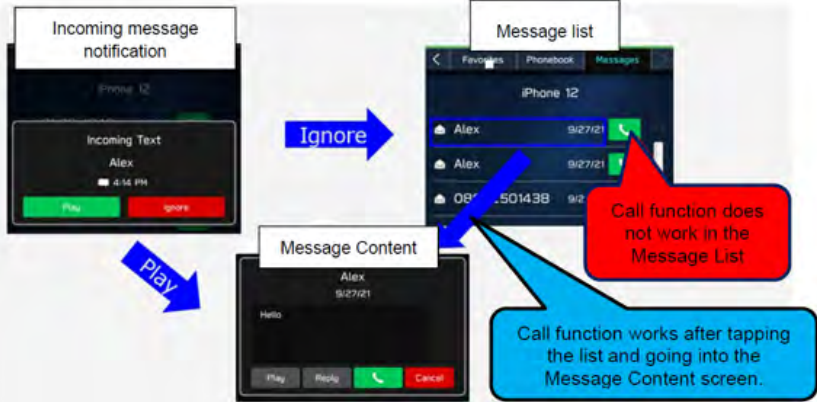
<p>15</p>	<p>Call function does not work in the Message List (after ignoring the incoming message notification.). However, the call function can still be used after getting into the Message Content screen by tapping the message list.</p>

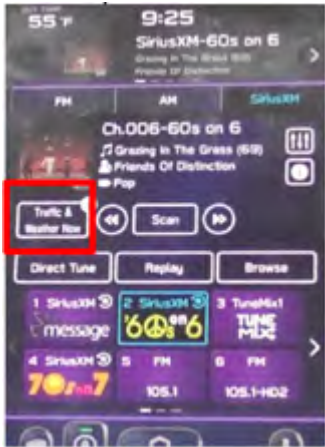
23	Soon after the cable has been removed from the AUX TERMINAL (USB Hub), icons on Home Screen stop functioning.
24	Phone Book is displayed in the order of the First Name even though the display setting was made in the order of Family Name.
25	<p>No response when touching "Traffic & Weather Now (TWN)" on SMX screen.</p>

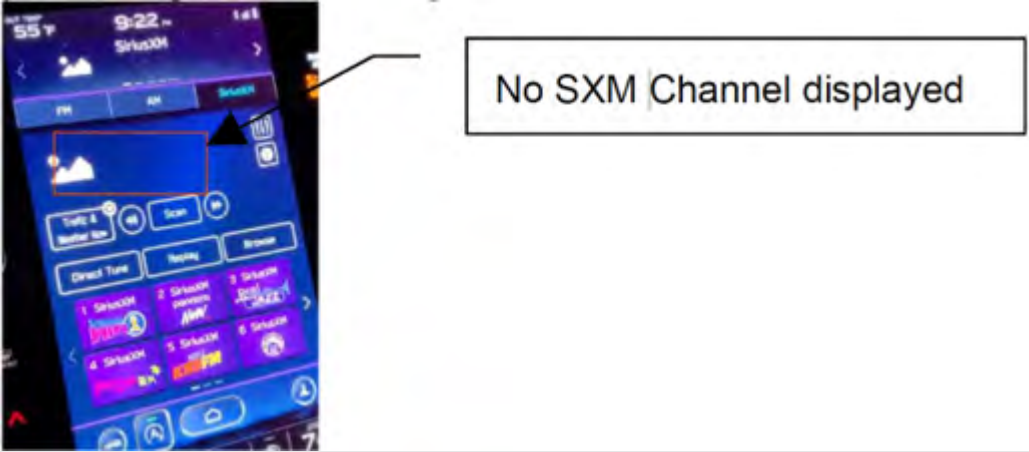
Number	Symptoms to be Improved:
26	<p>SXM has blank screen and no sound when the SXM screen had been selected as audio source at the previous ignition off timing.</p>

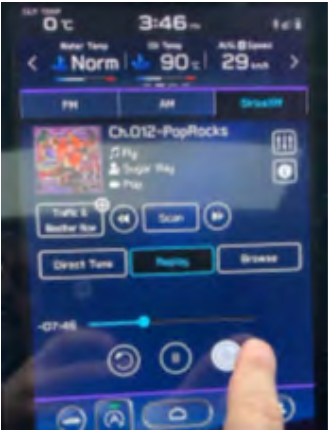
28	SXM has blank screen and no sound when the audio source is change to SXM.
29	<p>“Fast forward” does not work in SXM replay function. (Fast Rewind works.)</p>

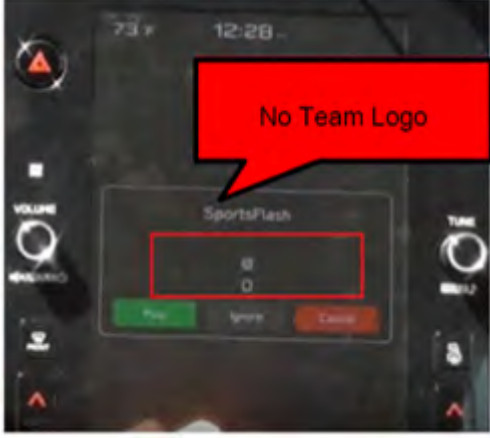
31	<p>The team logo is not displayed on Sports Flash screen when the SXM screen had been selected as audio source at the previous ignition off timing.</p>

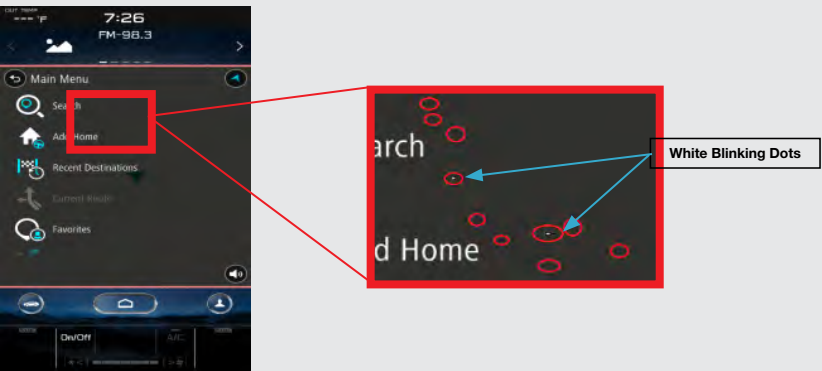
Symptom #	Description of Symptom:
1	Several minutes after Engine start, the Center Information Display (CID) reboots.
2	<p>After an extended period of usage, some white blinking dots appear on the display.</p>

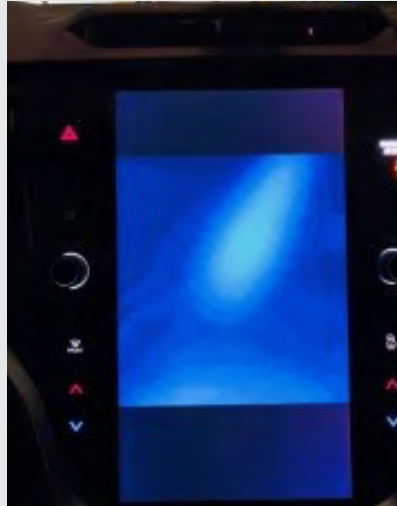
Symptom #	Description of Symptom:
13	CarPlay connection cannot be established. When connecting an iPhone via USB, "CarPlay Unavailable" is displayed and CarPlay does work.
14	The HOME screen goes blank. When the screen is switched from Camera mode to HOME, no icons are displayed as shown below.

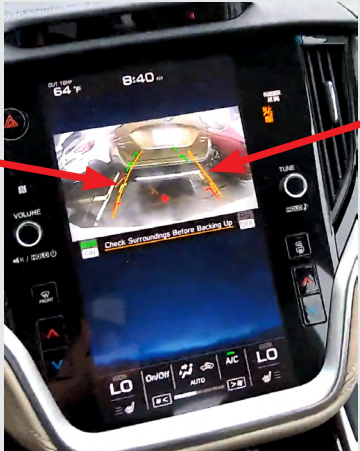
Symptom #	Description of Symptom:
2	<p>Delayed response of rear view camera guide lines. When the rear view camera is activated and the steering wheel is turned, there is a delay before the steering-responsive guide lines respond to the steering wheel input.</p>

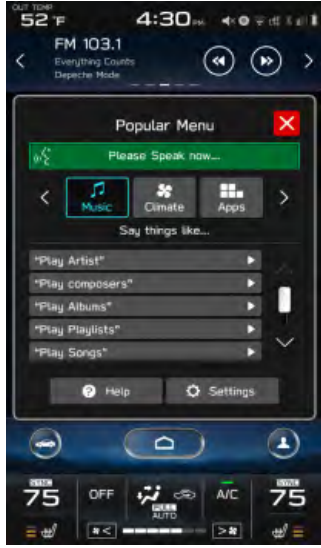
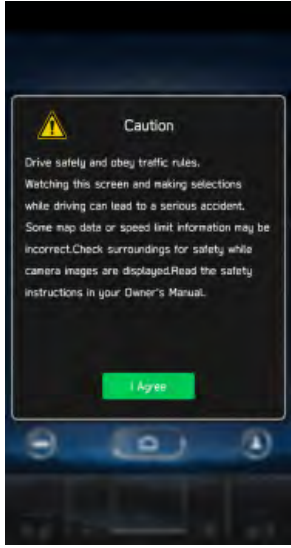
Symptom #	Description of Symptom:
5	<p>When using Voice Recognition to search for a 'Nearby POI' (Point of Interest) in Canada with FRENCH language selected, the CP1 display turns black and displays a Caution / disclaimer message.</p> <div style="display: flex; justify-content: space-around; align-items: center;">
