SERVICE BULLETIN

APPLICABILITY: 2023MY Outback & Legacy
2023MY Ascent

NUMBER: 15-311-23R

SUBJECT: FOTA (Firmware Over-The-Air) Reprogramming for DENSO Gen 4.5 Audio Navigation Infotainment Systems via DCM

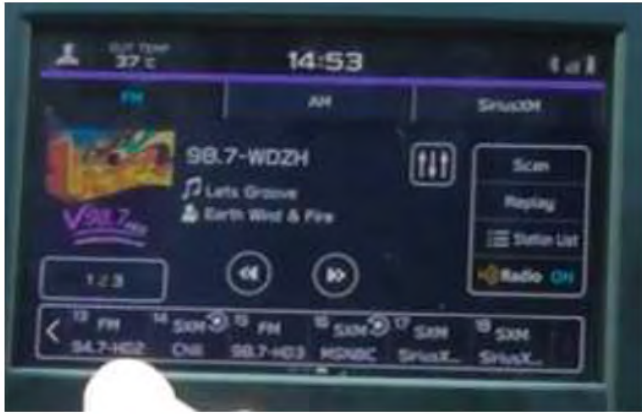
6	Android Auto Wireless (AAW) cannot be connected.
7	Android Auto Wireless (AAW) cannot be started from “Manage Devices” Screen.
8	Sound volume control does not work while using Android Auto. It is caused by data communication error between Android device and CCU.
9	Cyclic short noise like a drilling or vibration is heard from speakers.
10	<p>Sound is lost when changed to Subchannel 2 right after a preset HD radio channel has been selected.</p>

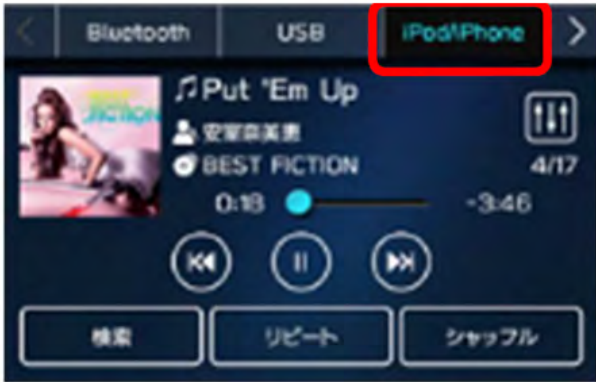
New repeat mode	Old repeat mode	“Repeat All”	--	“Repeat current album/folder”	“Repeat current album/folder”	“Repeat current track”	“Repeat current track”	“Cancel repeat”	“Cancel repeat”
New repeat mode	Old repeat mode										
“Repeat All”	--										
“Repeat current album/folder”	“Repeat current album/folder”										
“Repeat current track”	“Repeat current track”										
“Cancel repeat”	“Cancel repeat”										
18	“Track-up/down” can be used across folders in “Repeat All” mode.										
19	<p>iPod/iPhone tab in Media screen cannot be selected, when connected by USB.</p> <p>The symptom occurs when the iPhone is connected to CP1.5 via Bluetooth in parallel to USB connection by error. (It is supposed to be connected either via Bluetooth or by USB.)</p>

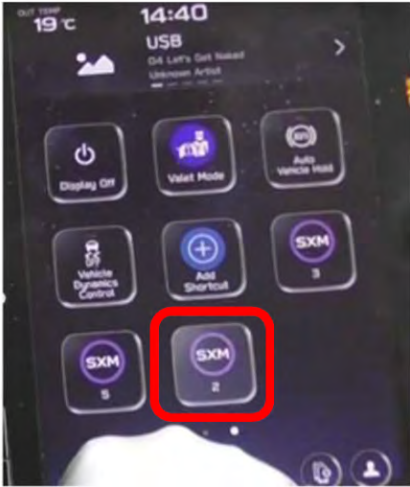
22	<p>Cannot pair new Bluetooth device or cannot connect paired Bluetooth device. This symptom possibly occurs after repeating IG OFF/ON operation while still pairing operation.</p>
23	<p>Cannot pair Bluetooth device, when Bluetooth device has long name including symbols.</p>
24	<p>SXM station shortcut created by the customer does not work when the SXM has not been used as audio source after the Ignition Switch was turned on in the ignition cycle.</p>

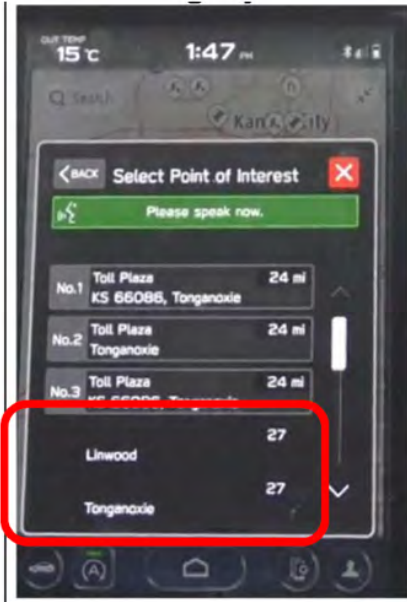
26	<p>Cannot connect to CarPlay via wireless connection. This symptom possibly occurs after the Ignition Switch was turned Off and On abruptly.</p>
27	<p>POI Search Result shows only city names and distances (without unit) when voice recognition POI search with Category name like “Find toll gate” is used.</p>
