**PRODUCT CAMPAIGN BULLETIN**

**APPLICABILITY:** 2005-2006 model year Baja  
 2009-2012 model year Legacy  
 2009-2012 model year Outback  
 2009-2012 model year Forester  
 2006-2012 model year Tribeca  
 2006-2011 model year Impreza (including WRX and STI)  
 2012 model year WRX and STI

**NUMBERS:** TKA-17R  
 TKB-17R  
 TKC-17R

**SUBJECT:** Takata Front Passenger Airbag Inflator Replacement

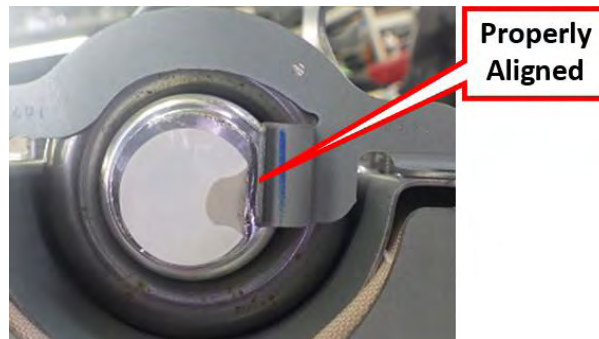
Make sure the “D-shaped” portion of the inflator harness connector boss aligns with the “D-shaped” portion of the original stopper plate as shown below. Do not peel the white harness connection dust cover at this time.

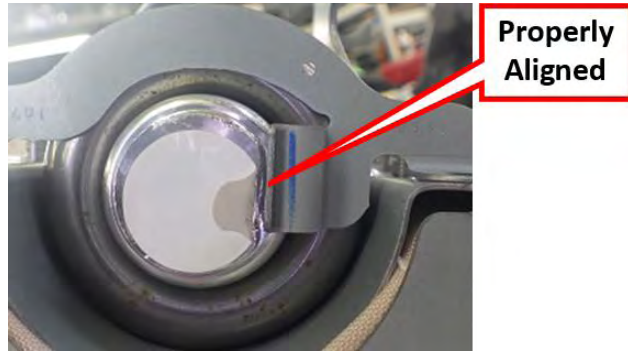
Make sure the “D-shaped” portion of the inflator harness connector boss aligns with the “D-shaped” portion of the original stopper plate as shown below. **Do not peel the white harness connection dust cover at this time.**

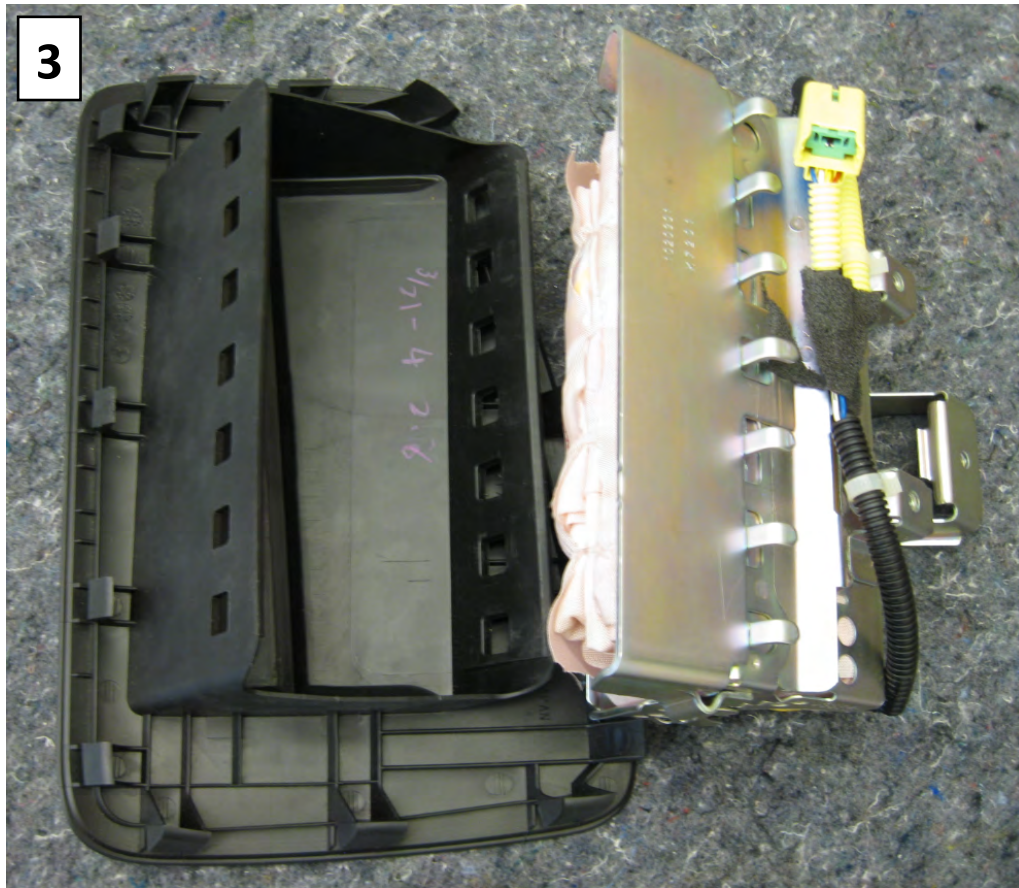
- Inspect the claw openings on the outside and inside of the cover for damage. If any found to look like the NG example photo below, the cover must be replaced.

Close-up of a witness mark left behind by the inside of the center retaining claw. This is normal and acceptable. There is no need to replace the cover for this.

Inside view of a damaged cover, shows tearing and material missing. This cover must be replaced.

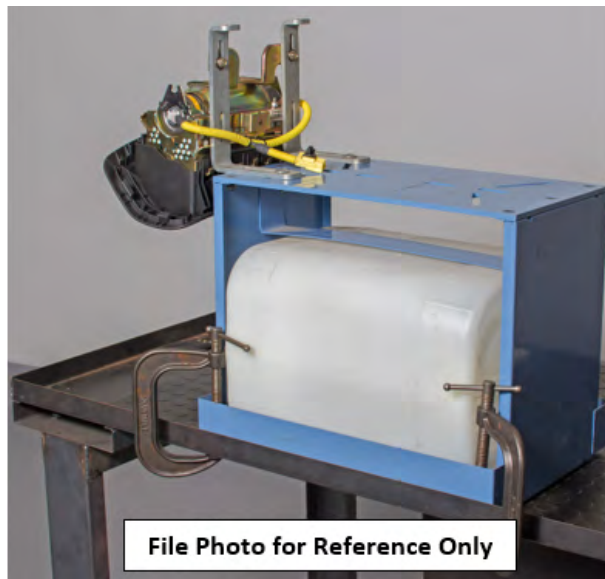
**REMINDER:** It is **STRONGLY RECOMMENDED** the removed airbag module **ALWAYS** be mounted to the Airbag Deployment Fixture (part number J-39401-B and file photo shown below) to better secure it during the inflator replacement procedure. When mounting the module to the fixture, pay close attention to the harness routing. Always perform this work in an area away from others to reduce chances of inadvertent injury should any deployment occur. Take your surroundings into account to avoid possible hazards should an inadvertent deployment occur or sources of static or other electricity that could potentially induce such a deployment.

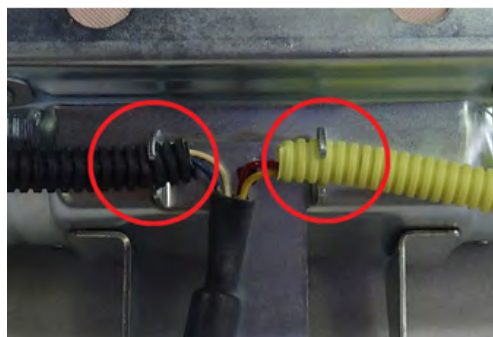
**STEP 3-** Remove both harness tubes from the retainer bracket.

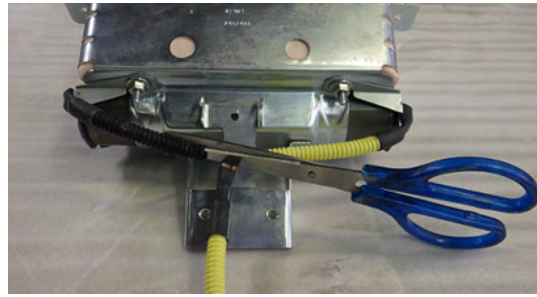
**STEP 4-** Using a scissor or wire cutter (no knives or razors) **CAREFULLY** cut the black harness cover tube (approximately 1 1/2 inches) enough to expose the blue and white wires inside. Provide enough room to install the Electro-Tap (shorting) connector.

**TAKE YOUR TIME AND BE CAREFUL TO NOT CUT THE 2 WIRES!**

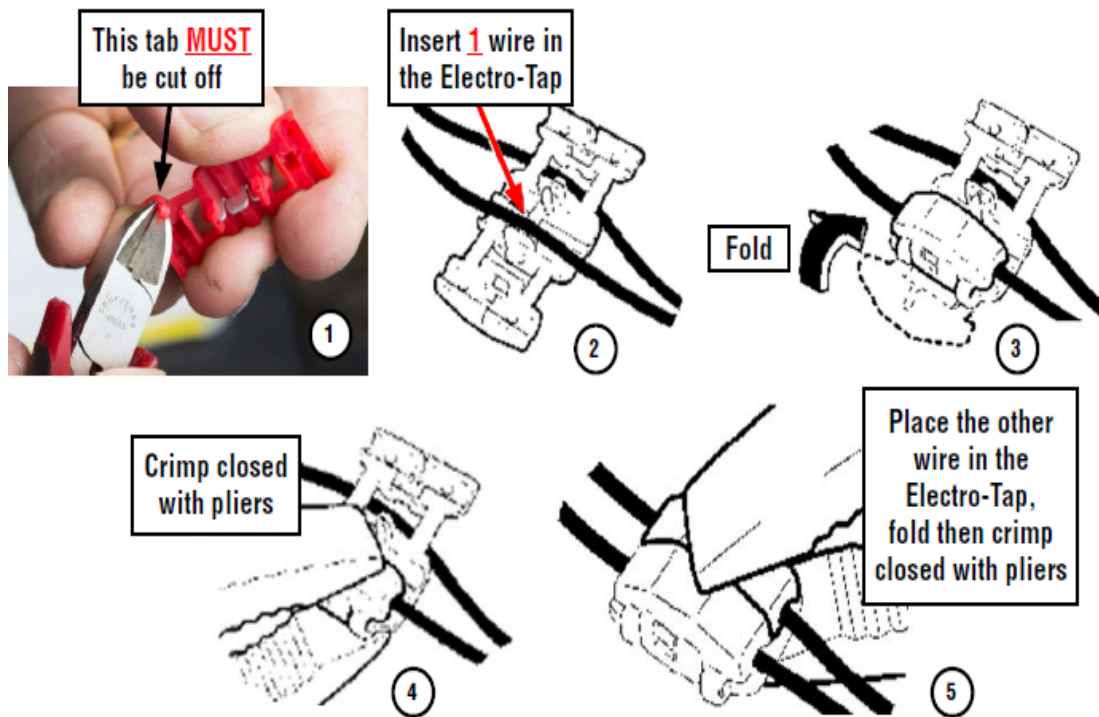
**STEP 5-** Short the blue and white wires together by installing the Electro-Tap connector. The connector creates a short circuit which acts as a safeguard to prevent against static discharge that may deploy the removed inflator. The tab portion of the Electro-Tap connector **MUST** be cut off prior to use to insure a good short-circuit is made as shown in the illustration below. **Follow the sequence below** for installing the Electro-Tap connector. Use pliers to squeeze closed the two sections of the connector together, **one section at a time**.

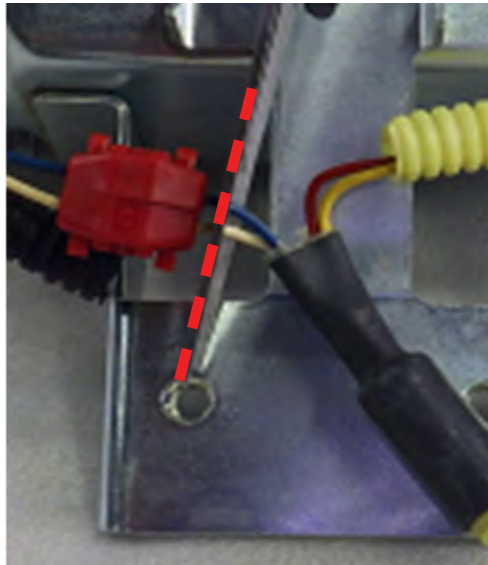
**STEP 6-** Once the Electro-Tap connector is fully crimped in place, cut the blue and white wires **on the body harness connector side** of the Electro-Tap connector. **NEVER ATTEMPT TO REMOVE THE HARNESS CONNECTORS FROM THE INFLATOR!**

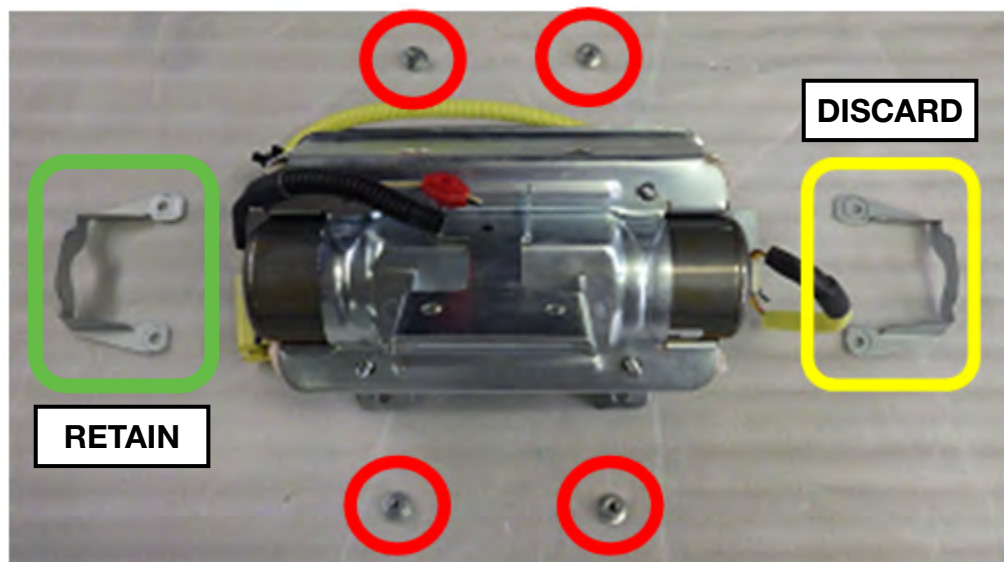
**STEP 7- USING HAND TOOLS ONLY**, loosen and remove the four (4) 10mm self-locking nuts along with both stopper plates. **RETAIN the stopper plate circled in GREEN** (Left-side bracket in image below) as it will be used during reassembly. Discard the removed stopper plate circled in **YELLOW** as it is no longer needed along with the 4 removed 10mm nuts.

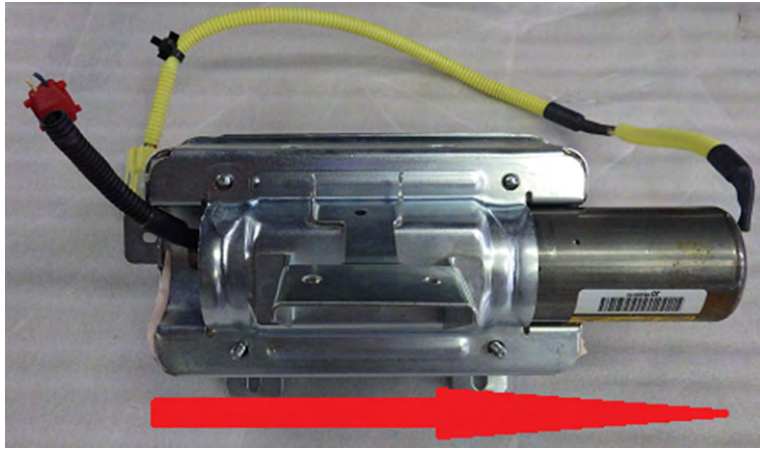
**STEP 8-** With the self-locking nuts and stopper plate removed, slide the original inflator out of the mounting bracket. Place the removed original air bag inflator back into the “cradle” of the Kit Box.

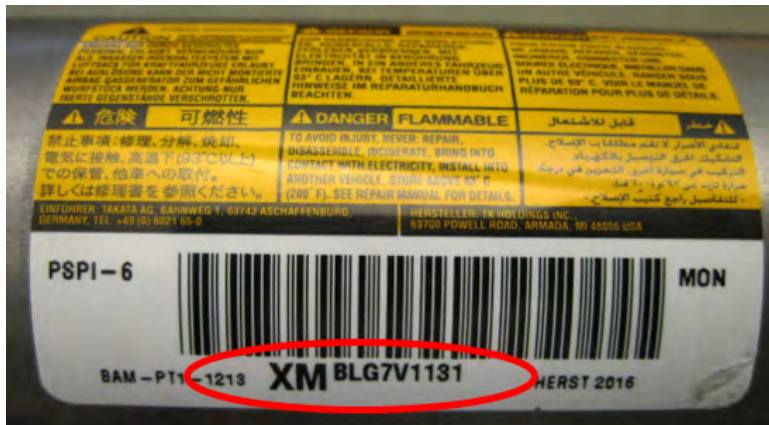
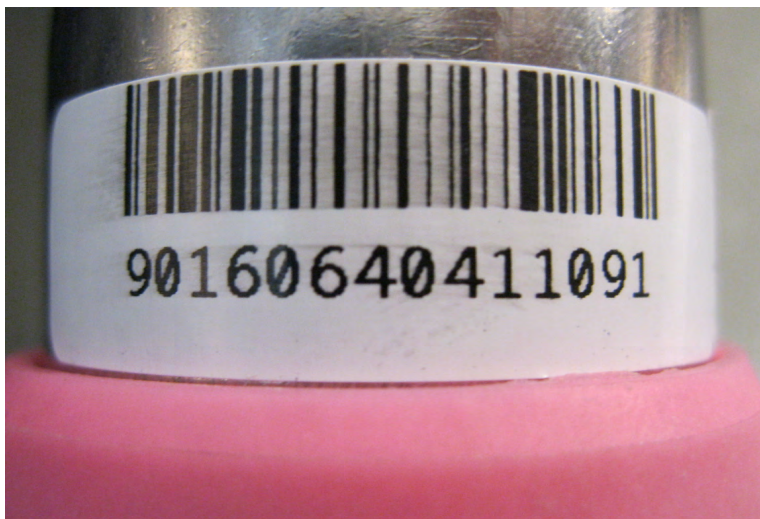
**STEP 9- VERY IMPORTANT:** Record the serial number for **both the new and the removed inflators** on the hard copy of the Repair Order. **For SOA and SDC Retailers ONLY**, this information will be required for claim approval. **For SNE retailers**, this information will be required for completion of the Part Return Notice which will be forwarded by the retailer to the PCC.

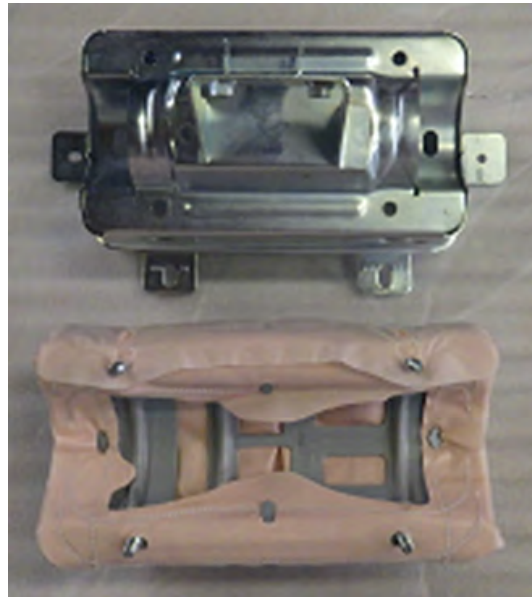
**STEP 10-** CAREFULLY remove the airbag from the mounting bracket (case).

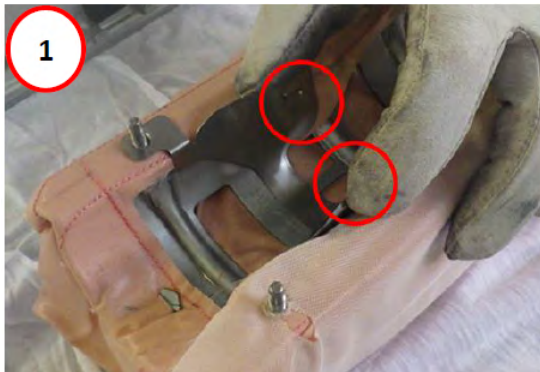
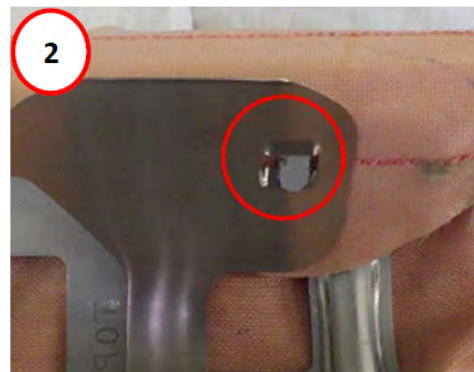
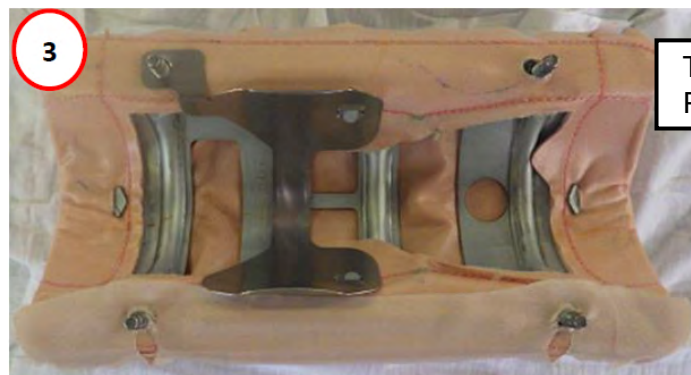
Thermal Insulator Properly Installed

**STEP 11-** CAREFULLY install the black thermal insulator into the back (inflator) side of the airbag as shown in photo 1 below. **CAUTION:** Gloves are recommended when doing this as edges of the thermal insulator can be very sharp. **TAKE YOUR TIME** and do not bend or twist the insulator any more than necessary to make it fit. The insulator can only be installed in one direction as shown in photo 3 otherwise, the airbag will not fit back into the module frame properly. Confirm both retaining claws come through the corresponding insulator holes like the example shown in photo 2.

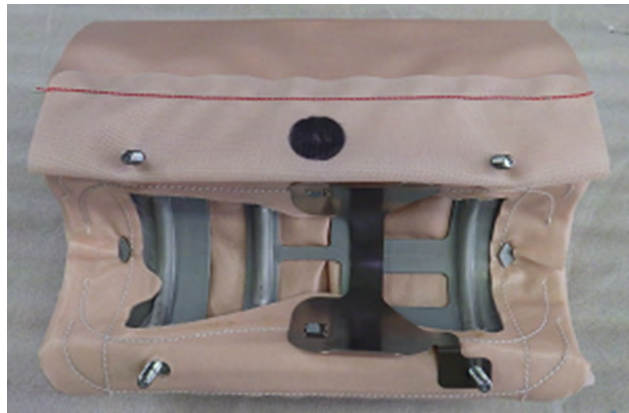
**STEP 12-** Install the protective sheet onto the studs of the airbag with the black mark in the position specified in the photo below. Due to the different spacing of the studs, the protective sheet will only fit properly when installed in this manner.

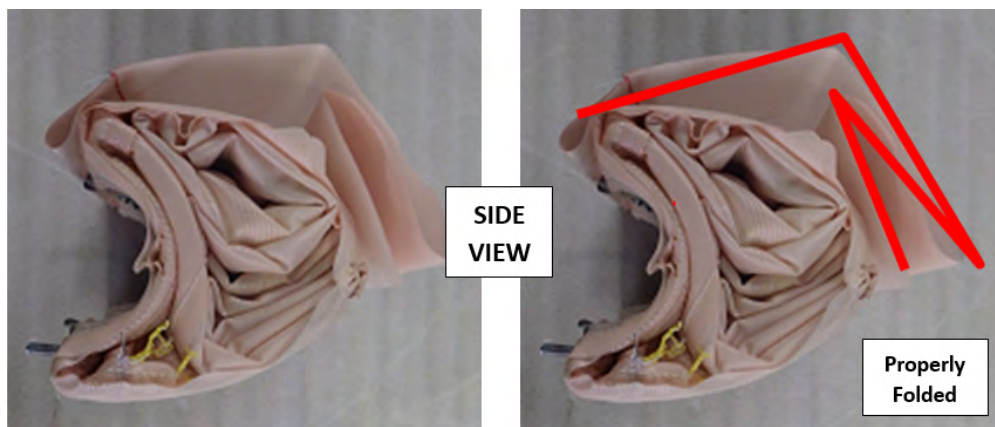
**STEP 13-** The protective sheet is properly installed when: **a)** it fits squarely on the studs, **b)** the black oval-shaped mark is facing up and **c)** the excess is laying over the top of the airbag and folded as shown in the side view photos below.

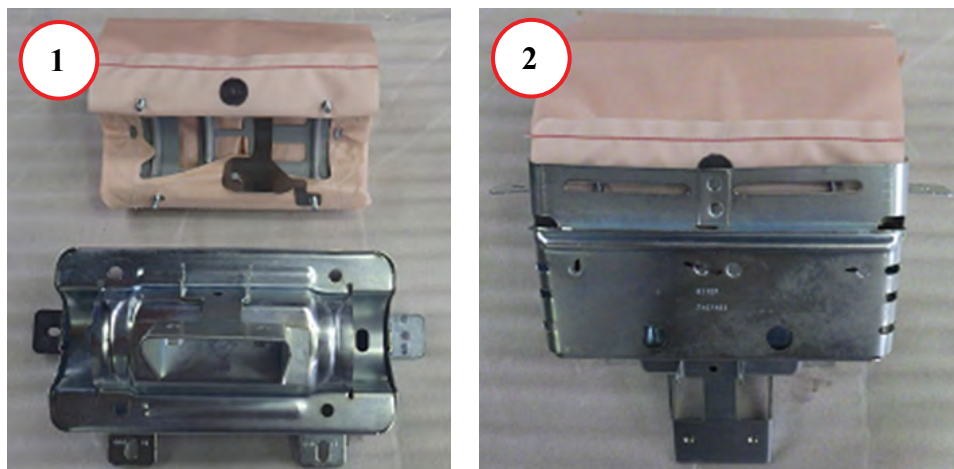
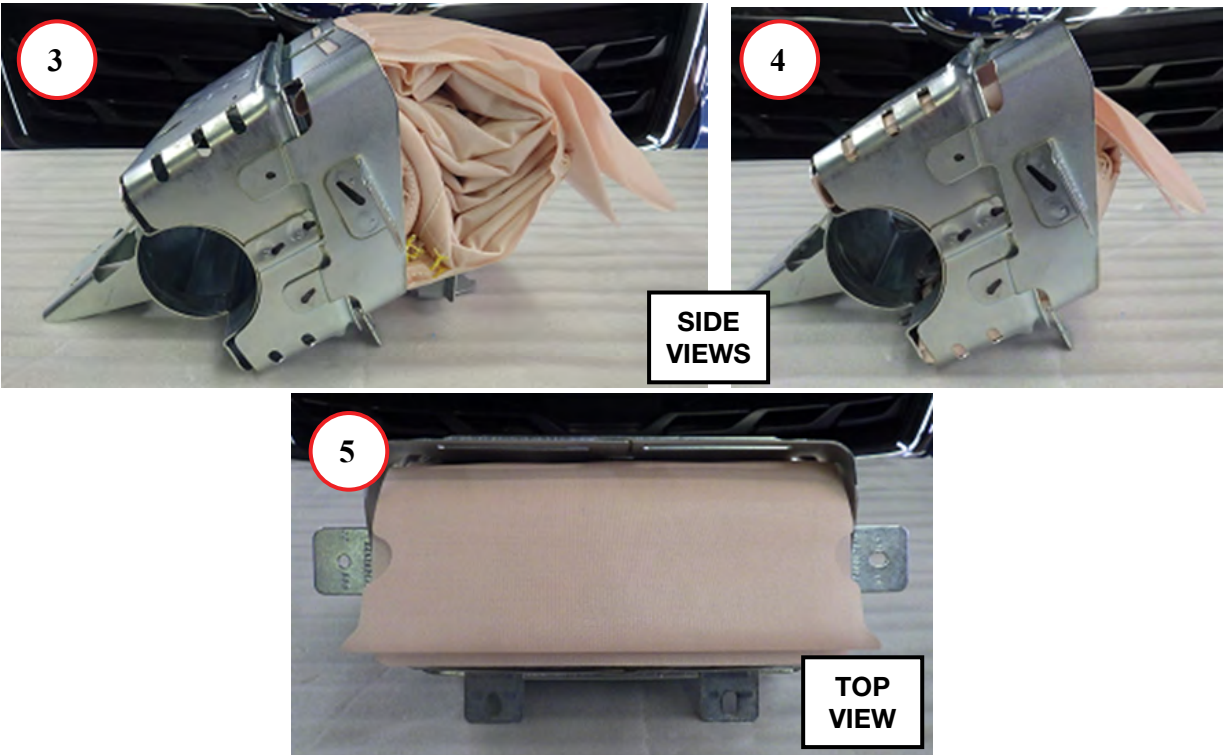
**STEP 14- CAREFULLY** refit the airbag back into the mounting bracket as shown in the sequence below.

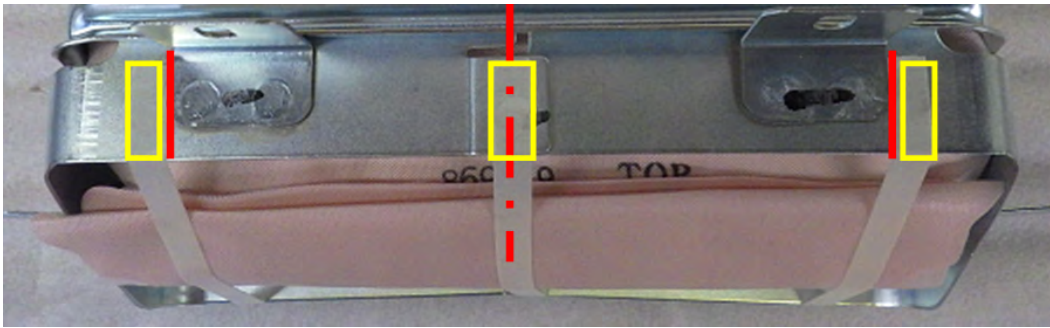
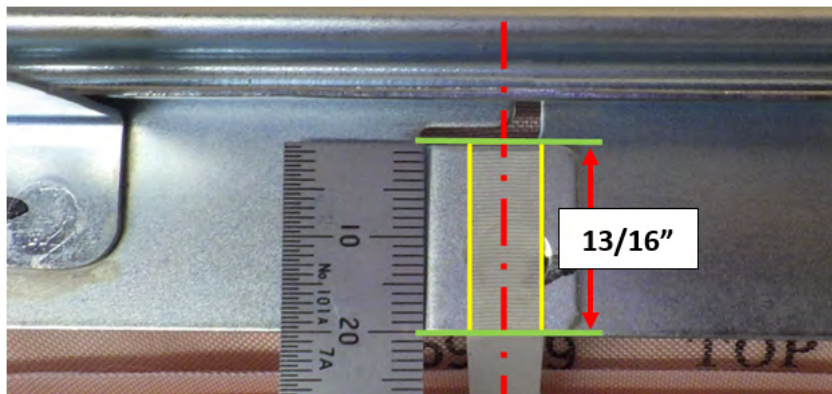
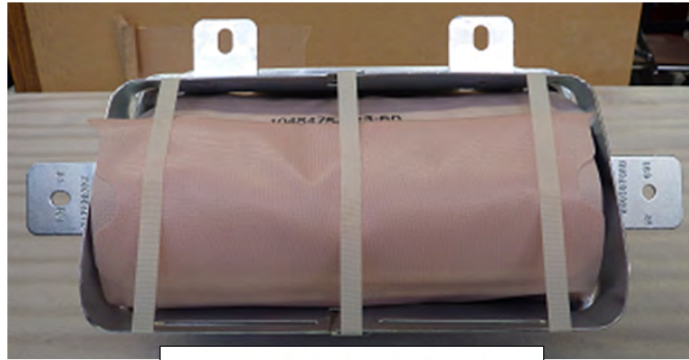
**Airbag Reinstallation Complete**

**STEP 15-** Apply the 3 anti-wrinkling tapes to the module frame as shown below to retain the protective sheet. The yellow rectangles represent the tapes and the red lines indicate where the tapes are to be positioned. Approximately 200mm (13/16") from each end of the 2tape should be applied to the module frame.

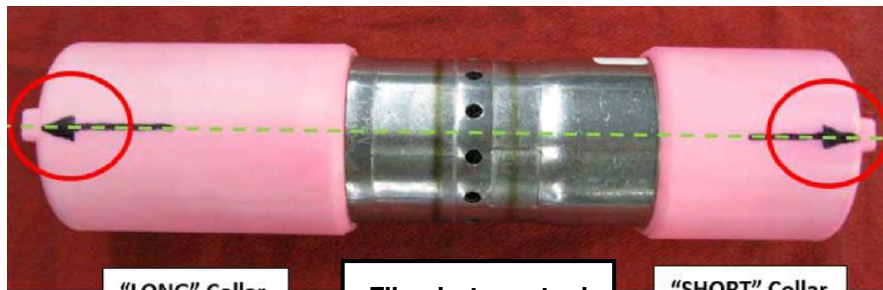
**“LONG” Collar**

**STEP 16-** Inspect the new inflator to confirm the locating protrusions on each of the pink collars are aligned as shown below. The “short” collar can be rotated as needed to align it with the protrusion on the “long” collar if necessary.

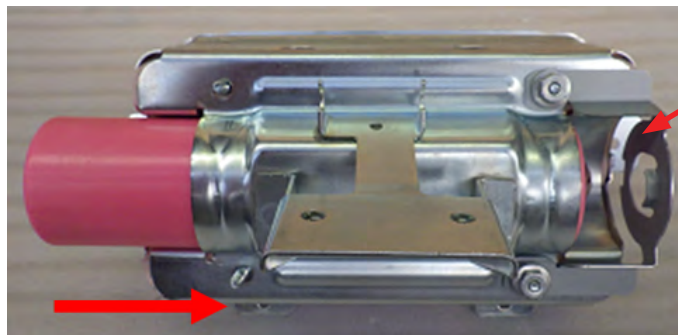
**New Stopper Plate Supplied with Kit.**

**STEP 18-** Slide the new inflator back into the mounting bracket, short collar end first. Align the tab on the new stopper plate with the notch on the end of the collar. When properly installed, the inflator will be tight against the stopper plate with no gap.

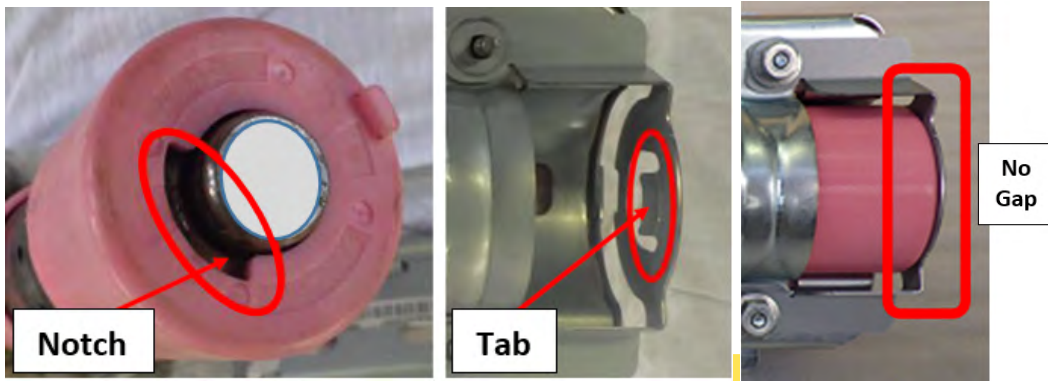
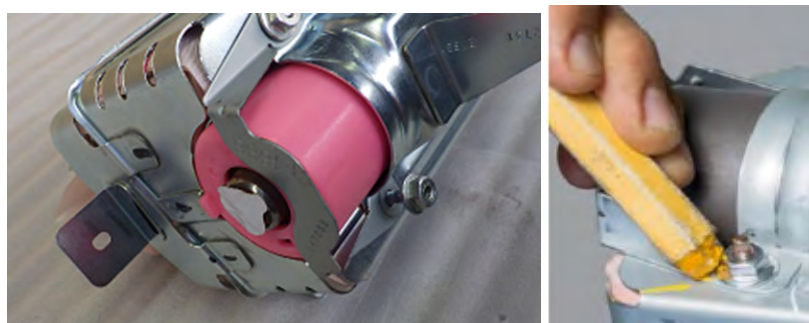
**STEP 19-** Reinstall the original (retained from **STEP 7**) stopper plate and the other 2 **NEW** self-locking nuts. **SLOWLY** tighten (to prevent over-tightening) while making sure both stopper plates stay tight against both ends of the inflator. **HAND TOOLS ONLY!** Torque the nuts to 31-38 inch-pounds. When complete, use a marker to indicate they have been fully tightened.

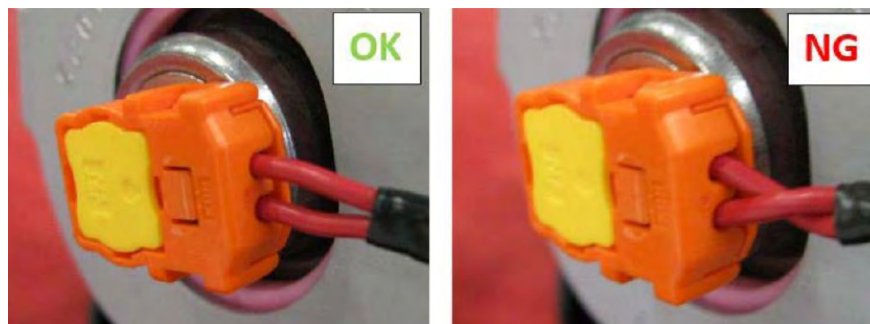
**BEFORE** connecting the harness to the inflator, make sure the harness is not twisted as shown below.

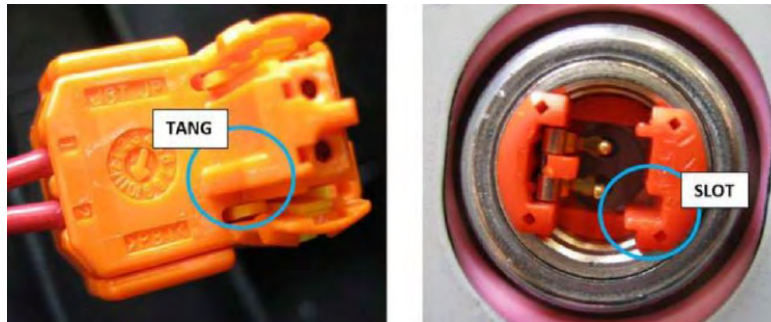
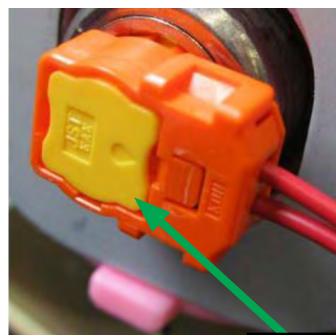
**Lock Tab**

**CAREFULLY** align the tang of the inflator with the slot on the inflator harness connector as shown below. Push down firmly on the yellow lock tab to engage the connector's locking claws into the groove inside the connector boss on the inflator end. Confirm the connector is locked by prying up **LIGHTLY** with a small flat-blade screwdriver. Repeat the procedure on the opposite end.

Once alignment is confirmed, push down firmly to engage the connector. When fully seated, press down on the yellow tab locking the connector to the inflator.

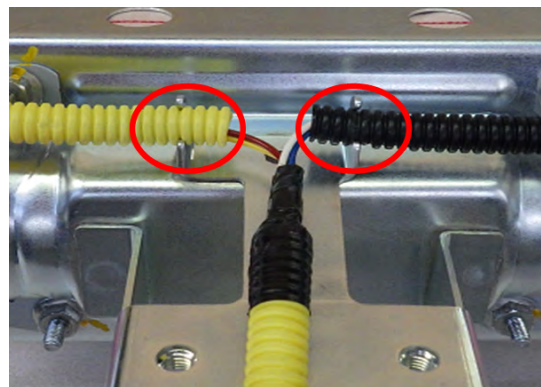
**STEP 21-** After connecting both sides of the harness, refit the harness cover tube back into the retaining bracket.
