Subject: Missing the V Series Instrument Panel Graphics on Vehicle Startup

Brand:	Model:	Model Year:		VIN:		Engine:	Transmission:
		from	to	from	to		
Cadillac	Escalade Models (Premium Only)	2024	2024

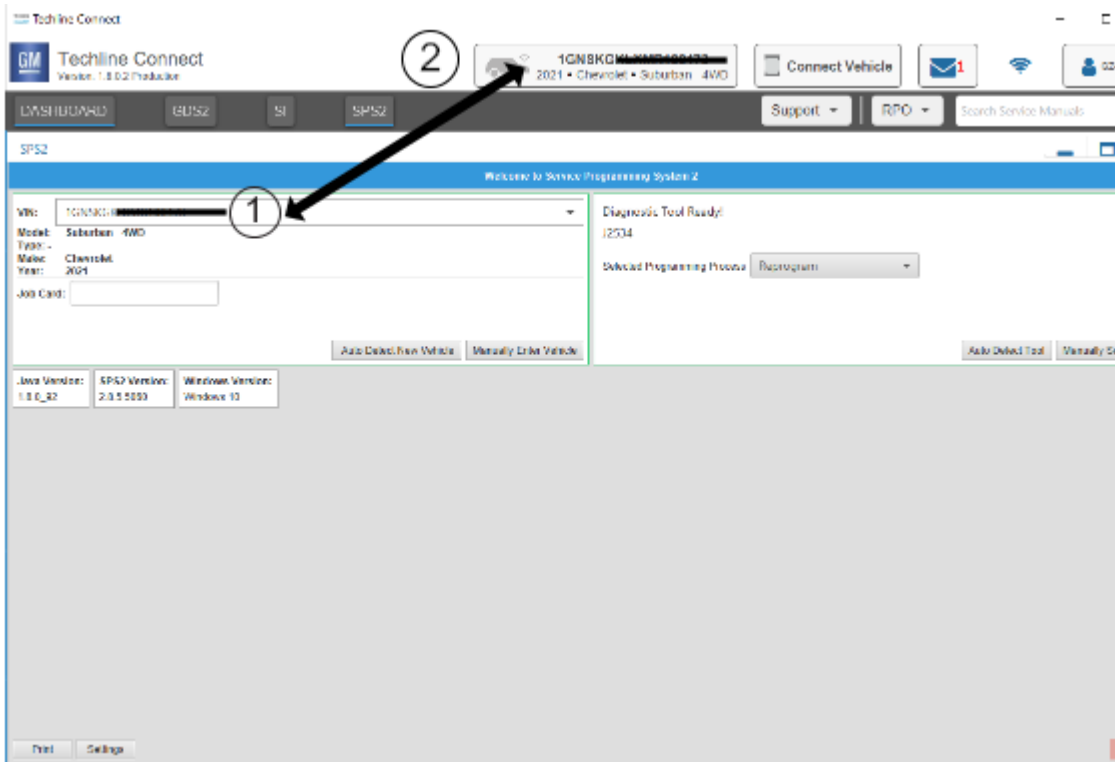
5743643

Caution: Be sure the VIN selected in the drop down menu (1) is the same as the vehicle connected (2) before beginning programming.

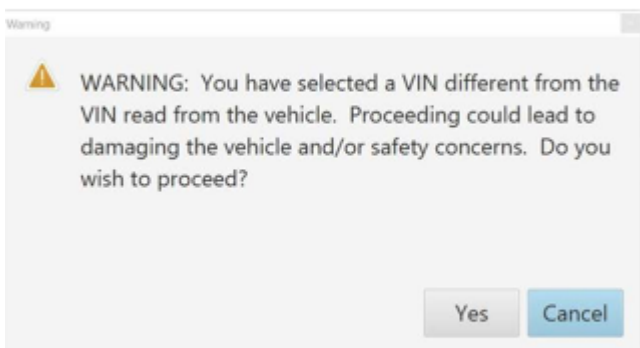
5877000

Important: If the vehicle VIN DOES NOT match, the message below will be shown

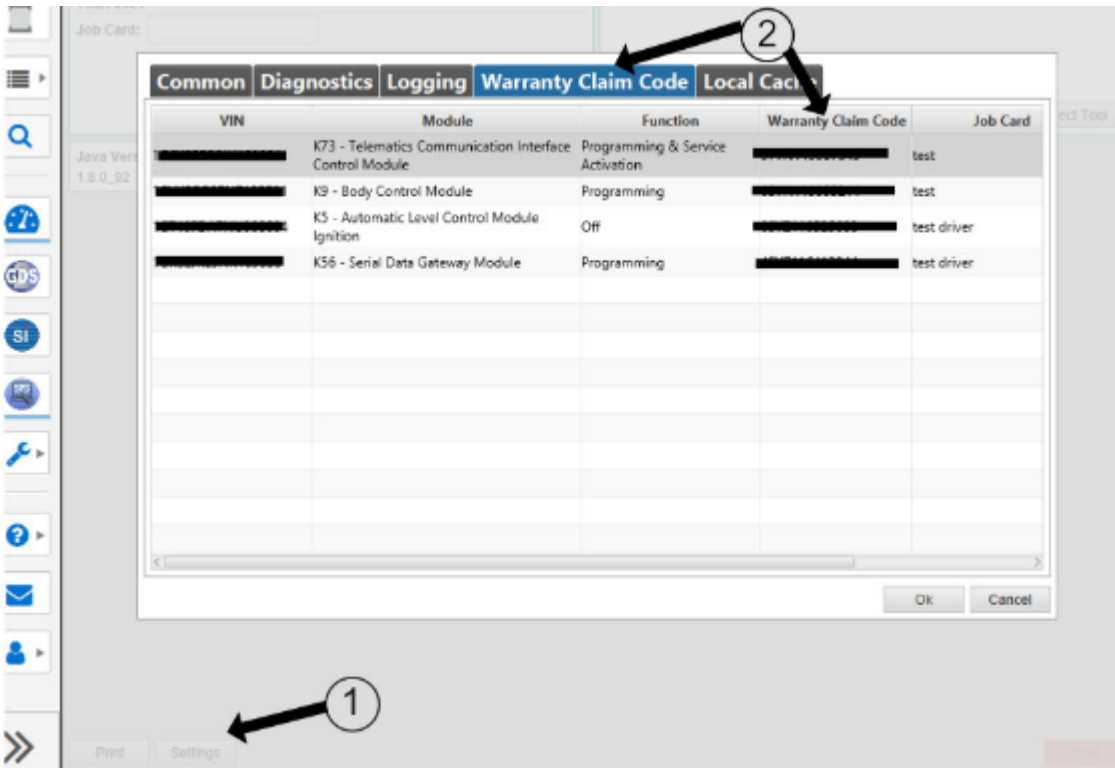
6125774

If the Warranty Claim Code was not recorded on the Job Card, the code can be retrieved in the SPS2 system as follows:
