Subject: Radio Software Version Y171 – Multiple Updates

This Service Bulletin replaces PIT5999, PIT6008, and PIT6032. Please discard all copies of PIT5999 and PIT6032 and PIT6008.

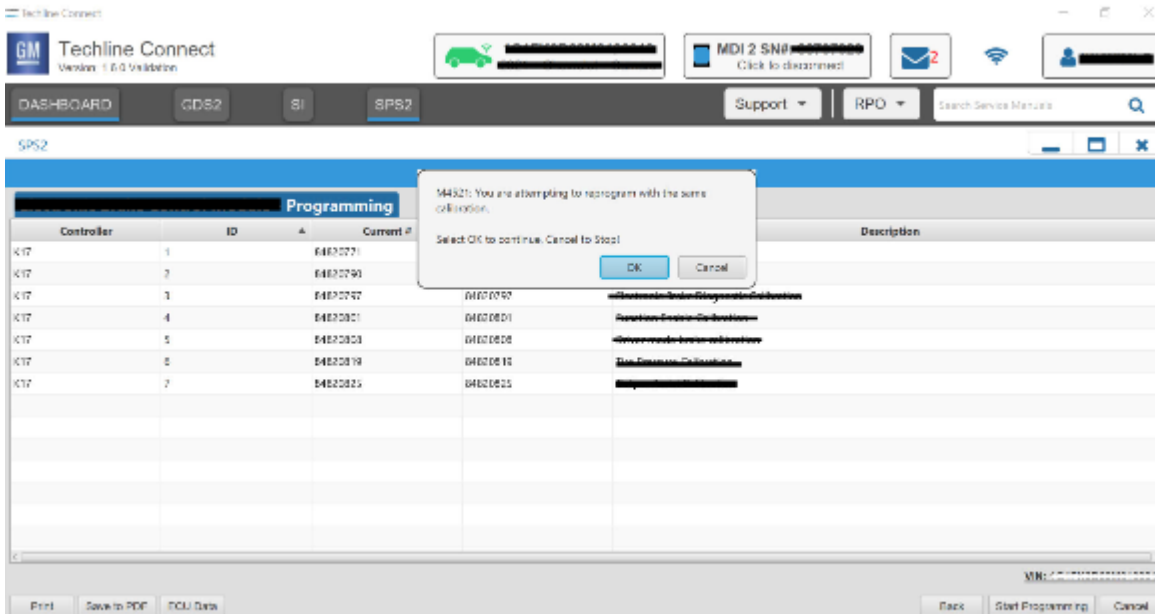
5644477

Important: Techline Connect screens shown above.

Important: If the same calibration/software warning is noted on the TLC Summary screen, select OK and follow screen instructions. After a successful programming event, the WCC is located in the Service Programming System dialogue box of the SPS Summary screen. No further action is required. Refer to the Warranty section of the bulletin.
