**Upper front suspension creaking/knocking noise**

<b>REF NO:</b> TJ 36527.5.0	<b>ISSUING DEPARTMENT:</b> Technical Service	<b>CAR MARKET:</b> United States and Canada	
<b>PARTNER:</b> 3 US 7515 Polestar		<b>ISSUE DATE:</b> 2024-01-02	<b>STATUS DATE:</b> 2024-01-24
<b>FUNC GROUP:</b> 7233	<b>FUNC DESC:</b> Mounting	<b>Page 1 of 4</b>

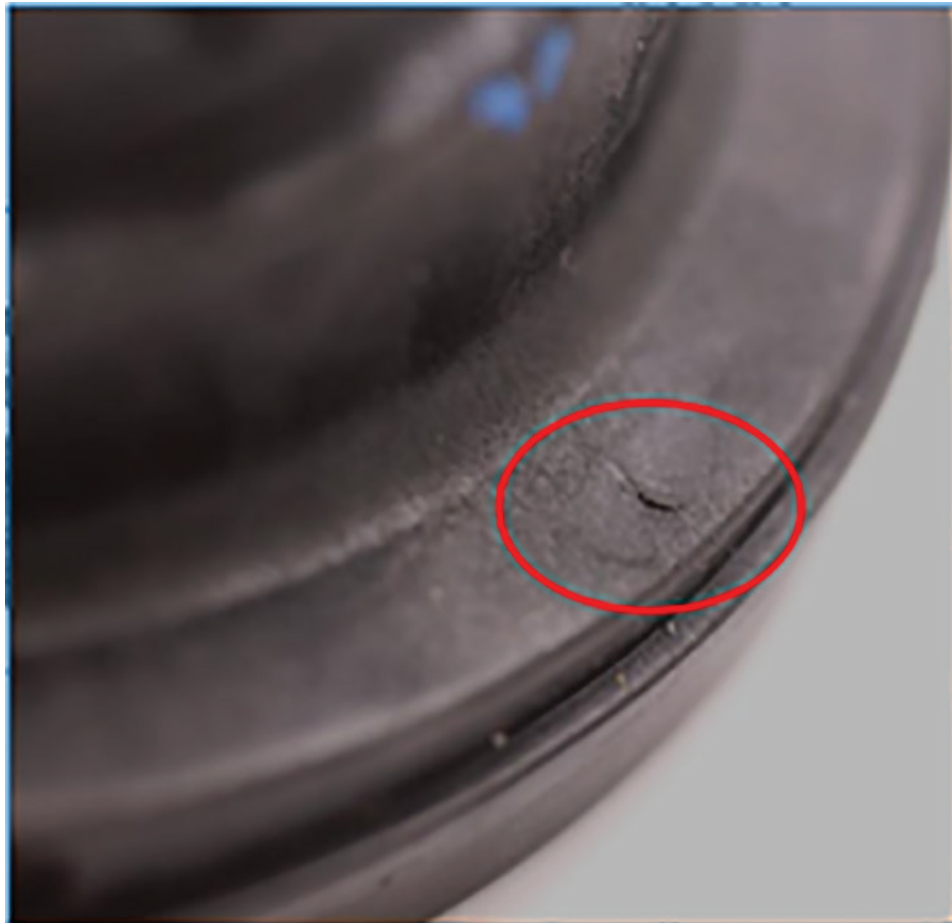
- During acceleration/braking (knocking noise.MOV and picture 1)
- During (slowly) driving over bumps and into turns (knocking noise.MOV and picture 1)
- During turning to left or right when standing still (Creaking noise.mp4 and picture 2)
- During parking maneuvering (Creaking noise.mp4 and picture 2)

See attachment for bearing to be replaced.

**Note:** It is OK to replace the upper bearing.
