Service Bulletin

Bulletin No.: 22-NA-112

Subject: 2020 - 2022 Silverado and Sierra Equipped with Diesel Engine Setting DTCs P20BB or P20C3

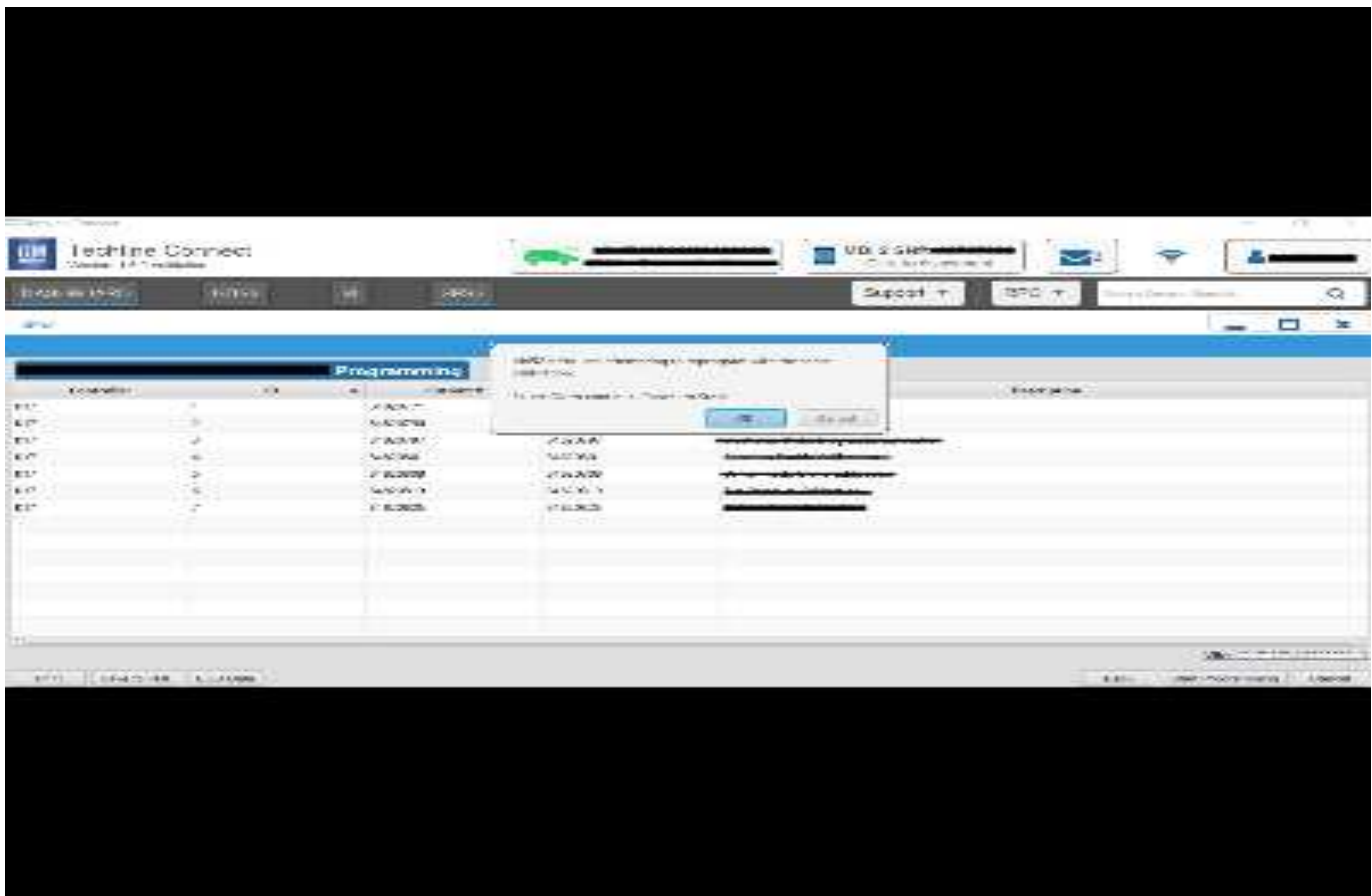
5644477

Important: Techline Connect and TIS2WEB screens shown above.

Important: If the same calibration/software warning is noted on the TLC or SPS Summary screen, select OK and follow screen instructions. After a successful programming event, the WCC is located in the Service Programming System dialogue box of the SPS Summary screen. No further action is required. Refer to the Warranty section of the bulletin.
