Service Bulletin

Bulletin No.: 21-NA-049

Subject: Diagnostic Aid – PicoScope Information and Setup for Transmission Related Concerns

Brand:	Model:	Model Year:		VIN:		Engine:	Transmission:
		from	to	from	to		
Chevrolet	Corvette	2020	2024	—	—	All	All

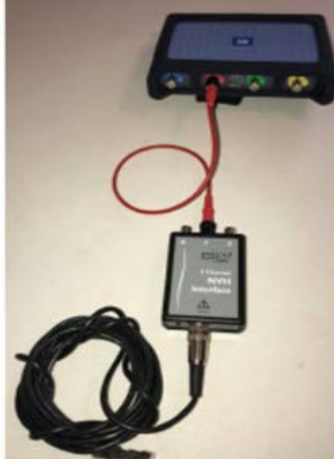
5751816

2. Open the most current version of GM NVH.

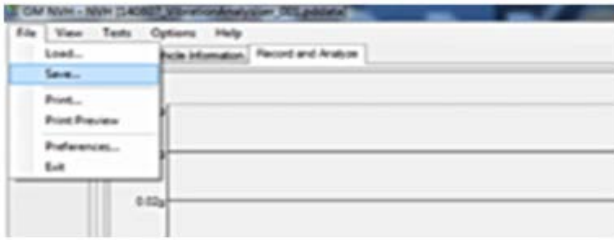
4. Drive the vehicle to verify condition and record a Pico data file of the concern.
 - ⇒ If diagnosing an acceleration or deceleration related concern, please hold the acceleration steady for 3-5 seconds After book marking while recording or allow a 3-5 second deceleration while recording. Tipping in and out of the throttle shows that it is load related but does not help isolate the source.
 - ⇒ If diagnosing a steady speed condition, please try and hold the steady speed for at least 5 seconds during the recording as it also allows for better isolation on our end when reviewing the files.
