GROUP	MODEL
ELE	2020-2024MY Multiple Models w/ AVN5W
NUMBER	DATE
303 (Rev 2, 2/09/2024)	August 2023

TECHNICAL SERVICE BULLETIN

SUBJECT: **AVN 5.0 WIDE NON-RESPONSIVE RADIO ICON (AM, FM, SXM)**

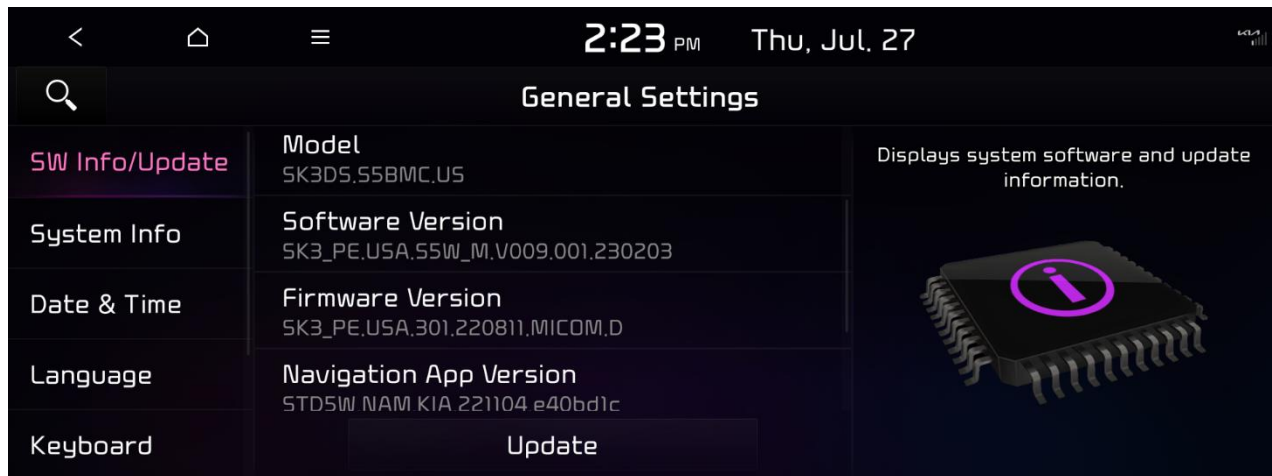
This bulletin provides information to update the software on 5th Generation AVN wide on certain 2020-2024MY Kia vehicles (refer to model list on page 3) to remedy a 'non-responsive' or 'inoperative' radio (FM, AM, SXM, etc.) concern. The affected AVN unit on the vehicles may not respond when pressing the 'RADIO' hard key/button on the AVN unit or when selecting the 'RADIO' icon on the AVN menu screen. Follow the procedure outlined in this publication to update the software on 5th Generation AVN wide units using the applicable USB Flash Drive A or B for the applicable vehicle.
