# Technical Service Bulletin

## 44 Repair Authorization - Model Year 2014 & 2015 alignment

44 14 54 2030275/10 August 26, 2014. Supersedes Technical Service Bulletin Group 44 number 14-53 dated August 13, 2014 for reasons listed below.

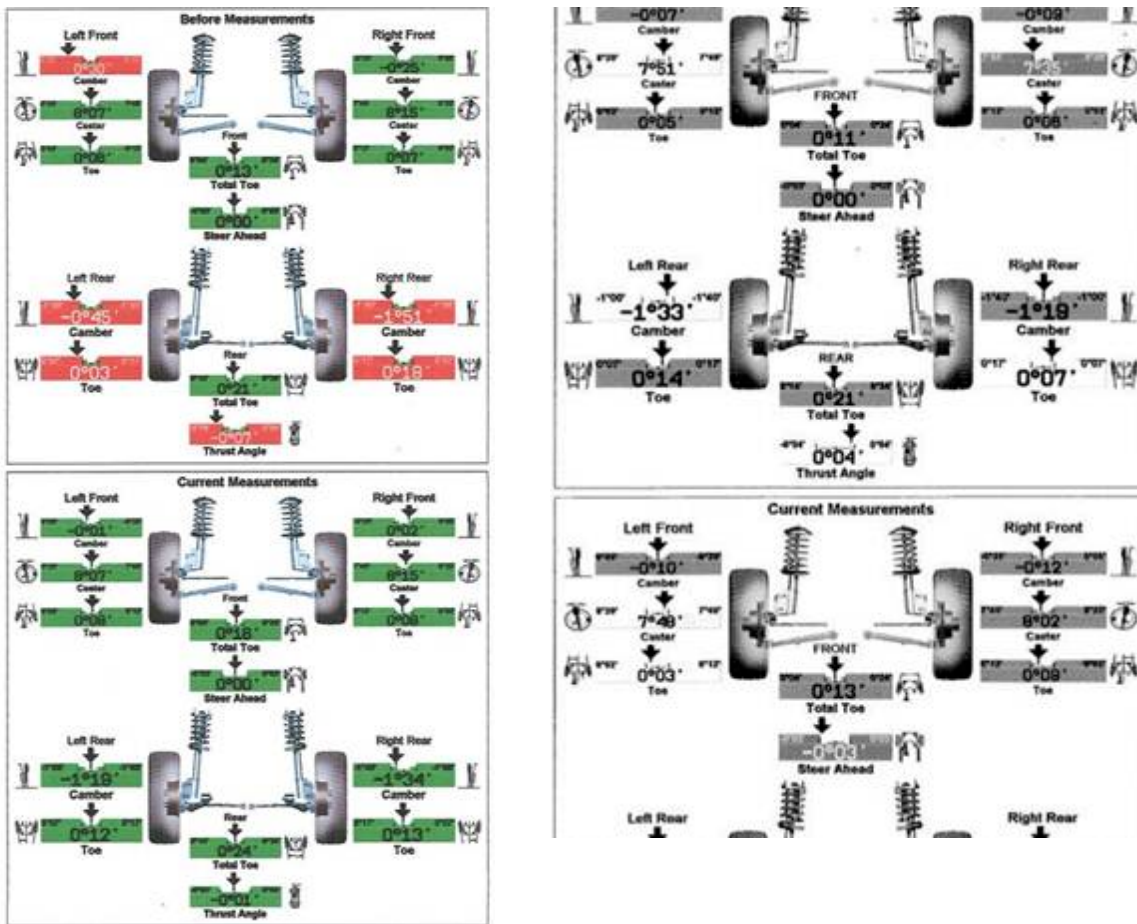
Figure 4. Examples of acceptable copies.

Examples of **acceptable** scanned copies with alignment values that are easy to read:

- a. The email must include the following information:
  - VIN
  - Repair Order number or claim ID
  - Mileage (from Repair Order)
  - Dealer Code
- b. Photo of the steering wheel should be a JPEG file and must clearly show how far the steering wheel is off-center.
- c. The before and after alignment measurements must be a scanned copy of the original in either PDF or JPEG format. Do *not* fax or send a photocopy of the documents. See the following examples of acceptable and unacceptable copies (Figure 4 and Figure 5).
