Technical Service Bulletin

44 Repair Authorization - Model Year 2014 & 2015 alignment

44 14 52 2030275/8 August 4, 2014. Supersedes Technical Service Bulletin Group 44 number 14-47 dated January 21, 2014 for reasons listed below.

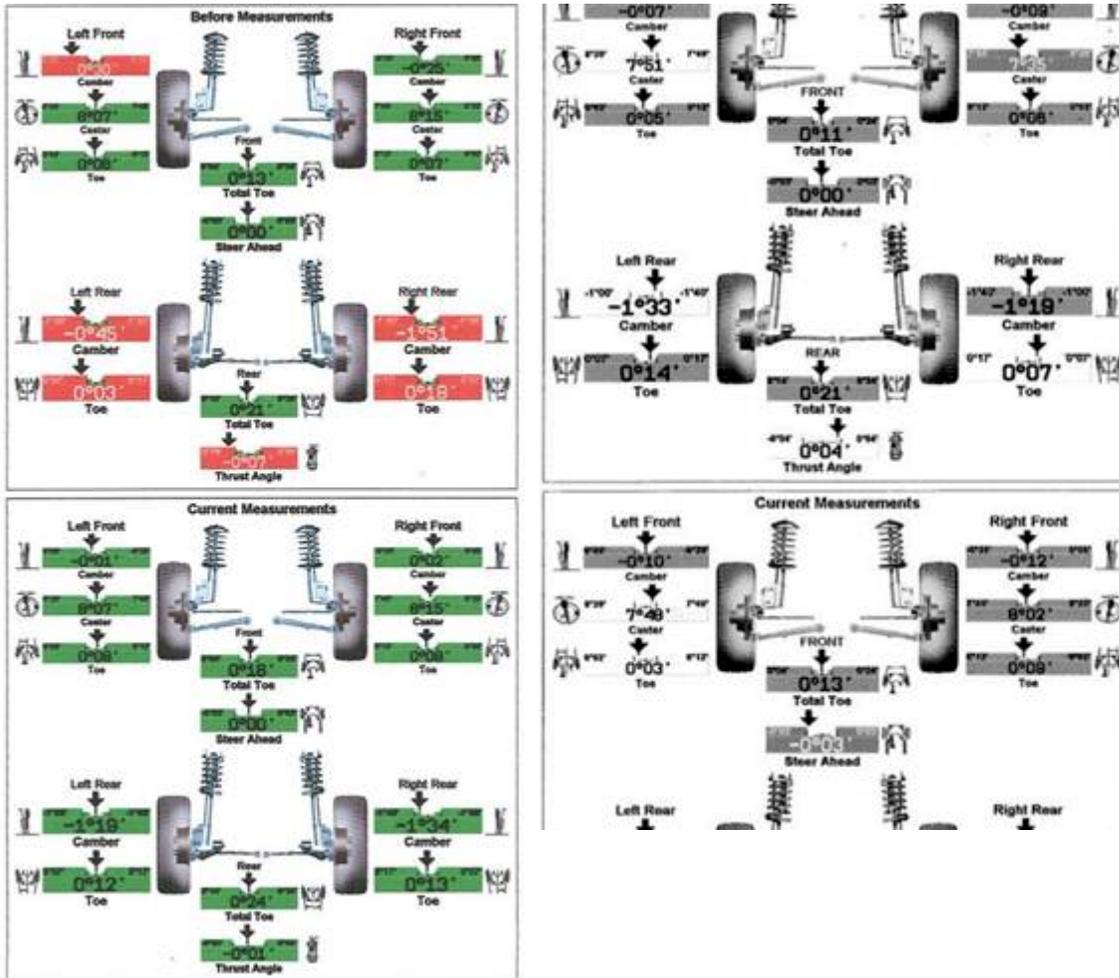
Figure 4. Examples of acceptable copies.

Examples of **acceptable** scanned copies with alignment values that are easy to read:

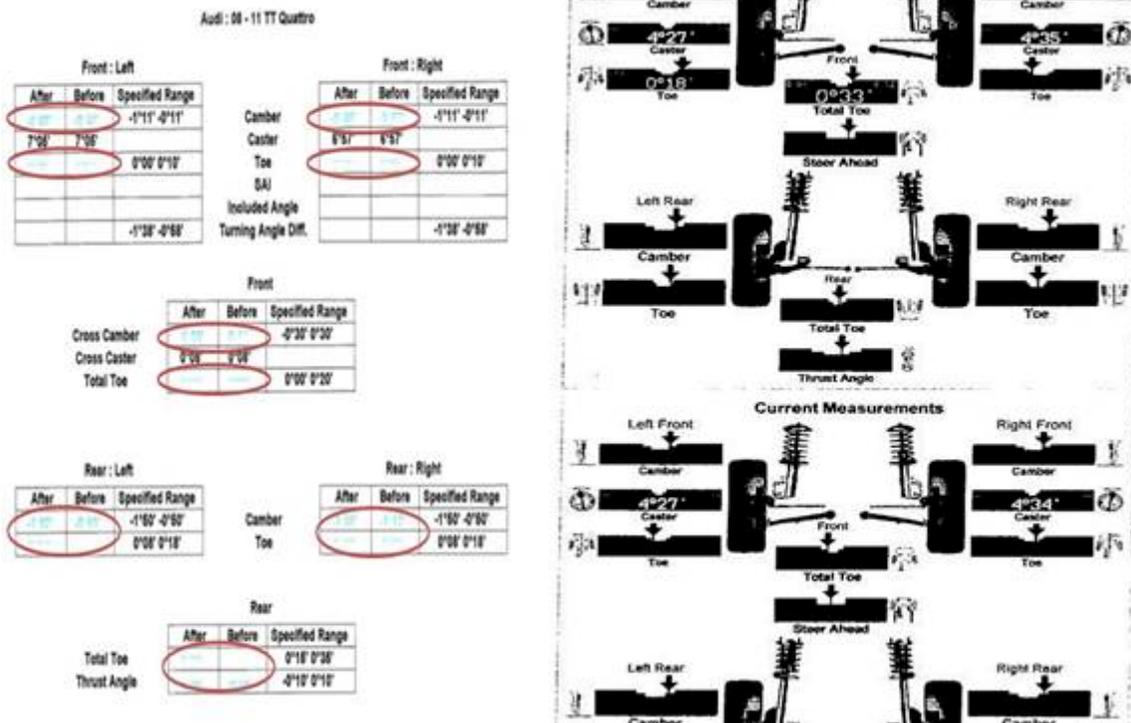
Figure 5. Examples of unacceptable copies.

Examples of **unacceptable** copies with alignment values that are missing or are difficult to see.
