Service Bulletin

Bulletin No.: 23-NA-115

Subject: Ticking, Tapping or Snapping Noise from Engine - 5.5L RPO LT6 Realign Camshaft Caps as Required

Brand:	Model:	Model Year:		VIN:		Engine:	Transmission:
		from	to	from	to		
Chevrolet	Corvette	2023	2024	—	—	5.5L (RPO LT6)	—

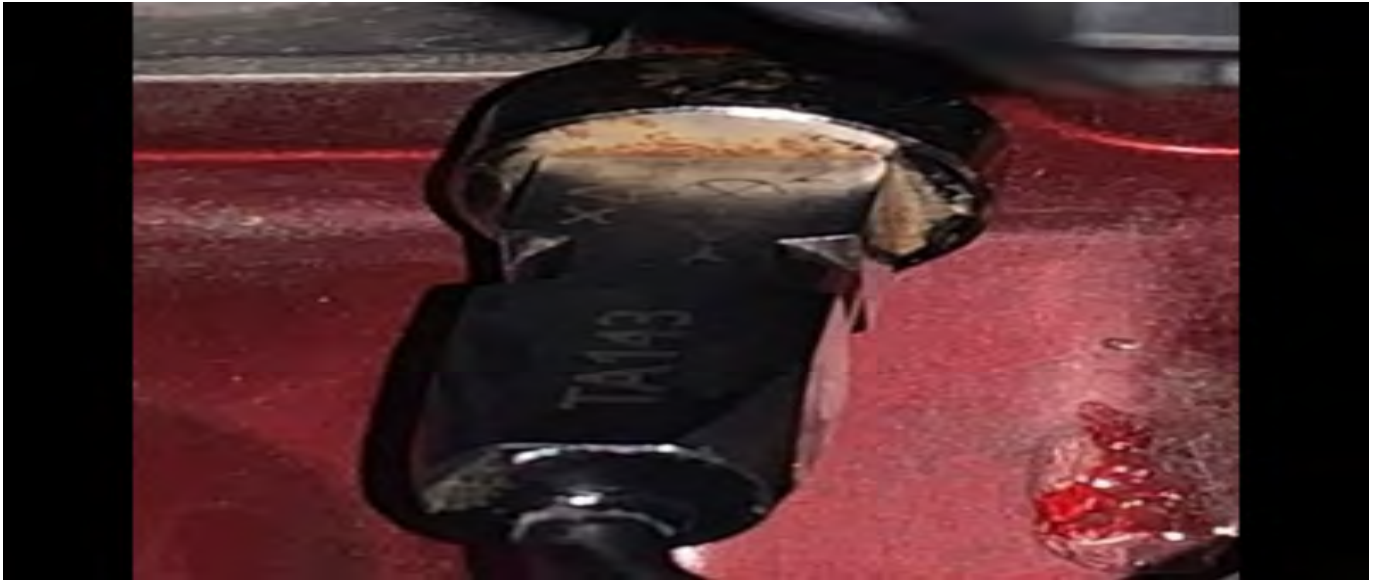
6374737

- ⇒ With the suspect bank determined, prep/position the accelerometer so the X, Y, Z coordinate system (that's laser etched) is facing upwards before securing to the bolt head. After accelerometer is placed on bolt head, double check to ensure its centered and did not rotate on the bolt head. Doing so will ensure the best results.

Important: Ensure accelerometer coordinates are facing up towards the intake.
