# Service Bulletin

Bulletin No.: 23-NA-115

**Subject:** Ticking, Tapping or Snapping Noise from Engine - 5.5L RPO LT6 Realign Camshaft Caps as Required

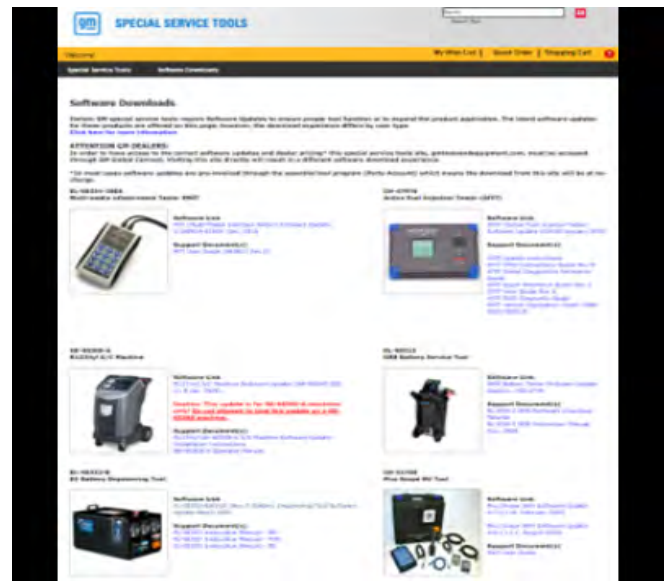
6374688

1. Log into GM GlobalConnect.
2. Click on the "Departments" drop down menu and select "Service."
3. Under "Applications" on the service page, select "Special Tools and Software updates." (in Canada, "GM Special Tools & Equipment - Software Updates")
4. You will now be re-directed to [www.gmtoolsandequipment.com](http://www.gmtoolsandequipment.com) (do not access this site directly as it requires the use of GlobalConnect to allow downloads).
5. Click the link under "Software Downloads" for the latest PicoScope software version and a new page will open.

6. Click the setup links and follow instructions to update the tool.

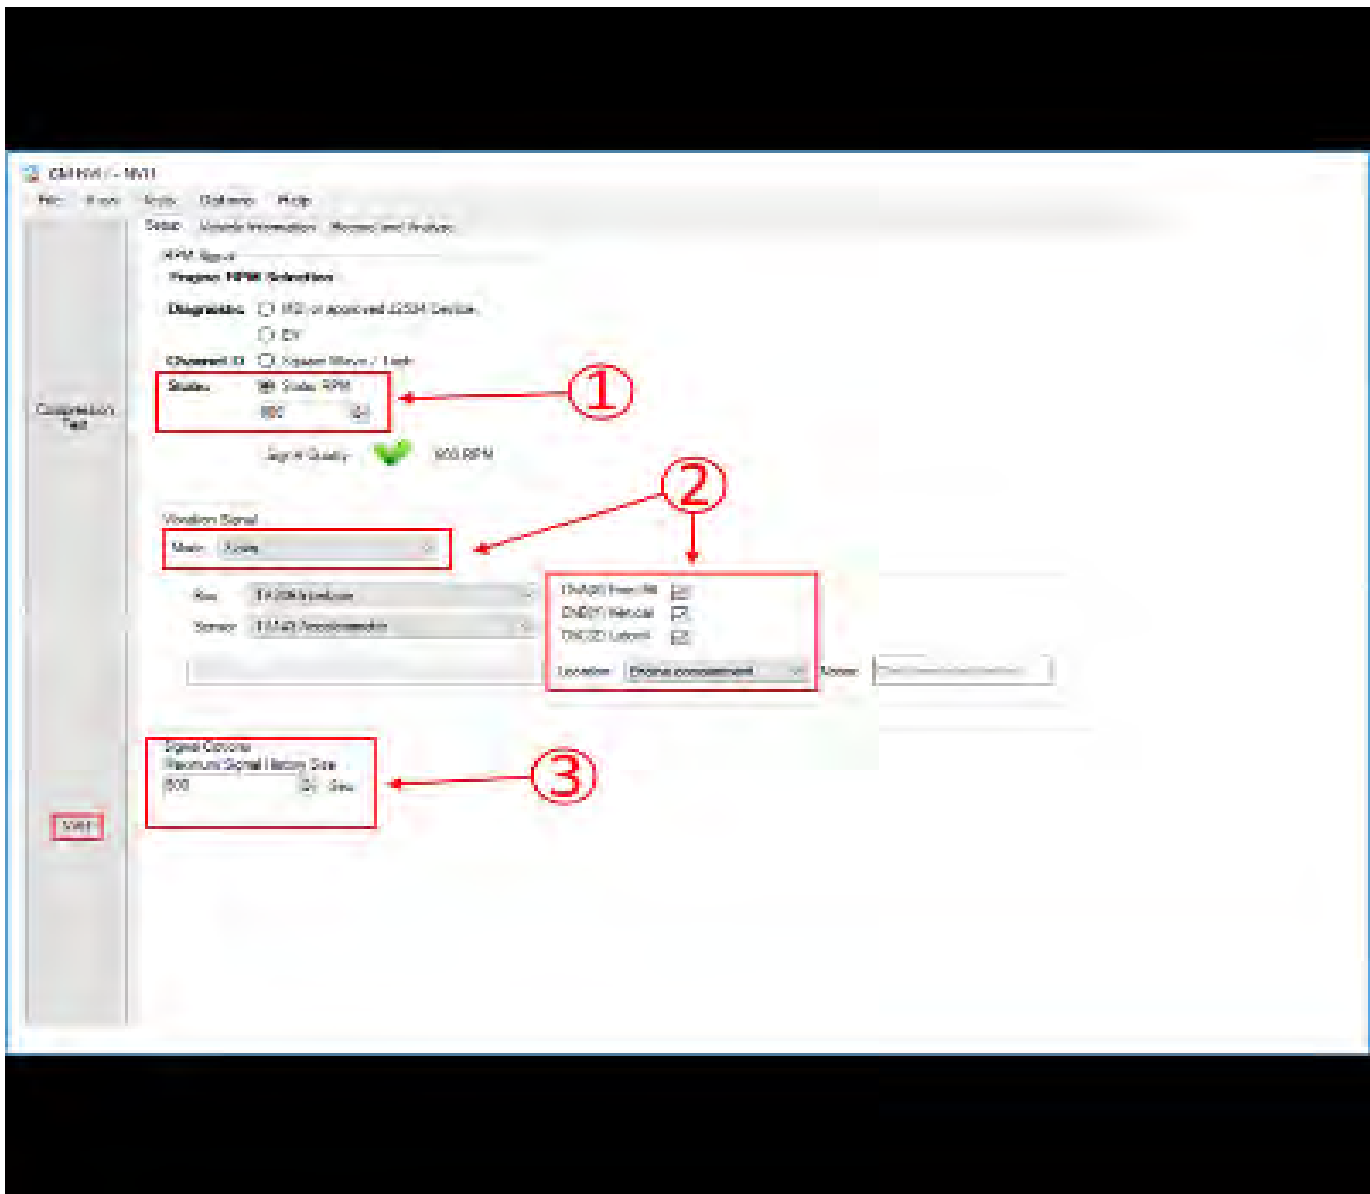
6374911

1. Open the GM NVH software and click on the NVH button.

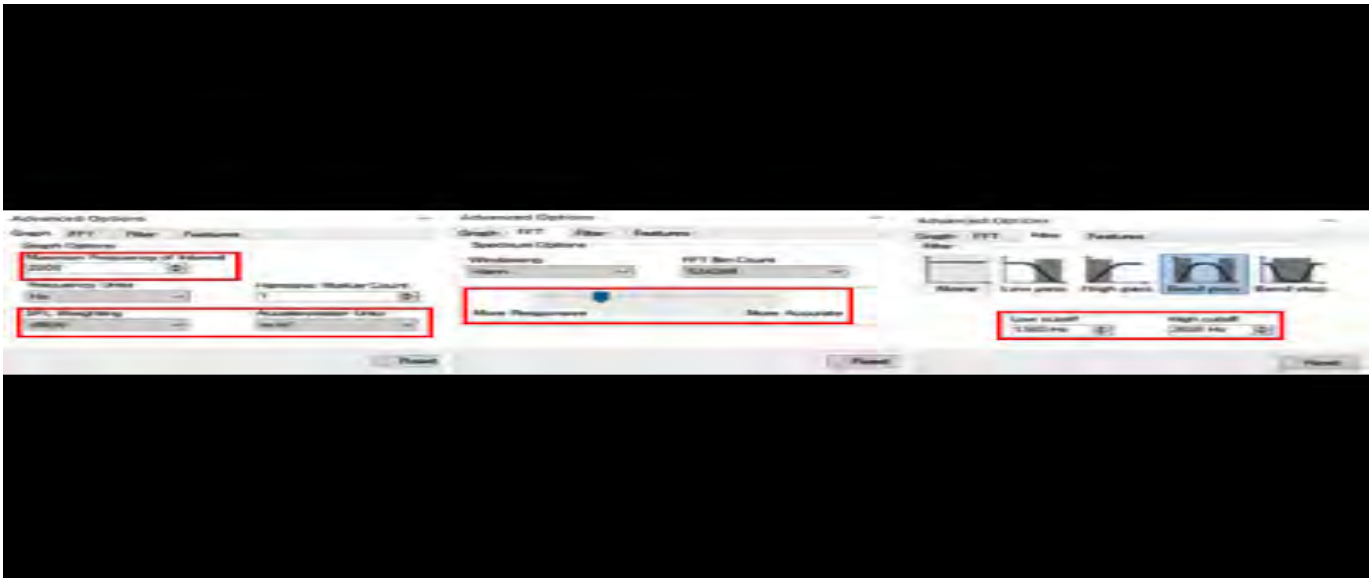
6374914

2. Start a new test with the setup wizard:
  - ⇒ 1) Under RPM Signal – Ensure Static RPM is set to 800 RPM.
  - ⇒ 2) Under Vibration Signal – Select three-axis mode then ensure all 3 channels are checked and the location is set to Engine Compartment.
  - ⇒ 3) Under Signal Options – Set the Maximum Signal History Size to 500 seconds.
3. Go to the setup screen to finalize the wizard setup.

- Go to options at the top then to advanced options and change the maximum frequency of interest to 2000. Update the SPL Weighting to dB(A) and check that the accelerometer units are (m/s<sup>2</sup>). Under the FFT tab, change the responsiveness marker to the position shown above. Finally, under the filter tab, add a bandpass filter from 1300 to 2000 Hz.
