GENERAL MOTORS
DCS6836
URGENT - DISTRIBUTE IMMEDIATELY

Subject: N232429880 - Service Update
Battery Energy Control Module

Models: 2023 BrightDrop Zevo 600
2023 – 2024 Cadillac LYRIQ
2022 – 2023 GMC HUMMER EV
2024 GMC HUMMER EV Pickup
2024 GMC HUMMER EV SUV

N232429880 Battery Energy Control Module

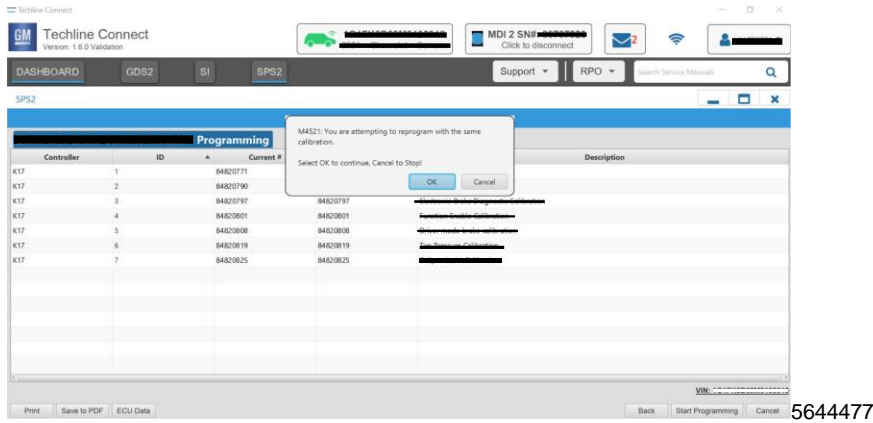
Important: Techline Connect screens shown above.

Important: If the same calibration/software warning is noted on the TLC Summary screen, select OK and follow screen instructions. After a successful programming event, the WCC is located in the Service Programming System dialogue box of the SPS Summary screen. No further action is required. Refer to the Warranty section of the bulletin.
