**SERVICE BULLETIN**

**NUMBER:** 15-236-18R

**SUBJECT:** Reprogramming File Availability for Optimization of Harman Gen 3.1 and Gen 3.1α Audio and Navigation Head Units

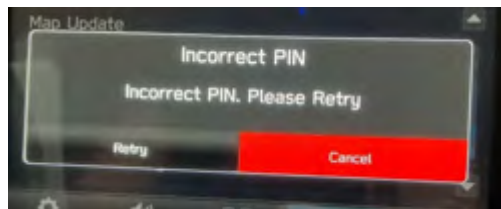
- 8) Repair Facility POI icons are now shown on the NAVI map display. See **NOTE 4** below.
- 9) Activation Code Not Accepted by Navigation System when updating Map Data

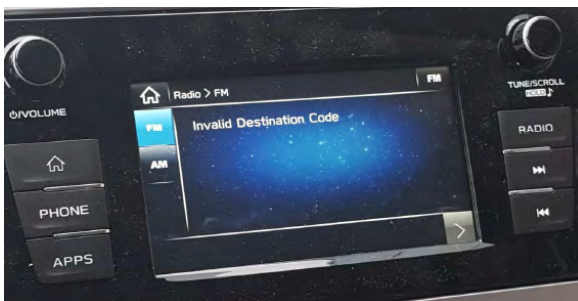
- 3) US State names corrected when using voice guidance.
- 4) Correction made for Pop / Crackling-type sound when using AM radio.
- 5) Navigation system freezes during loading / start-up.
- 6) Music skips/cuts out while using Apple CarPlay.
- 7) Hands-free feature freezes intermittently while loading.
- 8) Navigation system freezes after entering a particular address using Voice Recognition.  
**NOTE:** All other functions are not affected.
- 9) The voice guidance volume no longer changes After Ignition Off/On. Once the Voice Guidance has been muted, the system retains that setting even after switching the ignition Off/On.
- 10) Invalid Destination Code message appears on the display while listening to the radio.
