SERVICE BULLETIN

APPLICABILITY: 2019-23MY Impreza
 2019-23MY Crosstrek (Including Hybrid Model)
 2019-24MY Forester
 2019MY Legacy & Outback
 2019-21MY WRX
 2019-21MY BRZ- Navigation -equipped Models ONLY
 2019-22MY Ascent

NUMBER: 15-256-19R

SUBJECT: FOTA (Firmware Over-The-Air) Reprogramming
 Procedure to Optimize Harman Gen 3.1 Audio / Navigation Units

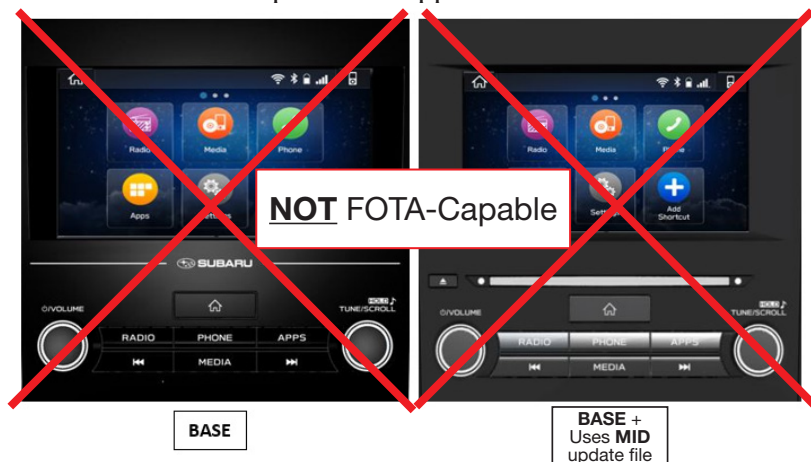
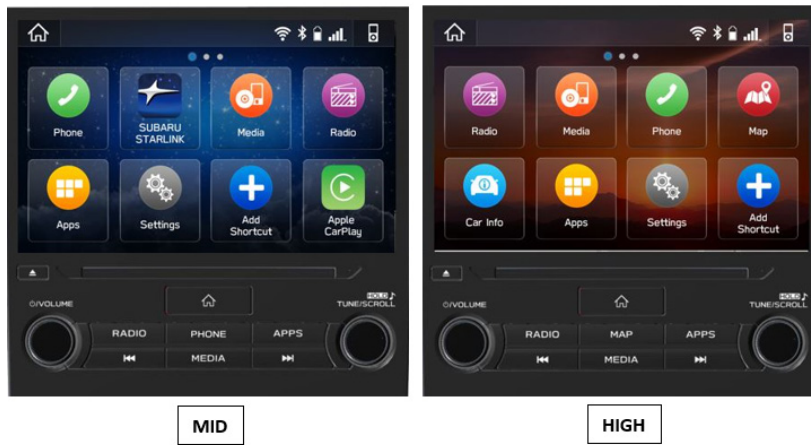
Reference photos of each head unit faceplate are supplied below:

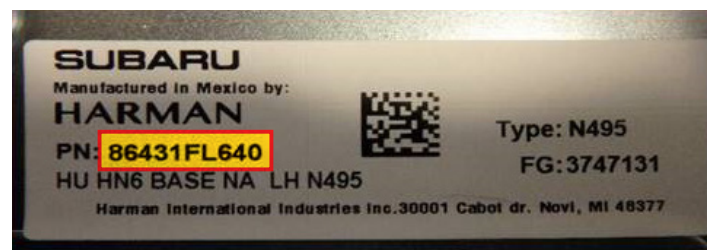
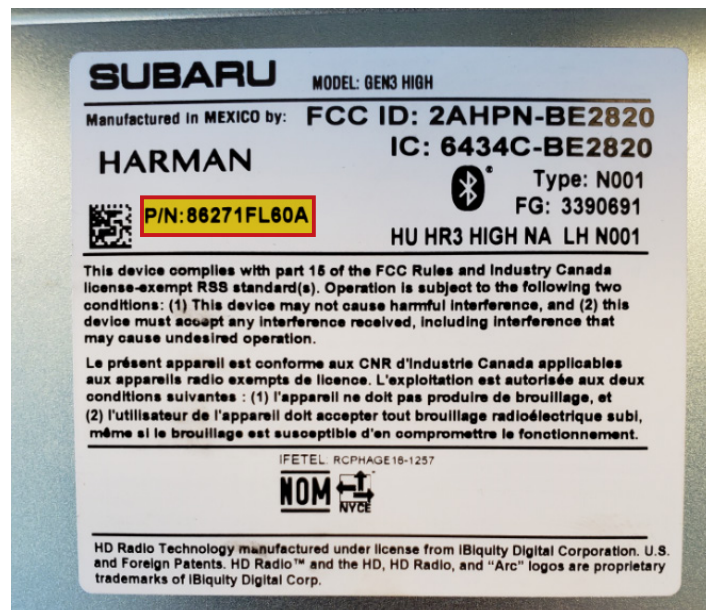
IMPORTANT NOTE: If the H/U needs to be removed for any reason, always confirm the part number shown on the unit matches the part number in the Electronic Parts Catalog (EPC) for the specific VIN being repaired. Example photos are provided below for reference.

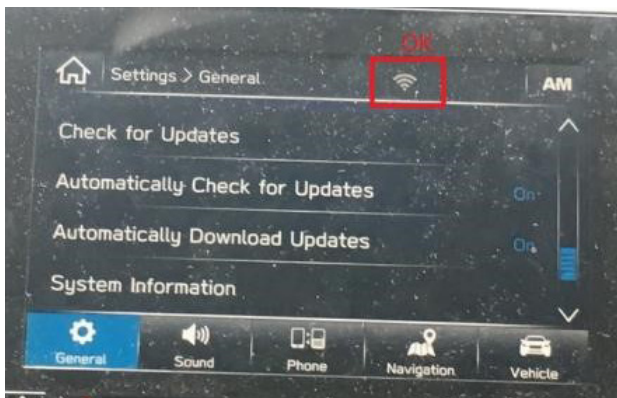
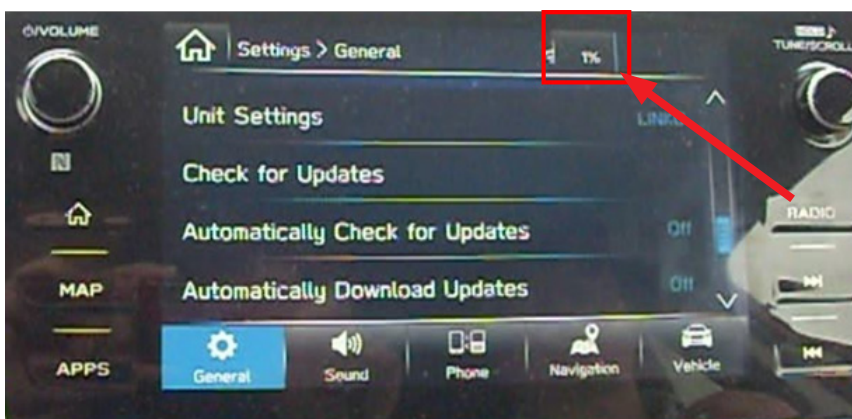
NOTE: Initially, it may appear that no action is occurring.

THIS IS NORMAL. Wait at least 2 minutes for progress percentage to appear in the upper right of the H/U screen before attempting to restart the process.
